Iowa Illinois Safety Award 2013

Iowa-Illinois Safety Council Safety Award Program

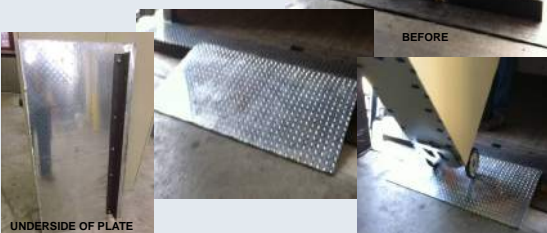
BEFORE

- Our box truck is a few inches higher than the dock. A metal plate was fabricated to allow an easy transition from the dock to the truck.
- The plate eliminates the trip hazard and reduces the risk of the load tipping.

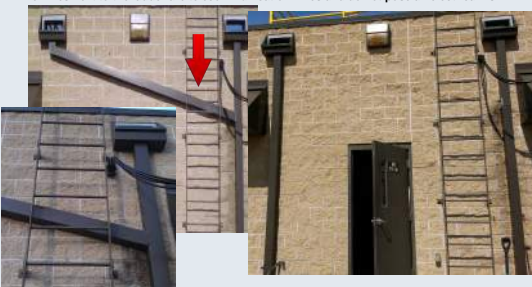
- A drain spout running behind a ladder leading to the roof, made it impossible to use one of the ladder rungs. The drain spout was detached and there are now two separate spouts, eliminating the hazard.
- The wires next to the ladder are telecommunication wires and do not pose an electrical risk.

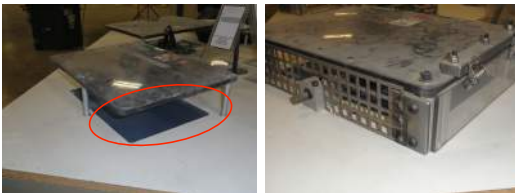
Windsor Windows & Doors Routing Tables

Windsor has several routing tables in the facility and time was taken to better guard the equipment for the safety of employees.

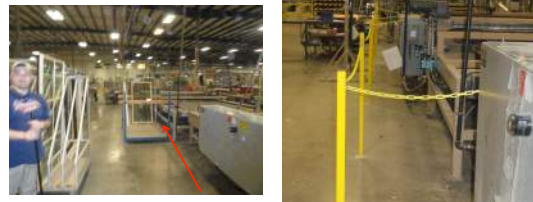
**Windsor Windows & Doors
Wood Casement Production Line**

Chains/barrier was added to the back side of the production area to prevent employees from entering the area – better guarding of equipment.

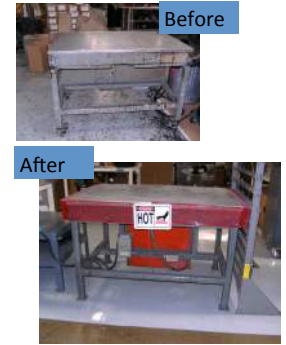
1. Hot Plate Visibility

- Hot plate oven not clearly marked, only gray framing
- Visitors to area were unaware that the table could be hot and burn them
- Installed hot signs and painted red to increase awareness

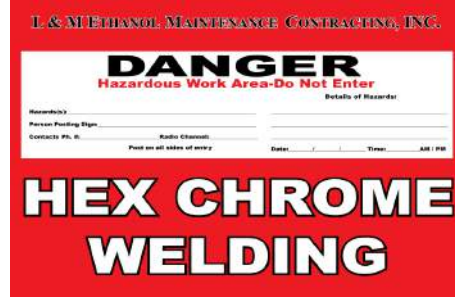
This is signage I designed to take the place of small hand written tags that our company was having issues with people not seeing and disregarding. Now all info is on the sign and we can better protect people from stepping through red tape areas containing Hex Chrome welding projects. Used in combination with our JSA this also allowed us to have all info in one spot for our guys to better determine hazards. This has been a great help for your professional safety outlook on jobsites.

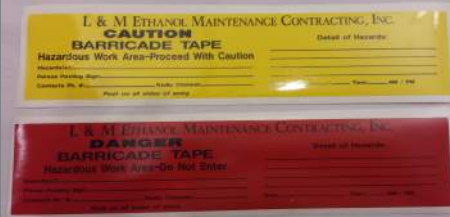
This year L & M implemented new stickers for use with any and all red or yellow caution taped areas of work. These stickers are much better at conveying what is going on in the area and who is in the area working. These took the place of everything from scrap pieces of paper to danger tags. The stickers have specific info where the other tags had to have all info written on them and many times people would forget a piece of that info causing a safety hazard in some cases

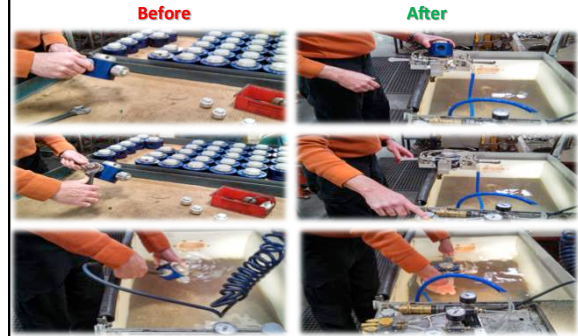
In order to leak test these products air connections and plugs were manually inserted by hand and wrench. There are 3 sides with a plug and 1 side with an air connection. The product had to be leak tested in the water tank and then disassembled. A pneumatic fixture was engineered eliminating manual assembly and disassembly. Ergonomic hazards were mitigated and efficiency was improved.

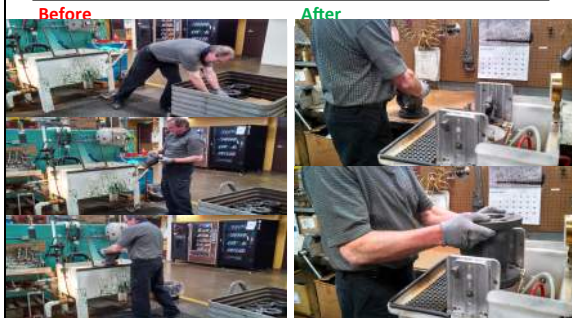
Leak testing of many products previously required employees to load a tub full of products and transport to a central leak testing station. The station would be manually reconfigured with adapters for the specific product being tested. This took valuable time and effort. Individual leak testers were engineered and ergonomically located at each work station eliminating much of the product handling, manipulation, and lost production time.

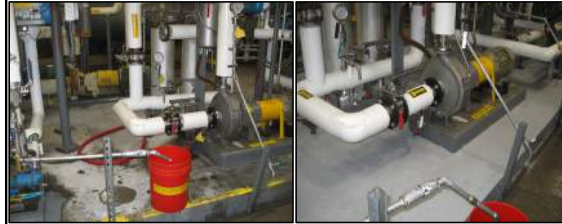
Traditional paint peeled with high temps and caustic exposure which made for slippery surfaces.

The surface was redone with anti-slip material then coated in temp resistant and chemical resistant paint.

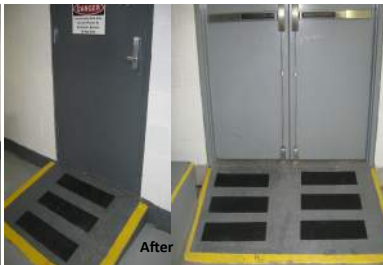
There is a sloped incline going in and out of Distillation. When this surface gets wet, it gets very slick and it is hard to get traction to push open the heavy doors because distillation is under vacuum.

We laid down grip strips so we have better traction, therefore reducing the slip hazard.

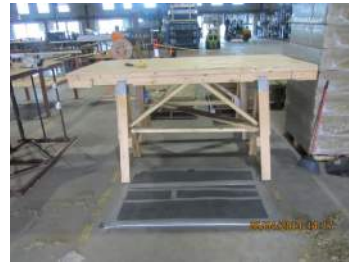
Work Stations

Work station built for proper height and ergonomic floor mat bought and secured in place for continuously standing at work stations.

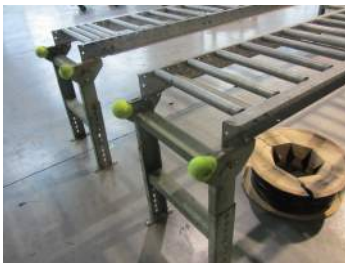
Edge Protection

A near miss reported a torn pant leg from the metal protrusions. Tennis balls were secured in place to guard the roller line ends.

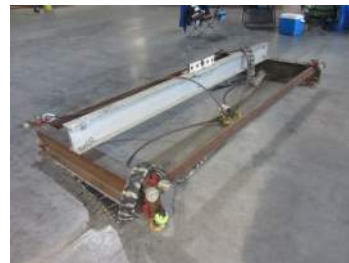
Edge Protection Continued

Unitized window picking apparatus was also equipped with modified tennis balls to protect from the metal ends.

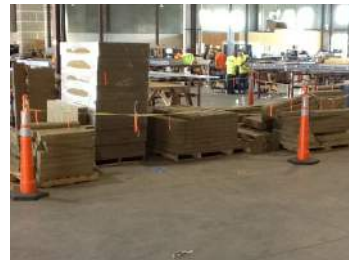
Material and Storage Areas

Cones and hulu skirt tape is used to discourage employees from walking through and over stored materials. Secondary function was to provide better visibility for fork truck operations.

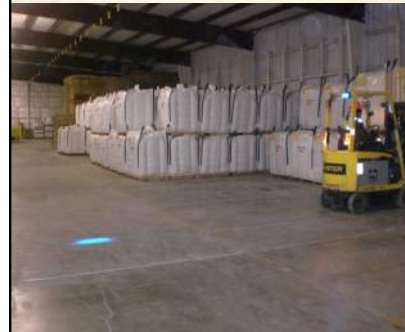
Forklift Blue Lights

Site Added Blue Lights to the backup system on all our forklifts. The light shines into the aisle as operators back out of a row of seed, alerting oncoming traffic. This system works especially well at blind intersections and when operators are deep into a bay.

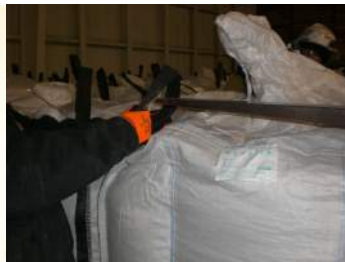
Hi-Viz Gloves

The site uses Hi-Viz gloves for hanging bulk seed bags on the forklift. This allows the operator to see the employees hands and reduce the chance for a finger getting pinched.

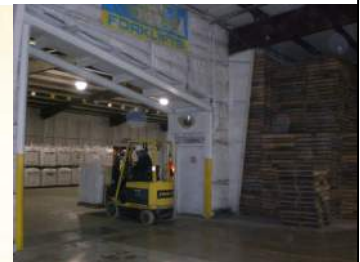
Forklift Speed

The site programmed our forklift speed down to 80% of max. This has resulted in a great reduction of tipped or spilled bags due to operators turning and hauling product too fast.

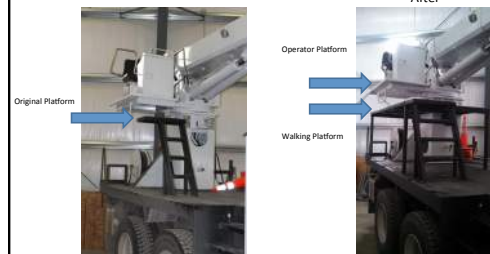
It was difficult for our crew members to access the operator's chair on our digger trucks with the original equipment being a small narrow platform. We added a walking platform all the way around allowing the operator to be able to get off and on easily. The stairs going up to the platform were also made wider.

The original setup was extremely dangerous. Employees would stand on a narrow elevated platform and then step onto the operator platform. Getting down was even worse if the small platform wasn't right under the operator. This is where we would see employees jumping from the operator platform to the bed of the truck. No one was injured getting on and off the old system but it was going to be a matter of time before they did. With the newly added walking platform, employees can get off and on the operator platform with a lot more area to move around no matter which position the boom of the truck is in. The stairs going up to the platform were also made wider.

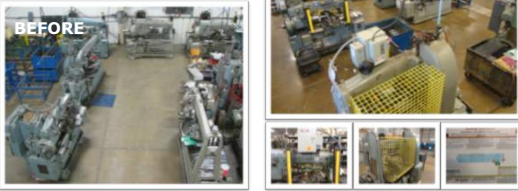
Before: Hobbs were unguarded, had blocked access panels, non-compliant e-stops, and had obsolete Lockout Tagout procedures.
Hazard: Entanglement and pinch points.
After: Lockout Tagout audit completed, LO/TO placards placed on each machine, employee LO/TO training completed. Hobbs were hard guarded on back and sides, and fitted with: light curtains at access point, secondary electrical disconnect, lockable air disconnect, and emergency stops. Layout change allows access to all panels. Ergonomic mats also placed at machines.

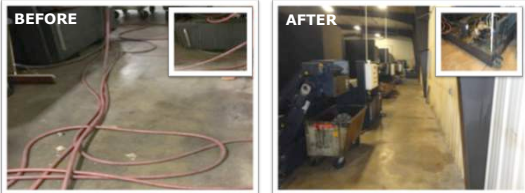
Before: Coolant was added to each of four interconnected horizontal machining centers by extending a 100 ft. section of hose to each unit multiple times each week. Each unit holds 300 gallons of coolant.

Hazard: Trip hazard caused by extended hose on floor and ergonomic concern pulling hose to each machine.

After: Coolant and water hard piped to each machine from a single source. Trip hazard and pulling requirement eliminated from operation.

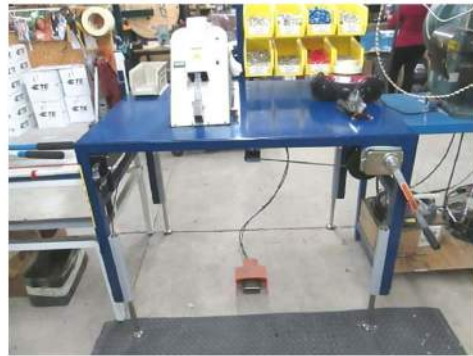
Wire Crimping station has adjustable legs and a tilt platform for the wire crimper to provide better angles to the work. Leg "kits" are being added to many other work stations to adapt to a variety of employee heights.

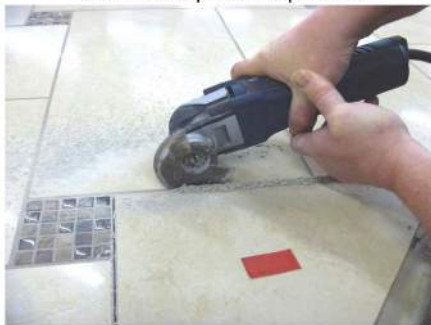
Vibrating tool replaced disc grinder for ceramic tile floor rework, practically eliminating dust exposures that had required respirators.

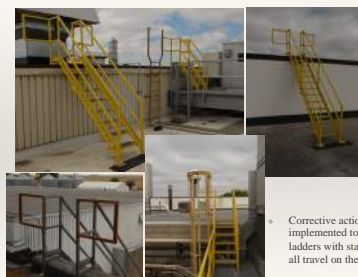
Stairways Replaced Ladders

- ◊ The use of ladders created a potential hazard for employees traveling from roof to roof

- ◊ Corrective action was implemented to replace all ladders with stairways for all travel on the roof

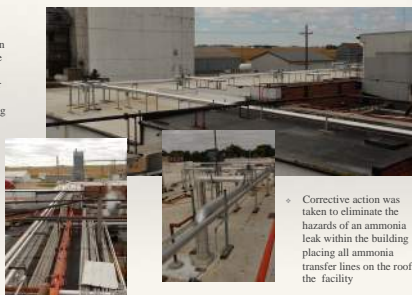
Relocation of Ammonia Lines

- ◊ A hazardous working condition existed within the facility with ammonia transfer lines distributed inside the building

- ◊ Corrective action was taken to eliminate the hazards of an ammonia leak within the building by placing all ammonia transfer lines on the roof of the facility

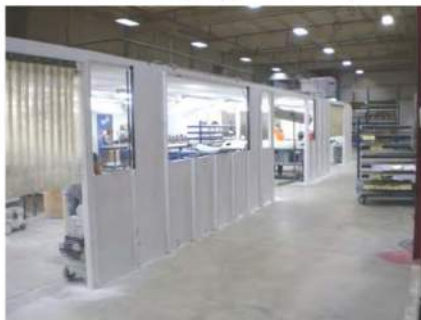
New Sanding Booth Combined Several Individual Locations Improved Lighting & Dust Capture

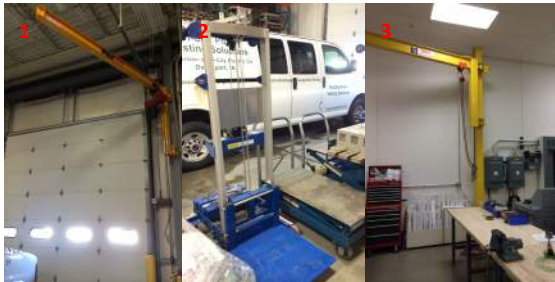
In the past, heavy circuit breakers had to be maneuvered off trucks and onto work benches in the tech shop. Many times, this required lifting. Therefore, we developed a "zero-lift" procedure for moving them from truck to bench. The breakers come in on a flat bed truck, a hoist picks them down onto a cart, where they are pushed into the tech area, then hoisted up onto the table. This helps significantly reduce strains/sprains risk.
