2019 Hazard Control Awards

an **nsc** chapter

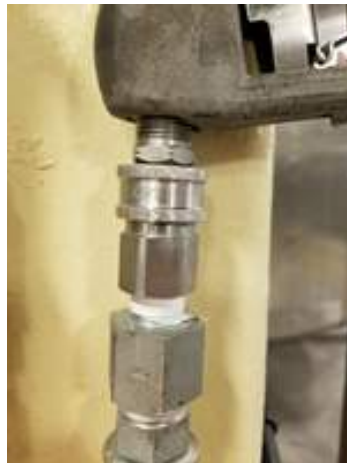
Washdown Hose Quick Connect Coupler

Employees were being exposed to thermal burns due to inadvertent release of spray nozzles from the connecting hose.

To reduce the risk O-rings were placed in between the spring loaded coupler to prevent inadvertent release of the nozzle.

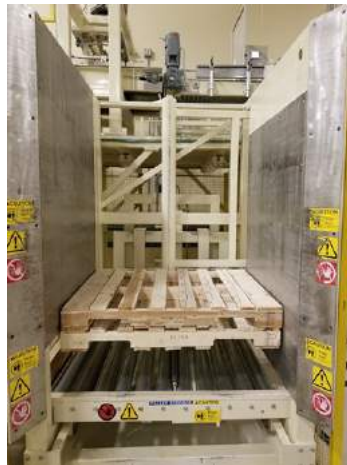
Improved Machine Guarding

Manufacturer design on automated pallet feeder did not fully protect employees. The diagonal photo sensors allows employees to reach in the machine and not be protected if it started automatically.

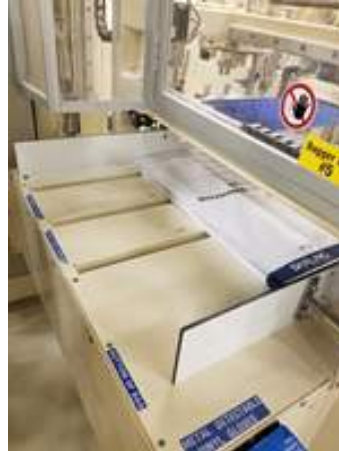
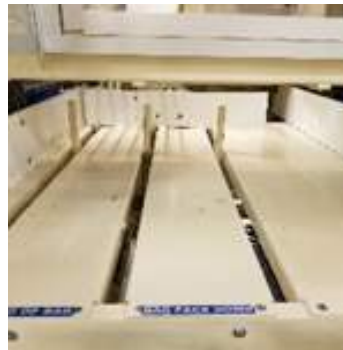
Improved Machine Guarding

The machine automatically pulls bags into the machine. If an employee was loading bags when the machine automatically starts, our employee could be at risk.

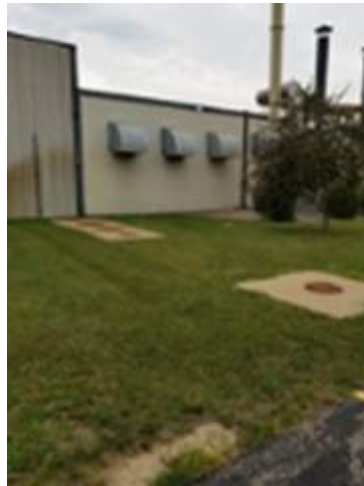
Fall Prevention

A fall risk was present while an employee was cleaning duct screens during wet or snowy weather.

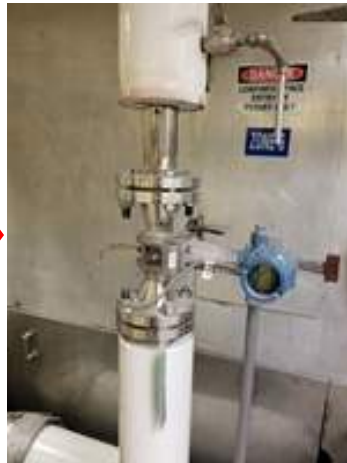
Thermal Burn Prevention

Some process piping was not being insulated due to the need to access the areas for service.

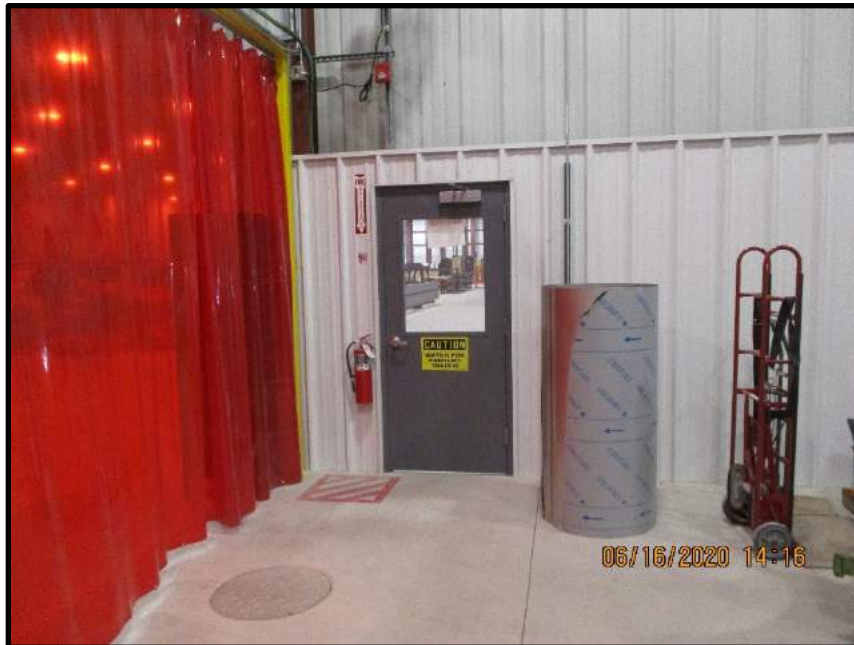
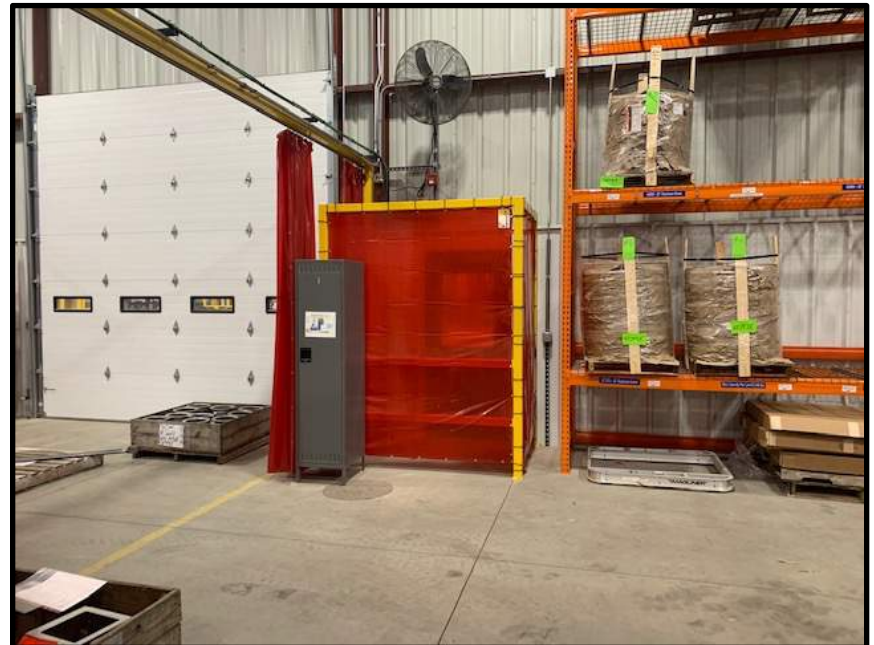
Before

Visitors to the Aluminum Weld Department were exposed to weld flash when entering the door into the Stainless-Steel weld area. A barrier with a weld curtain was installed to eliminate the exposure to a weld flash hazard.

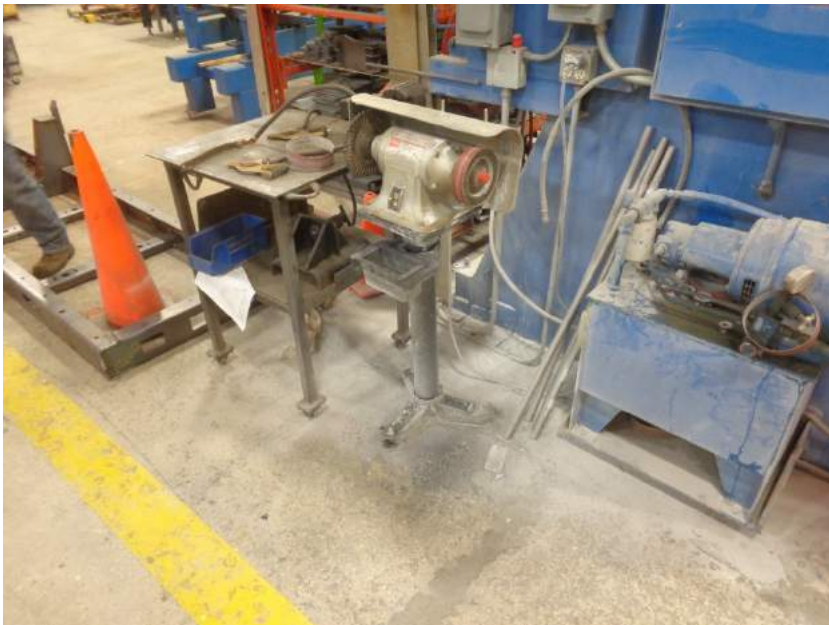
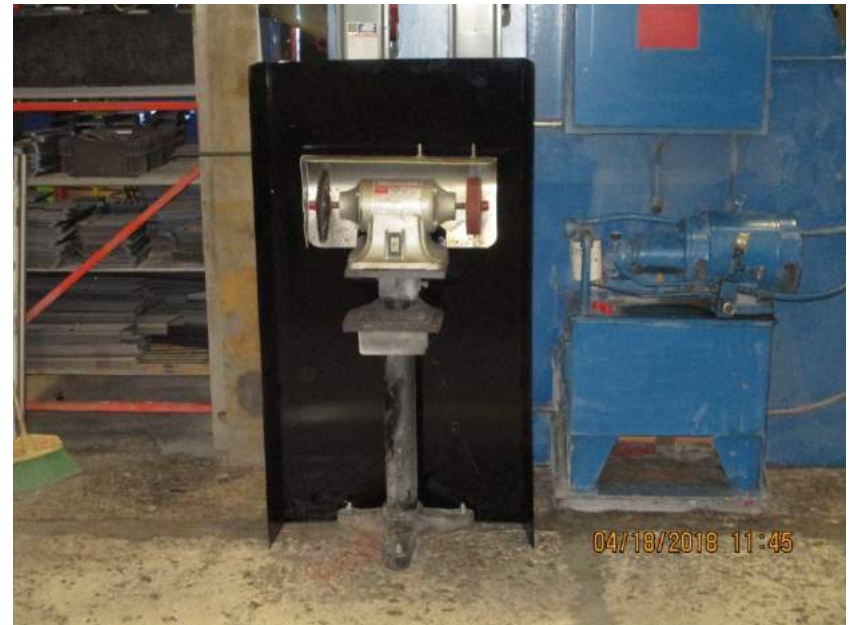
Before

**The area surrounding the pedestal sander was always containing grindings.
A containment shield was constructed and placed around the pedestal sander containing the grindings.**

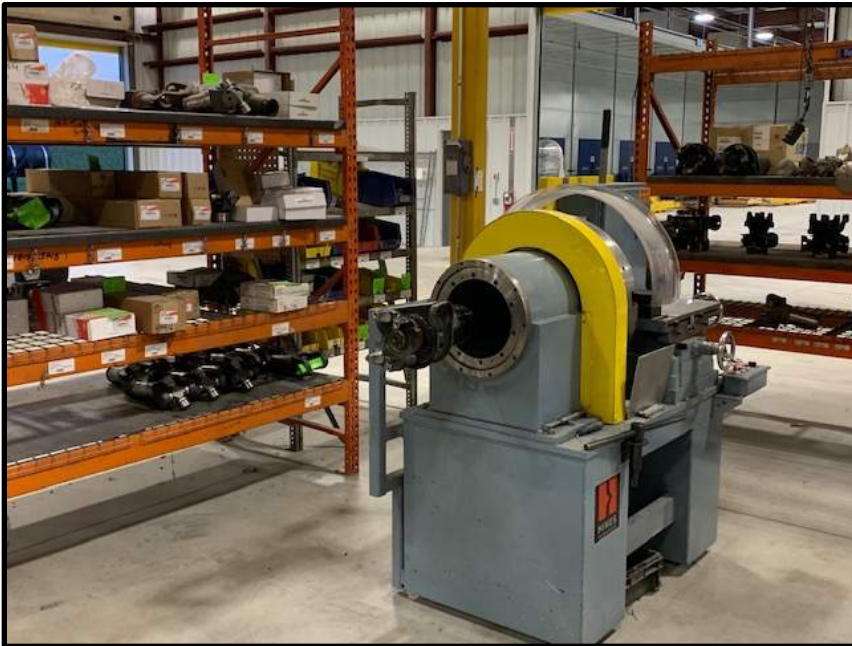
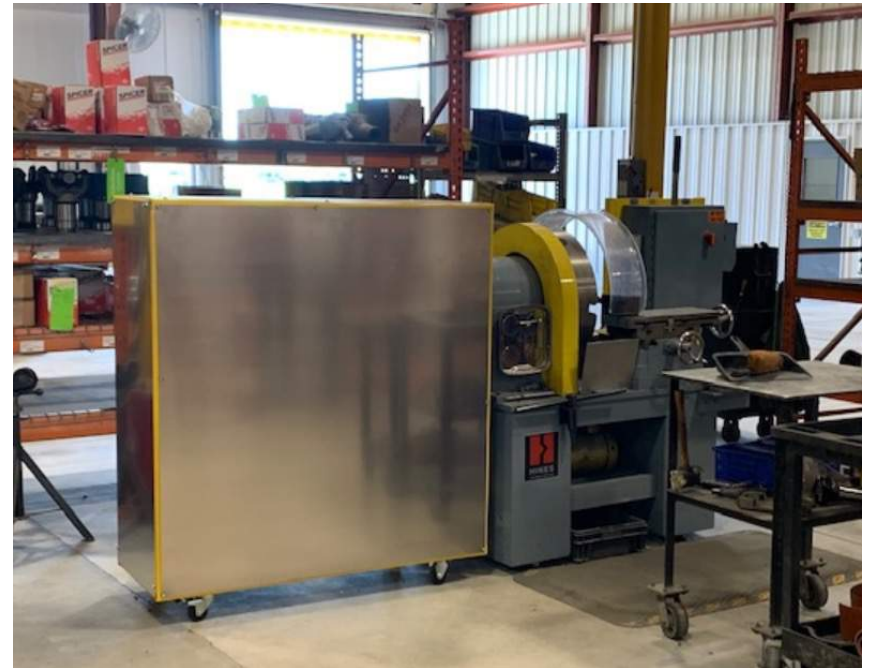
Before

Driveline Lathe: The PTO shaft extends past the confines of the lathe. A guard was designed and installed to enclose the rotating shaft.

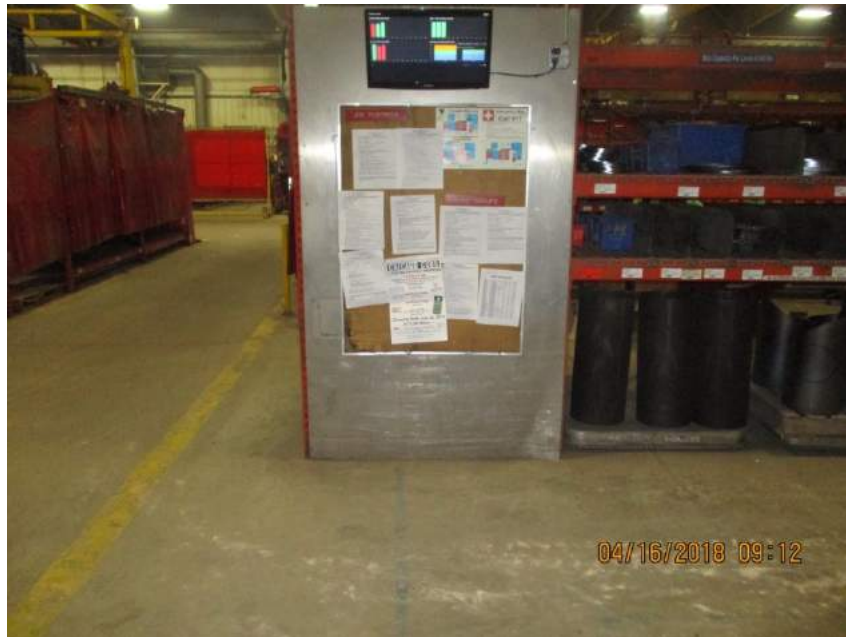
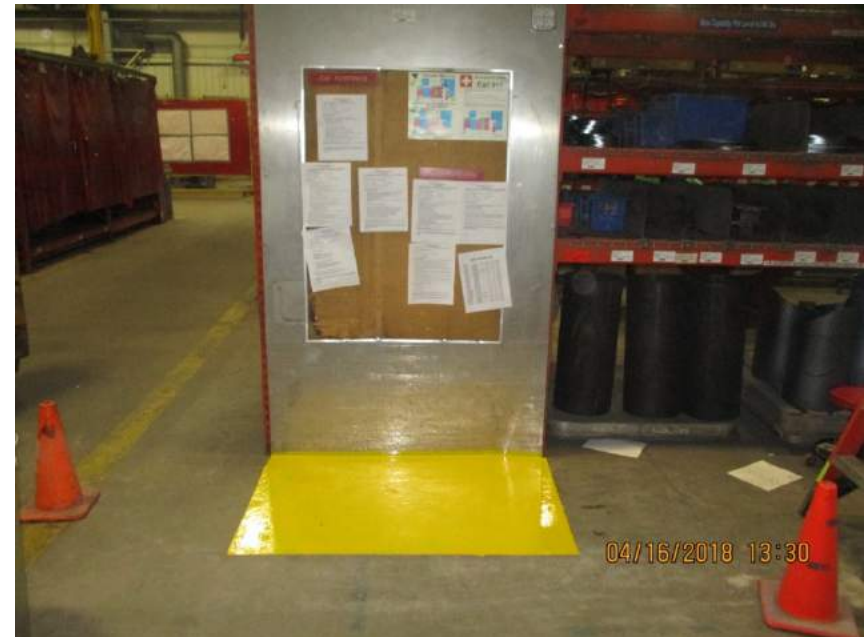
Before

Items were being placed directly in front of an employee communication board obstructing access. Area was painted yellow to identify restricted area.

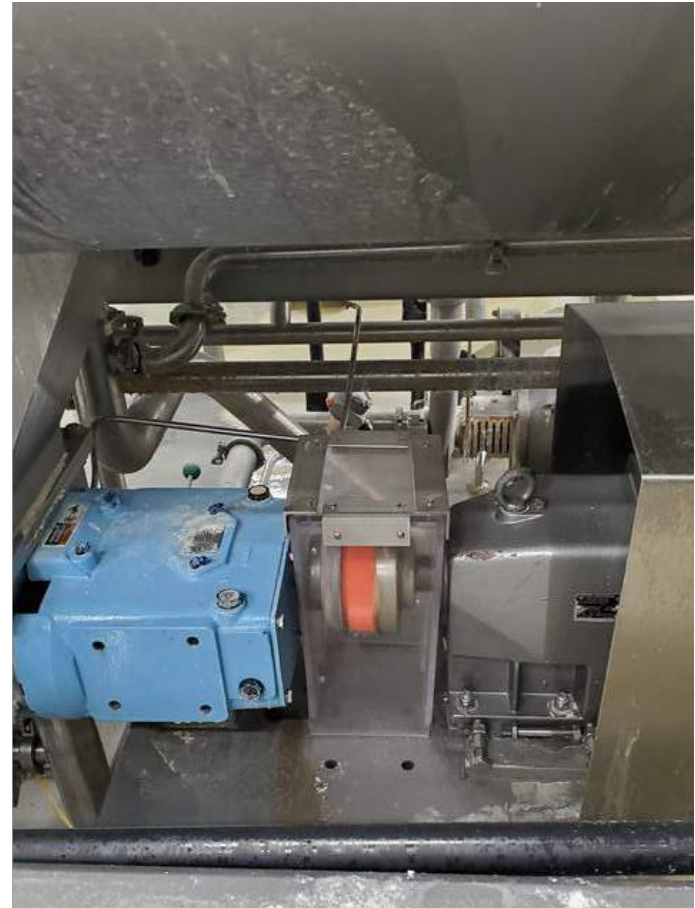
AFTER GUARD

A guard was added to eliminate the hazard of the spinning shaft.

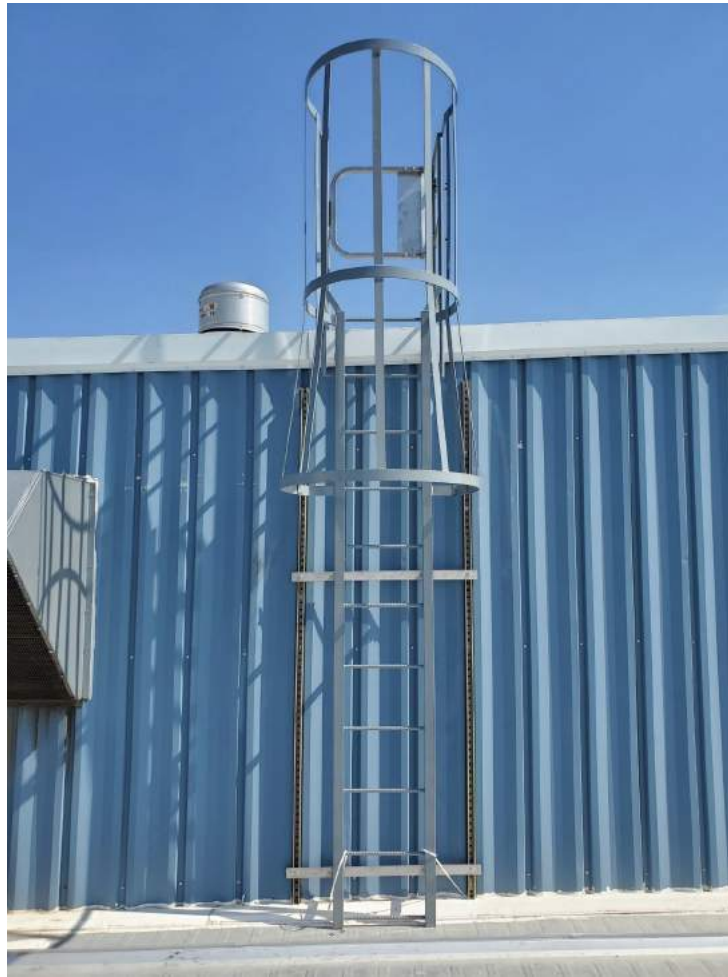
Roof Access Improvement

The fixed ladder replaced an extension ladder that was previously used to access that portion of the roof.

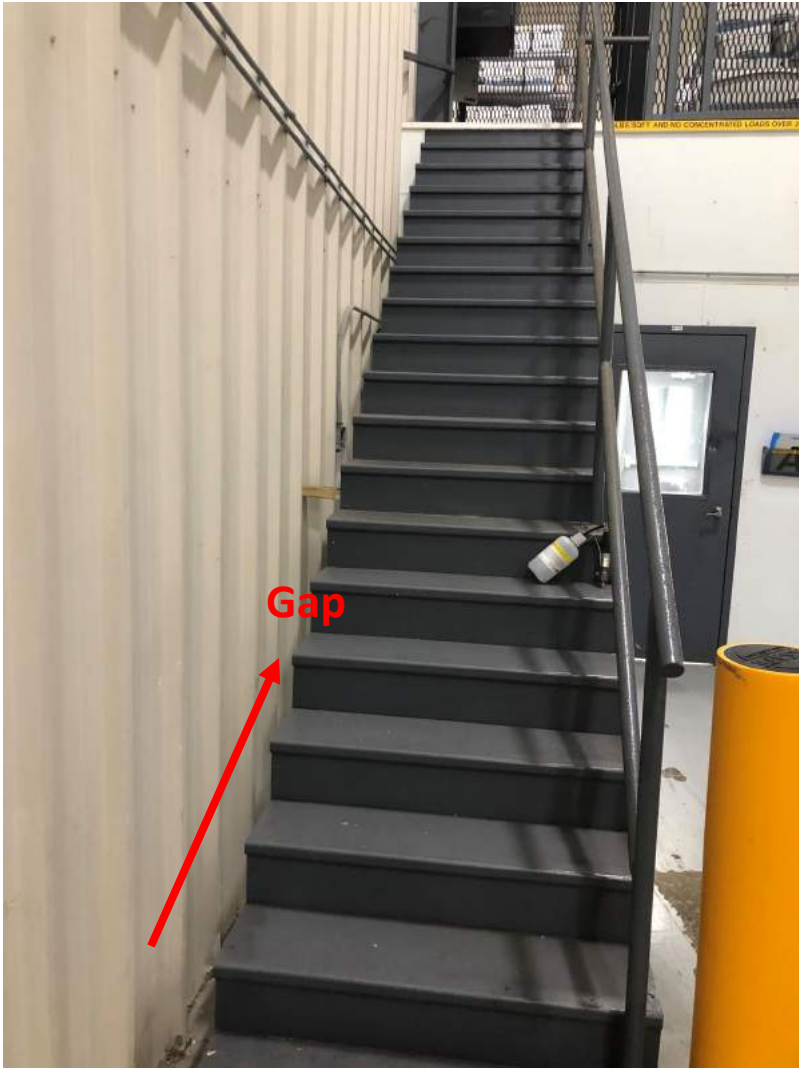
Silo Steps Handrail

- A handrail was added to the steps to help minimize slips/trips/falls

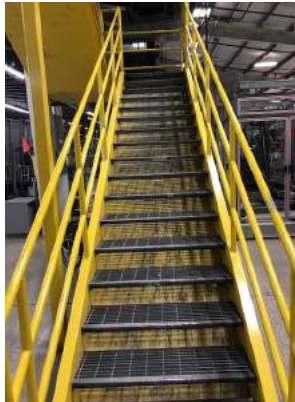
Before

Stair treads to our Mezzanine are metal which can be slick in the winter with wet shoes.

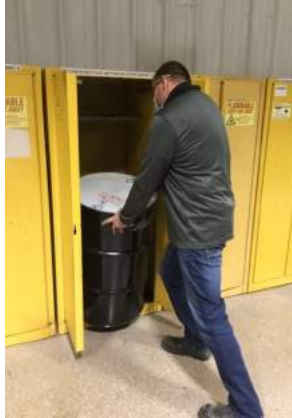
Before

When putting barrels into flammable cabinets, we had to manhandle them.

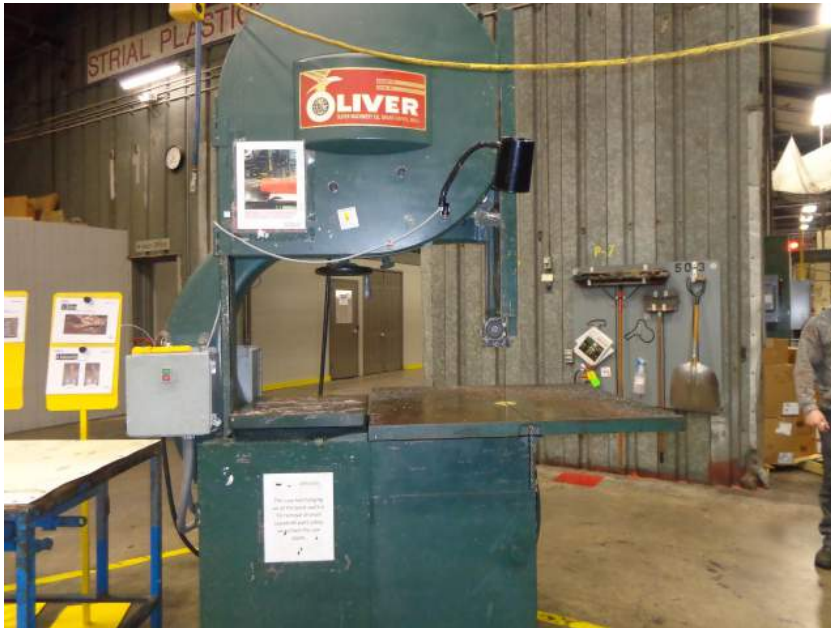
The old style of cutting our field tile was with a band saw. Possible hazards cutting hands or fingers while pushing part through to cut ends off.

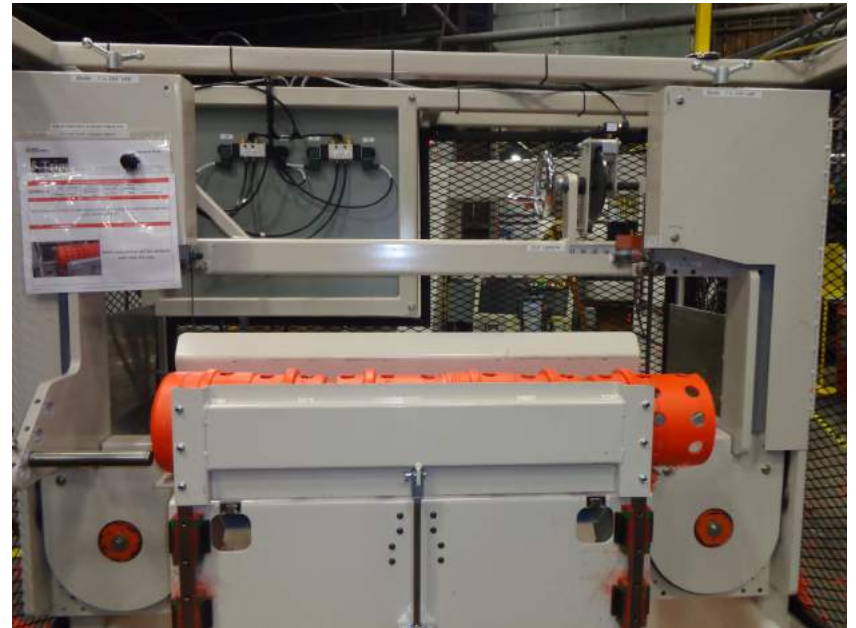
Our new fixture used to cut the ends off our field tile. We eliminated the hazards. Now just put the part in the fixture and push a button.

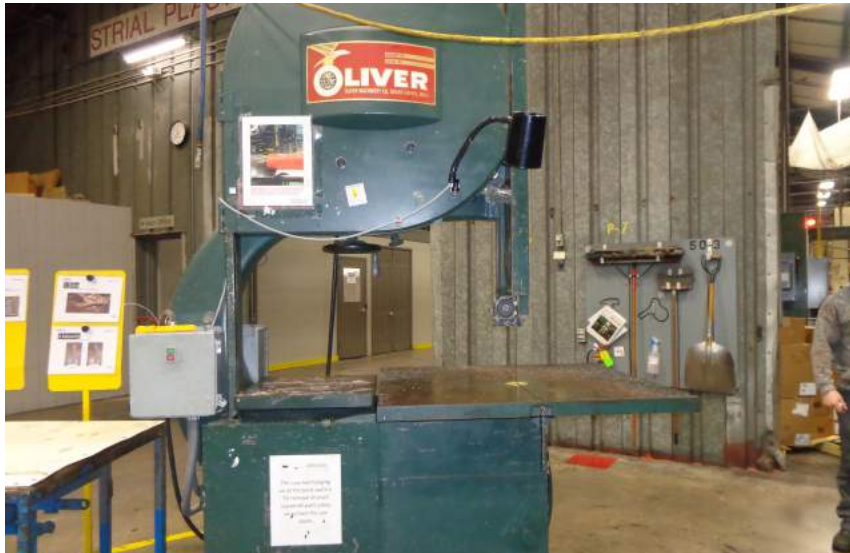
The old style of cutting the ends off our deer legs. Using a bandsaw, the possible hazards of using a bandsaw, cutting hands, or fingers, Which could be severe injuries.

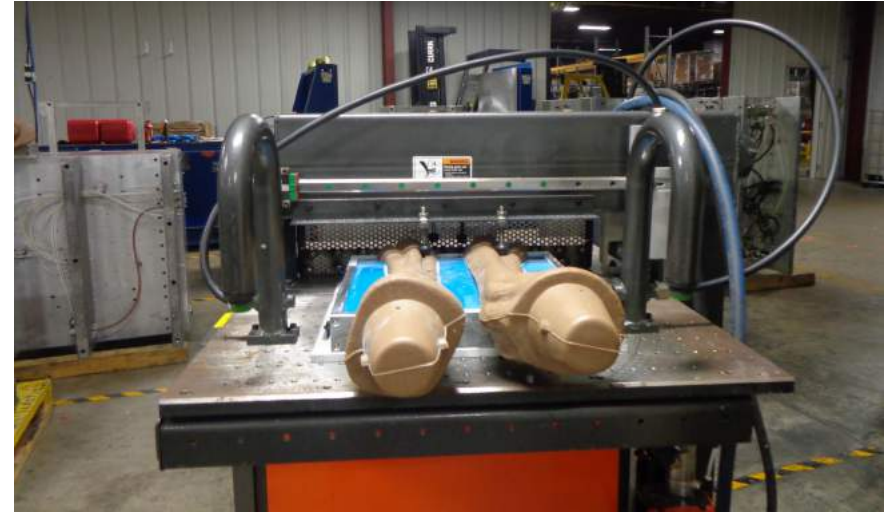
- The new style of cutting the ends off our deer legs. Set parts in the fixture and push button. We have eliminated the hazards of possible injury with the new deer leg fixture.

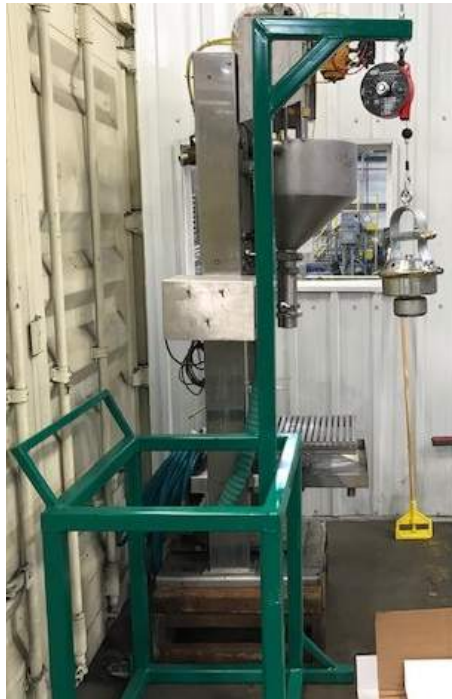
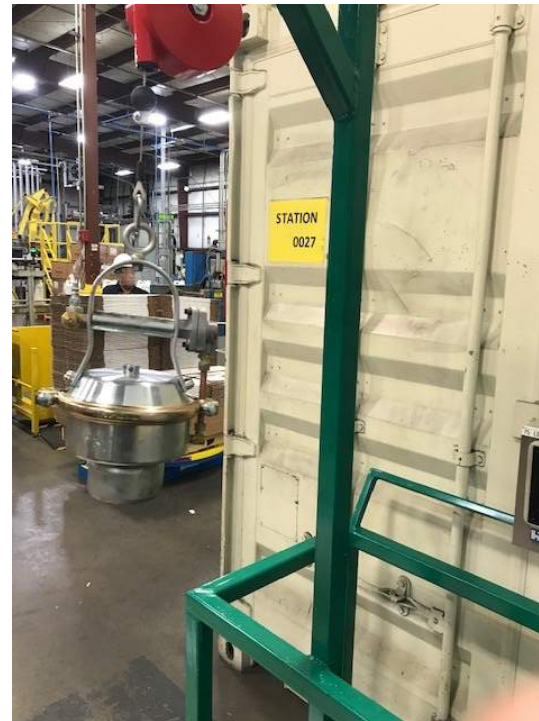
One of our containers required this press weight to be sat into the pail opening. This press weighs about 15 pounds and had to be lifted to shoulder to head height (depending on the user height). This had to be done around 2,000 times per shift. Even with job rotation this was a physically demanding task. Working with our maintenance group we designed a mobile cart outfitted with a tool balancer that holds the press. The operator now only needs to position the pail under the press and guide it down. The cart allows it to be removed from the line and stored when not needed.

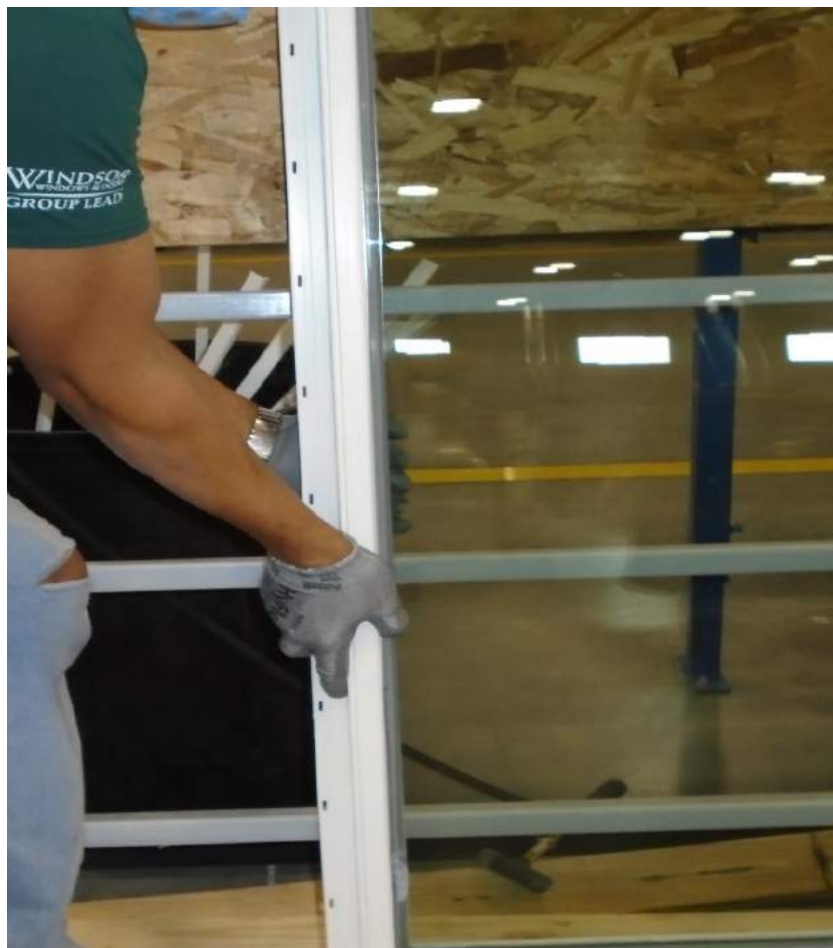
Hard for operator to grab these large doors.

This tool fits over the installation fin and locks in place. This gives the operator a good grip on the door.

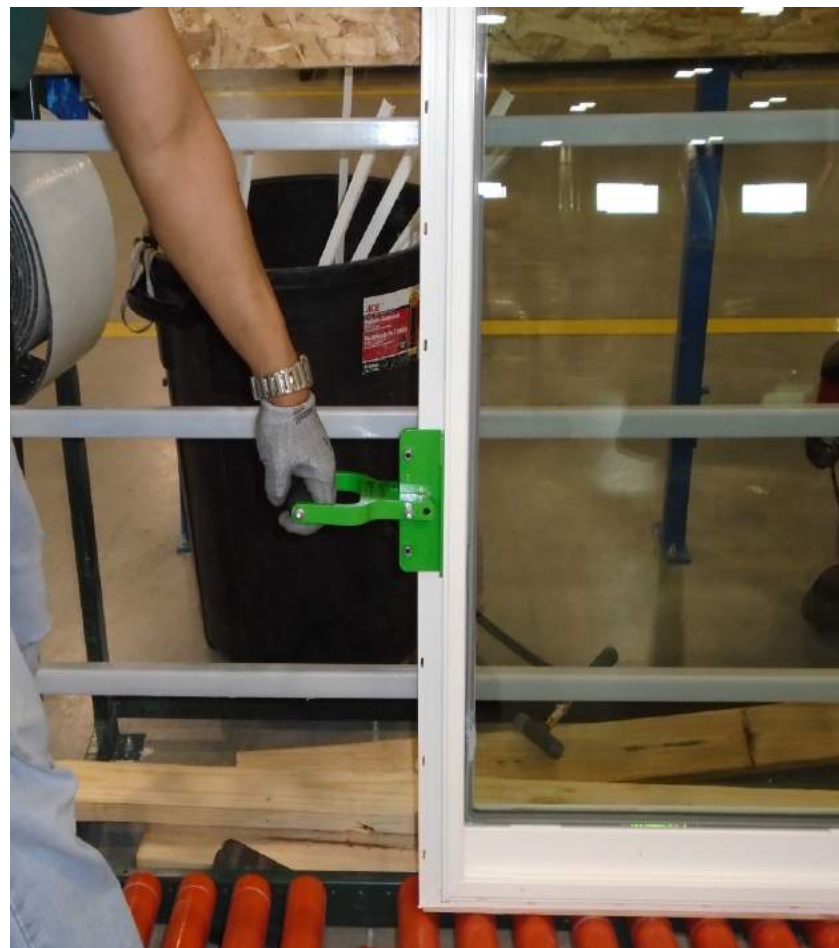
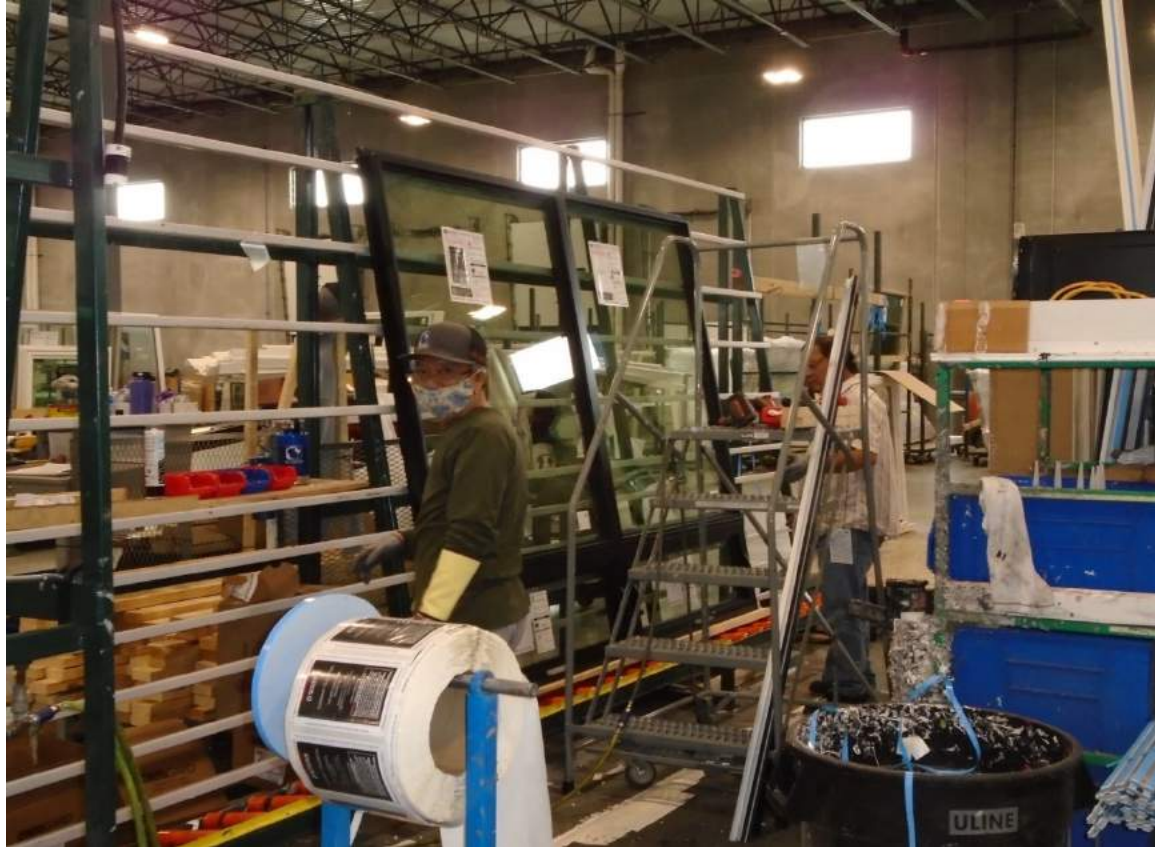
Vinyl Casement Set Up

In order for operators to do work on the tops of these large mulls, the employee would climb up on the racks. A ladder was placed in this area to give operators level ground to stand on.

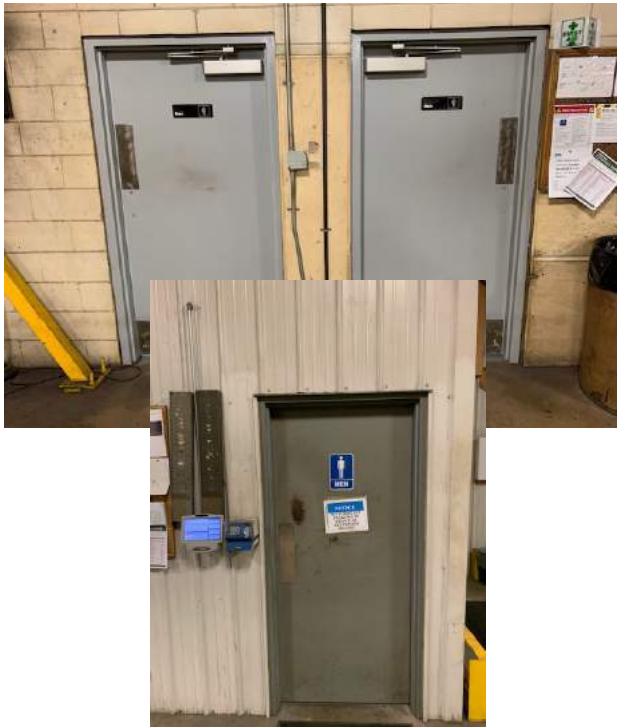
Before

- Smooth Stainless – slip hazard
- Bulges and uneven seams – trip hazard
- Identified by newly formed Safety Committee and planned for hazard mitigation

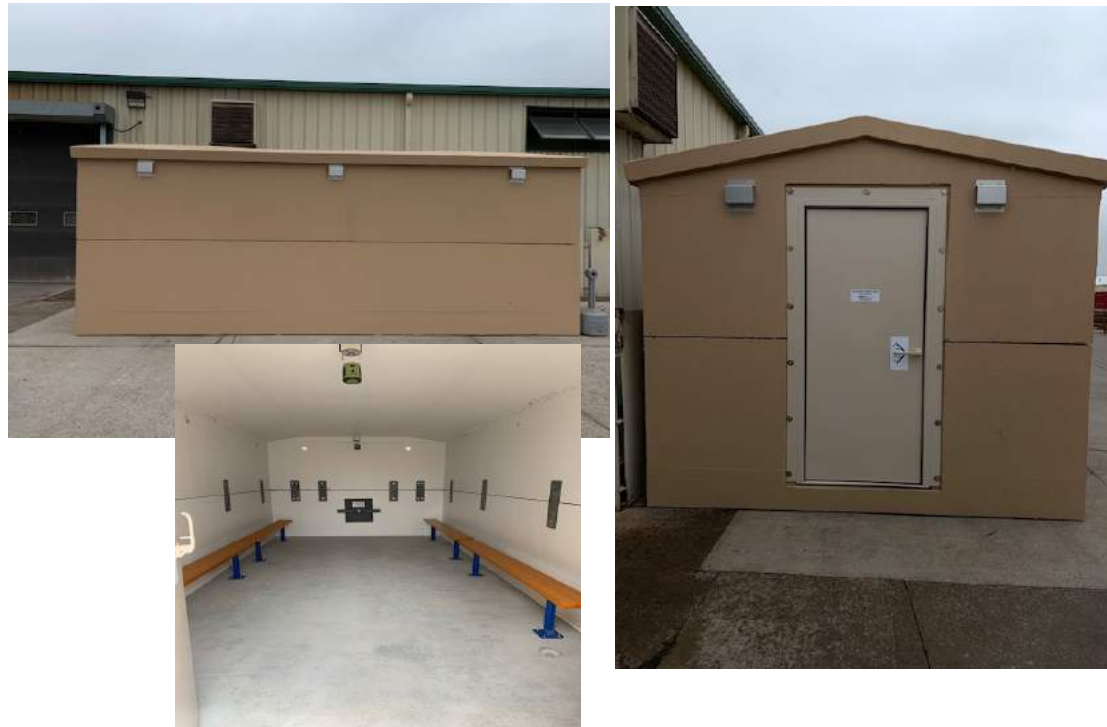
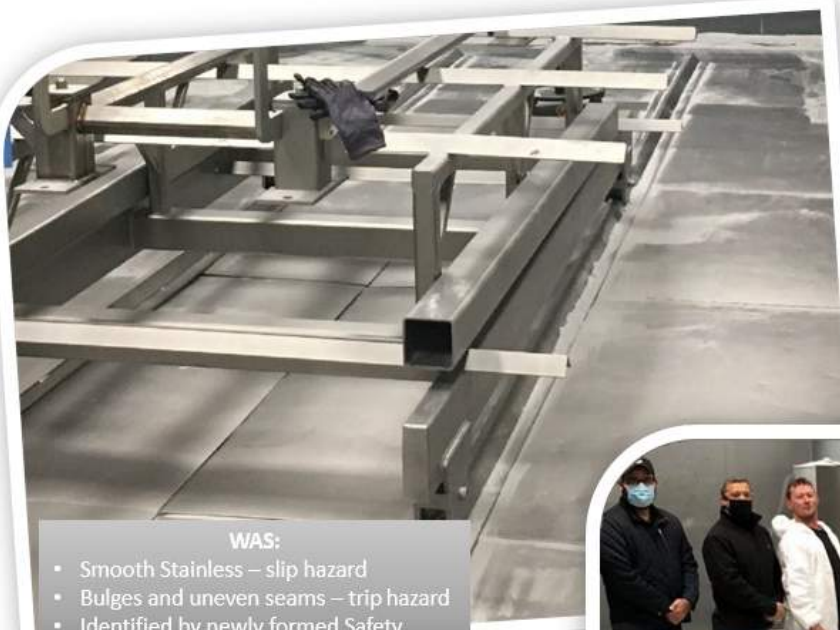
After

- New, non-slip surface with even panel seams – a safe place to work!
- Pictured: PFI-SATX employee owners who KEEP IT MOVING!

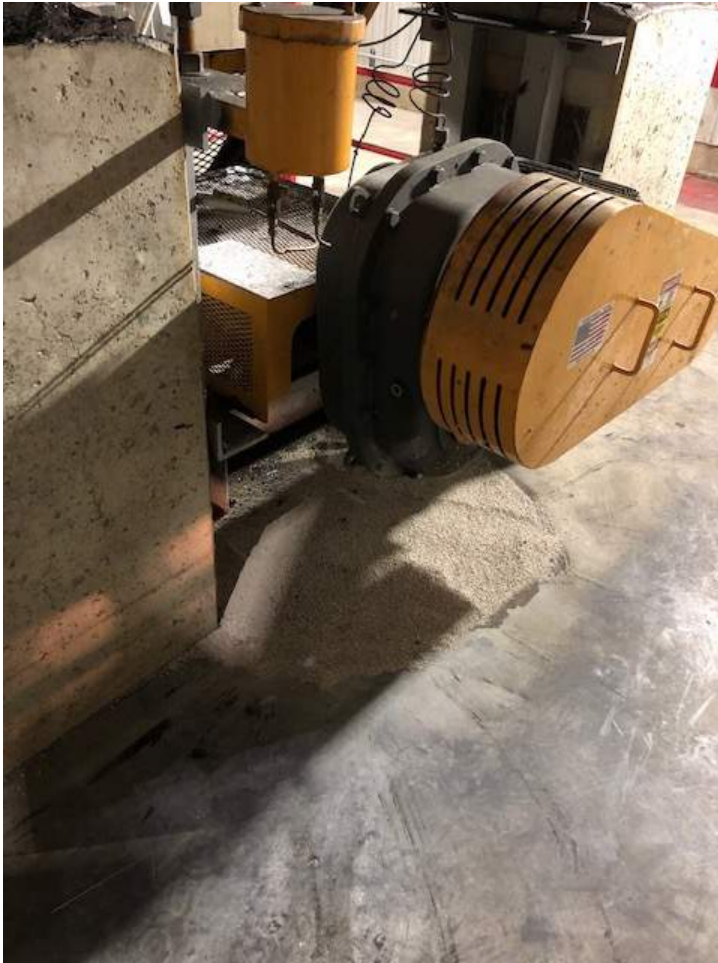
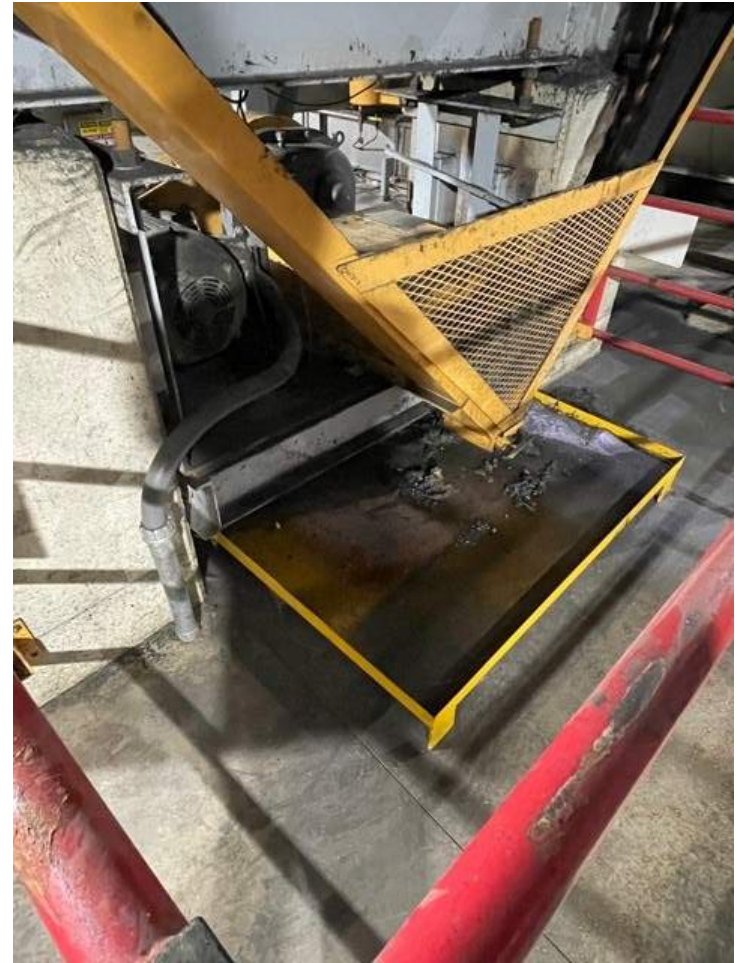
- Before: floor dry, graphite, oil/grease would gather on the floor creating a housekeeping and slip issue.
- After: A “catch pan” was made to collect all the debris so it can be pulled out and cleaned without creating a hazard.

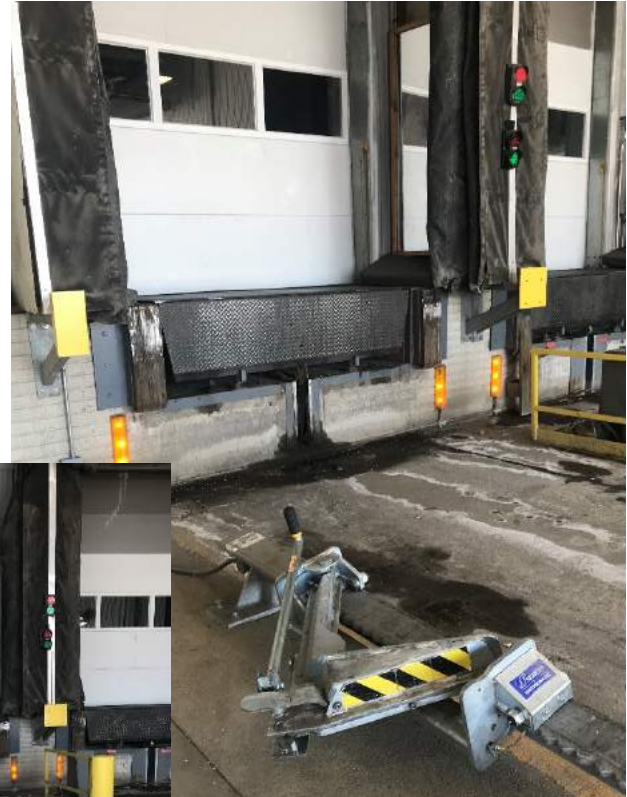
- Inconsistency in securing international containers and trucks with lift gates and/or damaged rear impact guards that can't use dock hook locks. Those trucks had to use manual wheel chocks.

- Installed secondary truck restraints with tire guides and control panels with green/red outside & inside LED lights at each dock.

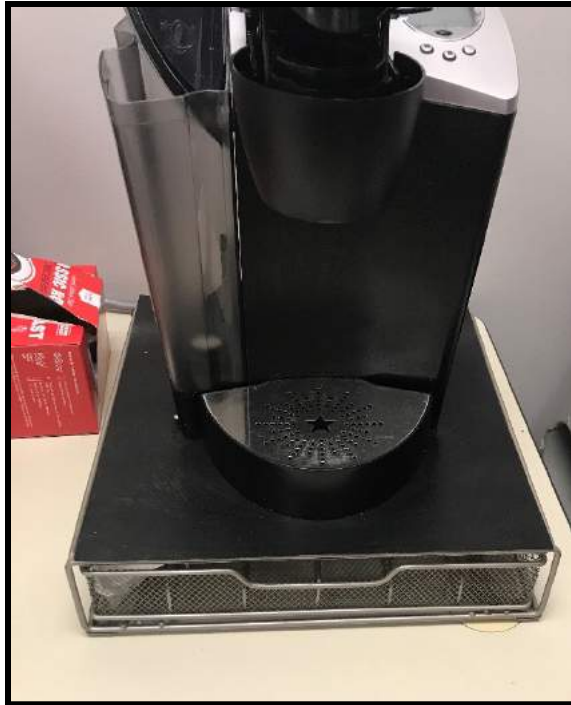
Before

The DAS Safety Committee conducts safety inspections periodically throughout the year. In the DAS Division of Human Resources kitchenette, they identified the coffee maker was left on and never turned off. As a result, it had generated enough heat to melt and deteriorate the auxiliary base it sat on.

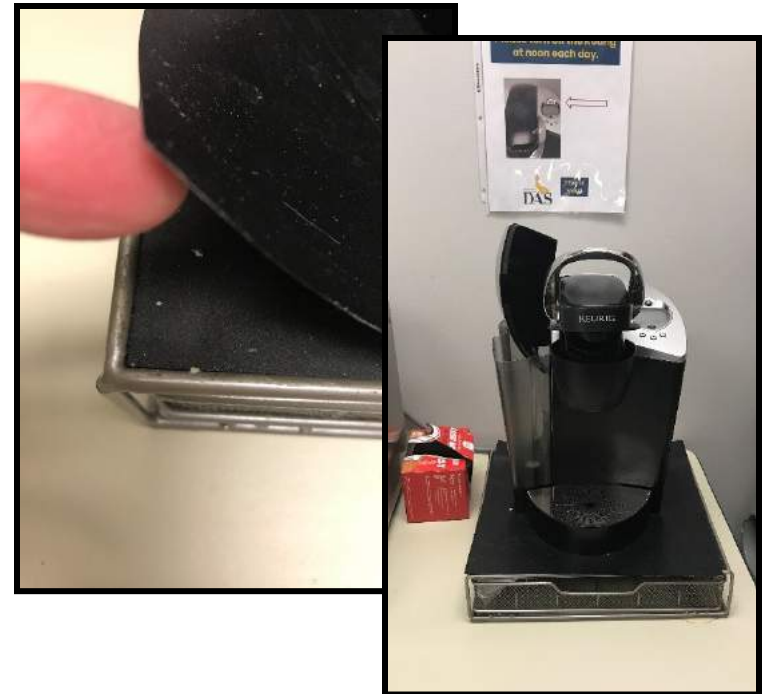
After

To resolve the potential fire hazard, a non-stick oven liner that withstands 500 degrees was purchased, cut to size, and applied to the a new auxiliary base. Directions for turning off the coffee maker were developed and posted near the appliance. In addition, volunteers assure the coffee maker is “off” every night.

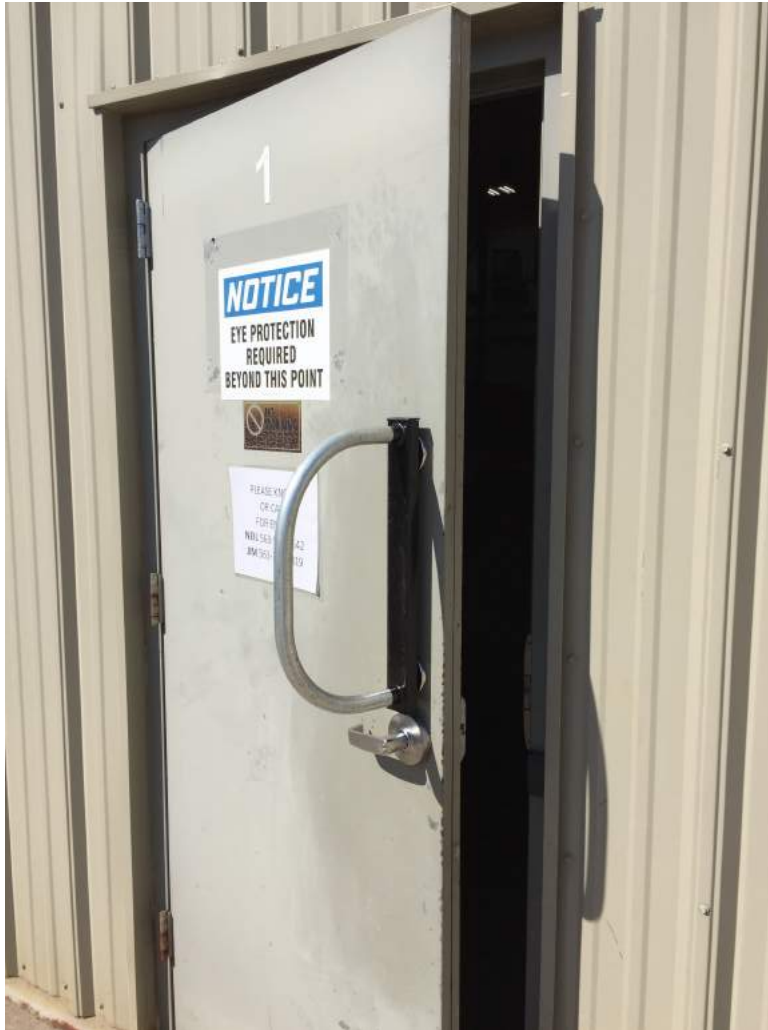
To reduce exposure and spread of Covid-19, custom door grabs were designed and fabricated in-house using EMT, steel, and magnets. This allows for the user to reach their arm through and pull open the door with the forearm opposed to touching with a hand. Since door handles are a community surface, this eliminates the risk of cross-contamination.

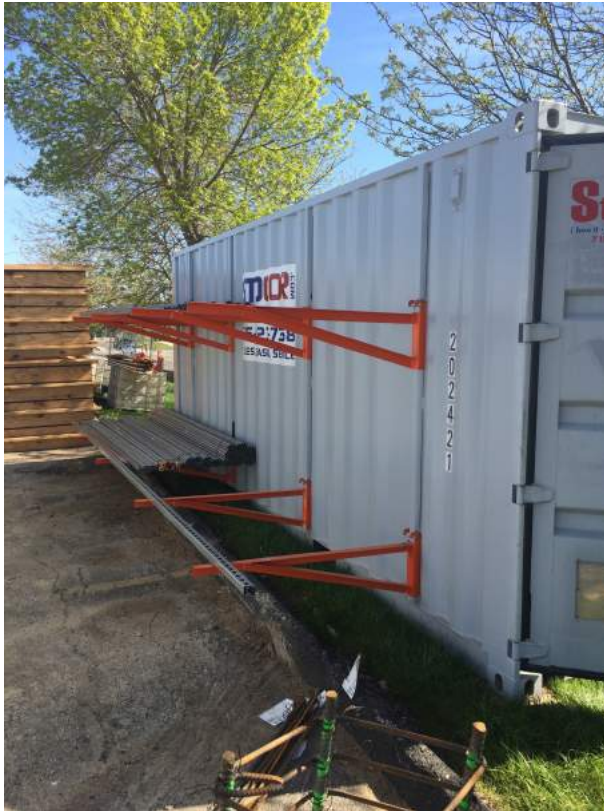
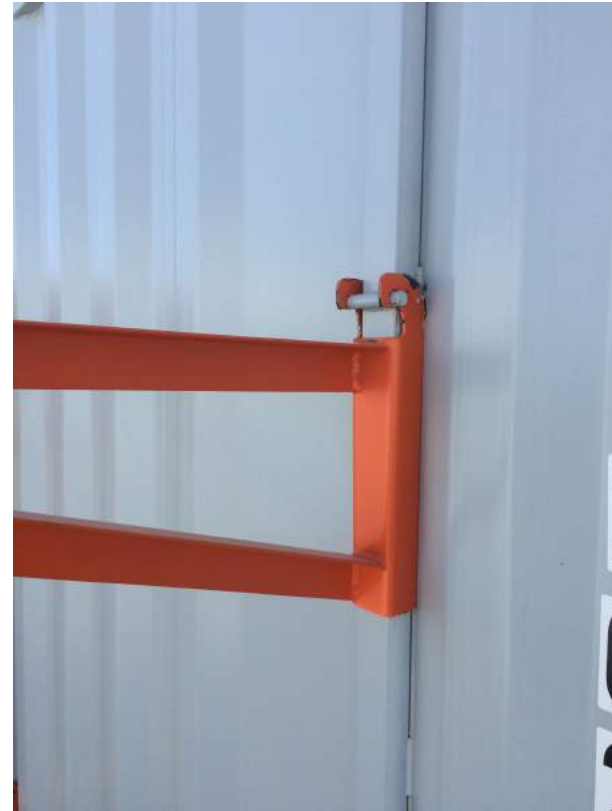
Conex conduit racks were purchased and installed to aid in material storage and injury prevention. By keeping the conduit off the ground, this eliminates employees having to bend over, sort, and pick up off the ground. The risk of musculoskeletal injuries and sprains/strains are reduced. This also provides better housekeeping to avoid trips, slips and falls.

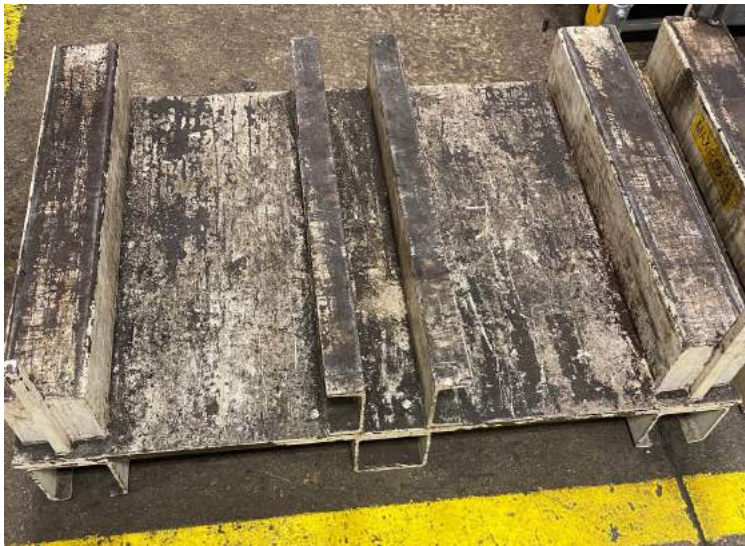
Pallet Pegs

We kept having near misses where blades would fall/slide off the edge of our pallets when being transported to other areas.

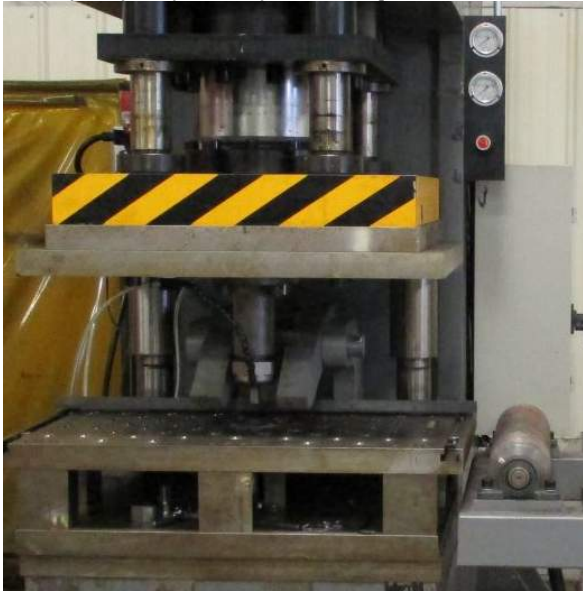
Before:

Our new punch for the heat treat area didn't have guarding or a way to ensure our operators didn't have

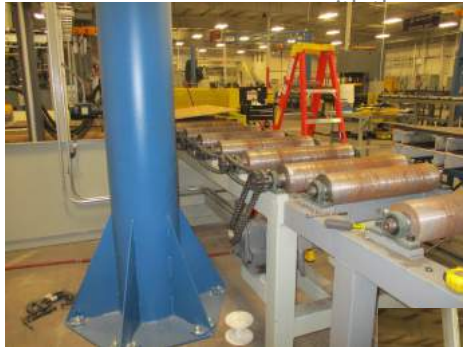
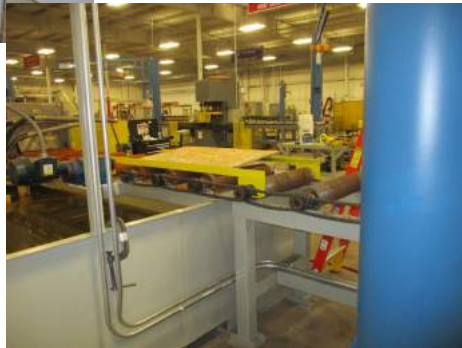
Before:

We installed a heat treat line and have been working on guarding. After it was assembled we saw a need for guarding on the quench tank exit line that did not come with the machine.

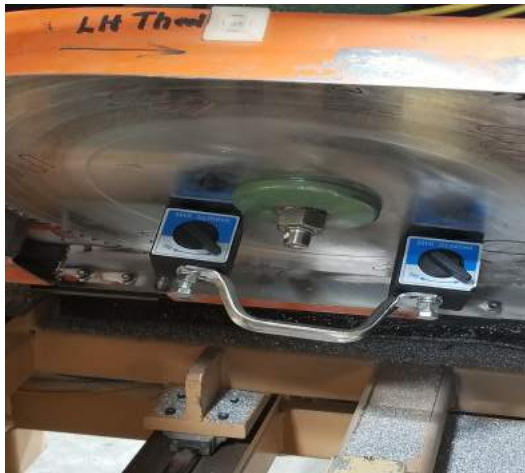
Before

- Having to change saw blade on machine and having to hold blade with one hand and trying to tighten bolt with the other. The blade is mounted at about a 45-degree angle
