2019 Hazard Control Awards

an **nsc** chapter

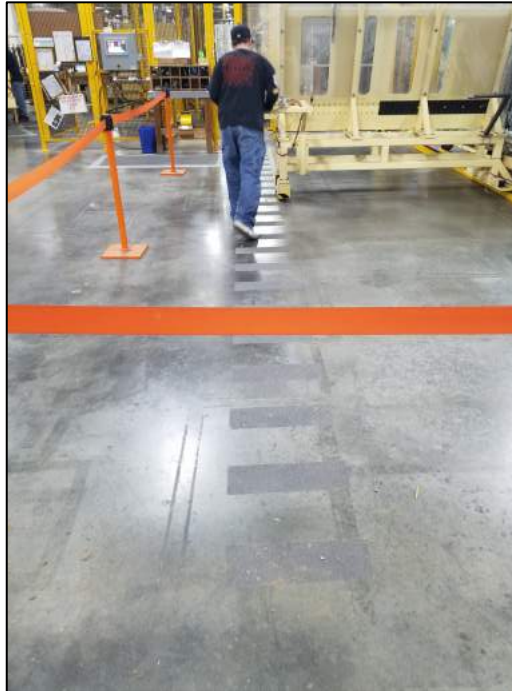
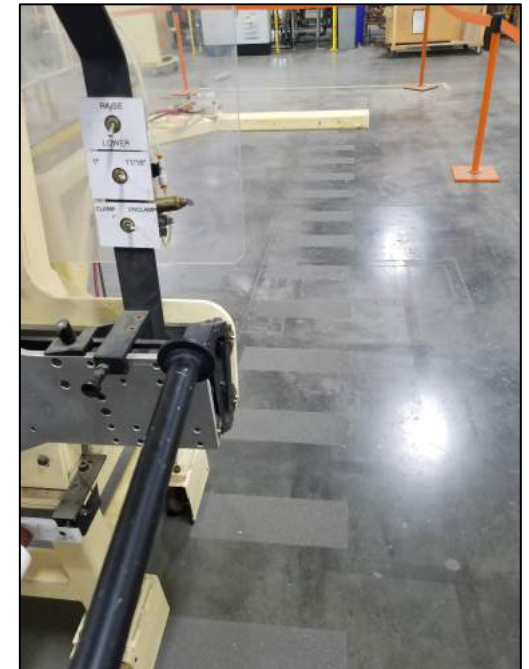
After:

The operator moving the carriage must push this forward or back to get the glass or bring it to the robot. In the summer when it is very humid, the floor can have some moisture on it and become slick. The rail system that it has makes it very easy to move, but with a slick floor the potential was there for them to lose their footing.

We added some anti-slip pads to the floor where the operator walked back and forth. This gives them the traction needed to move without the risk of slipping.

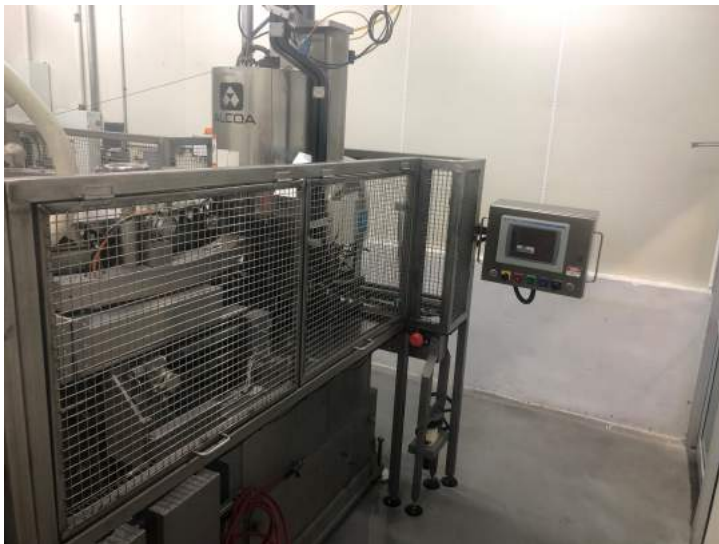
Closed

After a recent on-site machine guarding audit by the IISC we identified some deficiencies in our machine guarding of our bottler filler. We re-designed our guarding to eliminate the deficiencies and to make it easier to open up for cleaning and maintenance to access critical components.

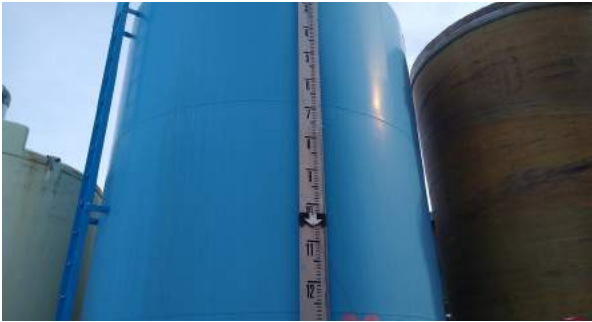
Before Picture

Filling tanks with finished product is a daily task in our operation. Mill operators periodically leave the process unattended to manually gauge tanks, as many tanks are some distance away from the mill control. Also, stuck floats, broken pulleys, or even bird nests can hinder the function of the gauge boards, giving false readings. Based on these examples, we had a higher risk of “loss of primary containment”.

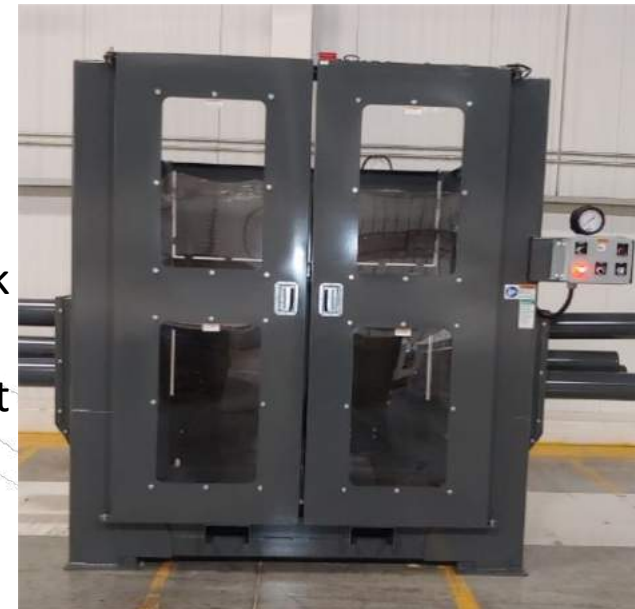
- In our previous situation our “super sack” products were coming into the facility hard and clumpy making it a challenge and an ergonomic safety concern for our employees. They were put at risk each time they had to unload these large “super sacks” into our batch funnels as they would often need to use dead blow hammers to release the product enough to flow into the process.
- To mitigate ergonomic injuries in the plant, a Bulk Bag Conditioner was purchased. Now employees place a bulk bag into the conditioner before batching. The hydraulic cylinders push plates in and out along side the bag to break up the contents allowing the needed product flowability without the manual operation.

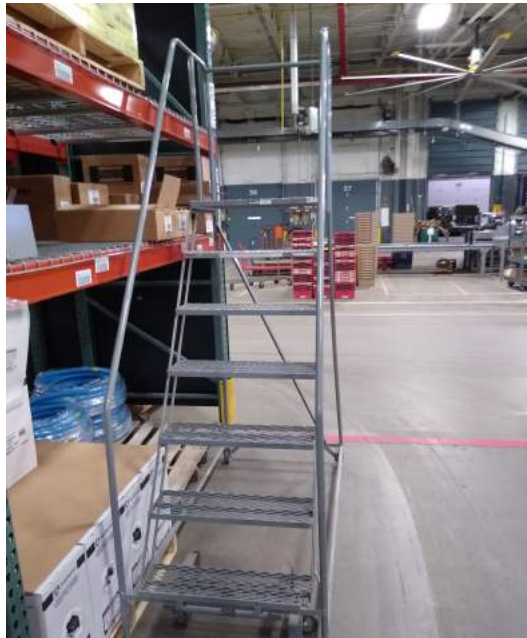
We had many faulty ladders in our warehouse. Our safety team did a ladder audit and deemed many unsafe. They were promptly taken out of service and replaced with new ones. Below is a picture of a new ladder.

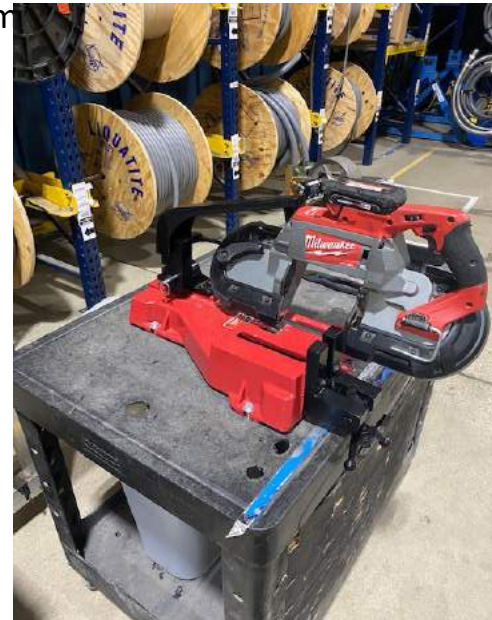
We were using bandsaws to cut wire/pipe and had a close call with saw blade slipping and putting an employee at serious risk. Since then, we have bolted all bandsaws down to carts. The risk of having a saw blade slip and jump out of someone's hand has been eliminated.

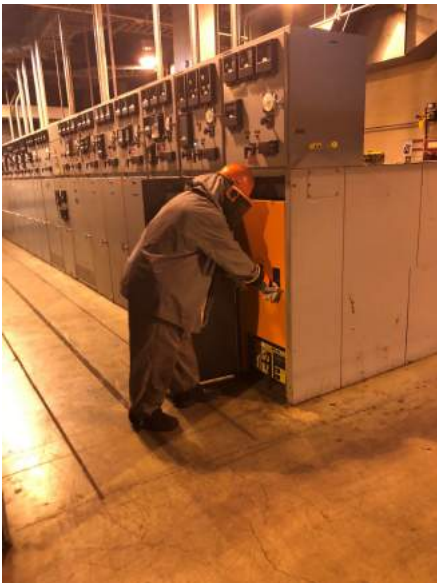
ARC Flash Hazard- Remote Racking Device

Our Employees were manually racking out breakers placing them in the line-of-fire of the ARC Flash Zone which requires the use of full body Arc Flash hazard suit for protection.

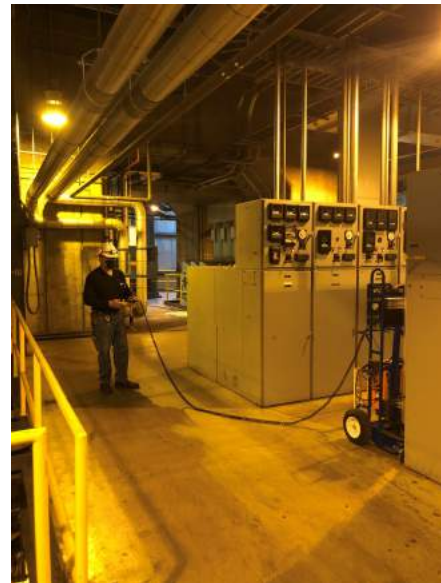
We purchased a remote racking device to keep our employees out of the Arc Flash Boundary. They can do the same job at a distance without being in the line-of-fire.

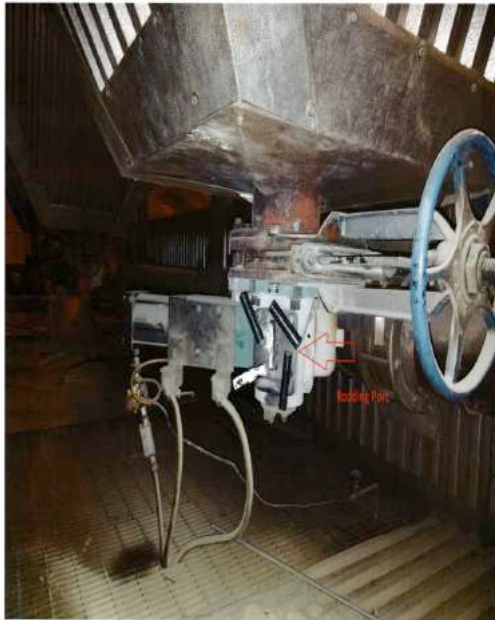
BEFORE

There is a small door that we remove on the end of the pipe that allows us to rod underneath the gate and get a flow path through the fly ash. Once the door is removed and we begin to rod, there is nothing to keep the fly ash from falling out of the pipe once it begins to flow. The fly ash will pile up on the floor, unless we attempt to get the door back on with hot fly ash flowing out.

We installed a long handle on the door so we can insert a rod into the pipe to start a flow path to get the fly ash moving through the pipe again. With the long handle it can easily be shut once the ash starts to flow out of the hopper without having to risk coming into contact with hot ash.

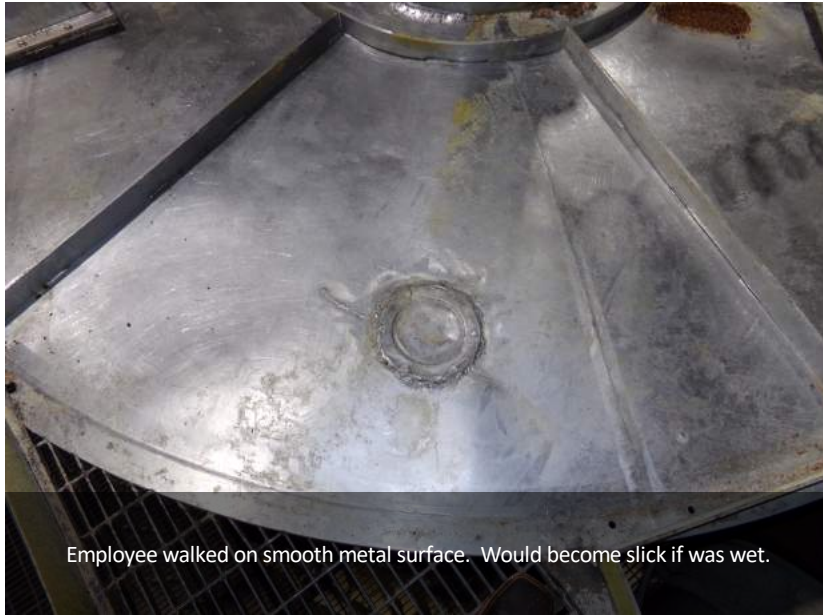
Employee walked on smooth metal surface. Would become slick if was wet.

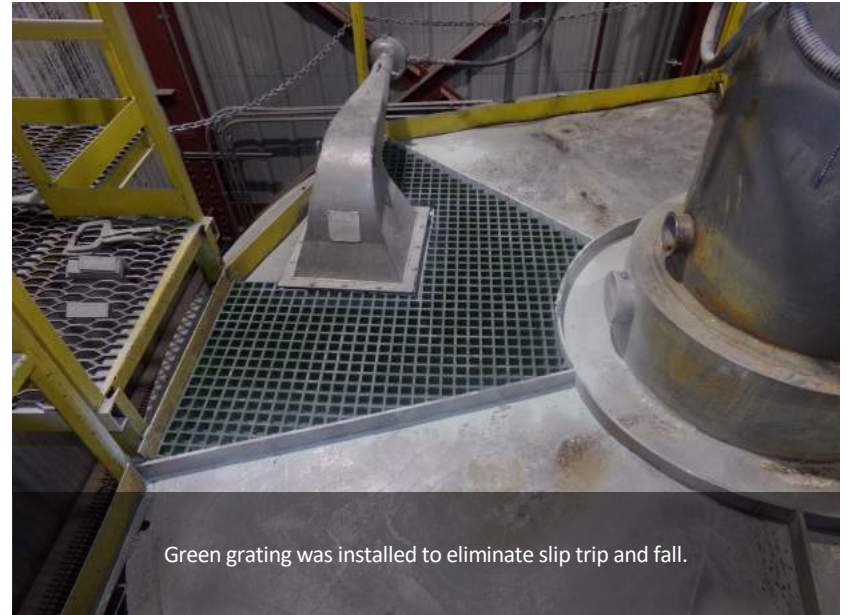
Slips on top of dryer 5

Green grating was installed to eliminate slip trip and fall.

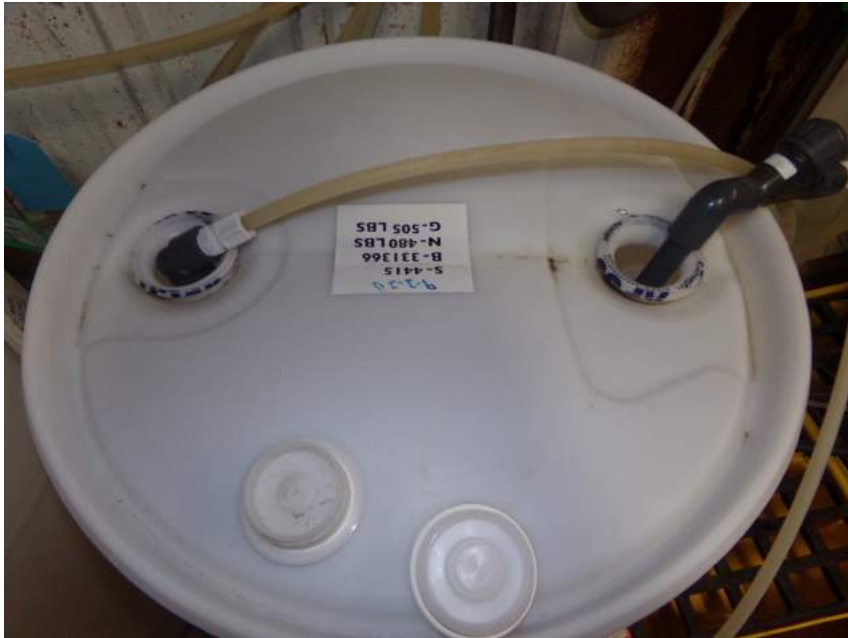
Sealing of chemical drums

Chemical drums caps could allow foreign object to enter drum.

Permanent caps were made and added to the wand so that cap could be put back in place eliminating foreign object to enter drum. Caps stay on the wand and can not be removed unless wand is taken apart.

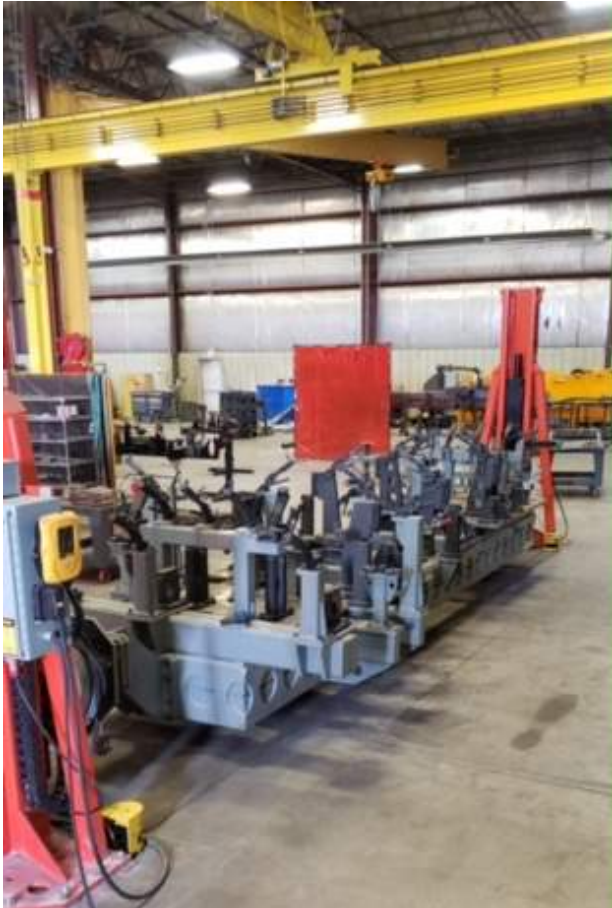
New Mainframe Fixture and Rotation Device

- **Less Rotations needed for work/welding**
- **Improved Ergonomics due to height control and rotation**
- **No step stools or ladders needed for reach**
- **Safety perimeter lights**

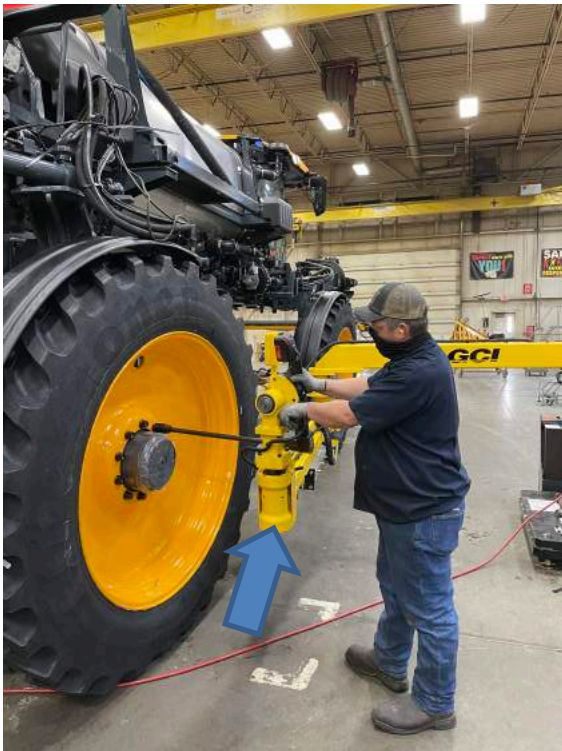
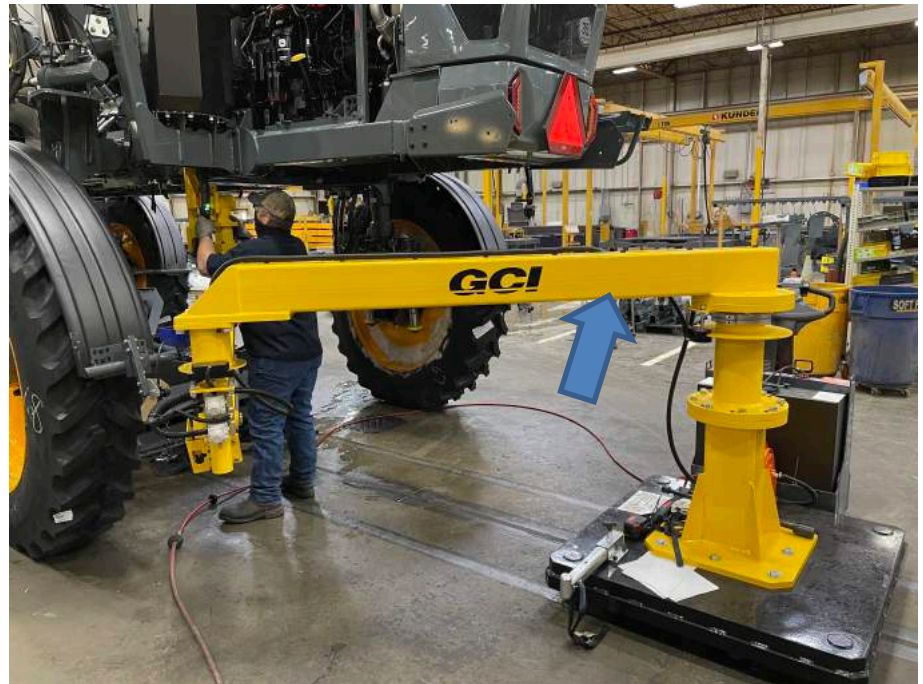
Manual torque tools vs High torque IR gun.

New high torque IR gun removes all the torque and holds the tool, so operator does not have to, which eliminates ergonomic concerns of holding tool above head for long periods of time throughout the day.

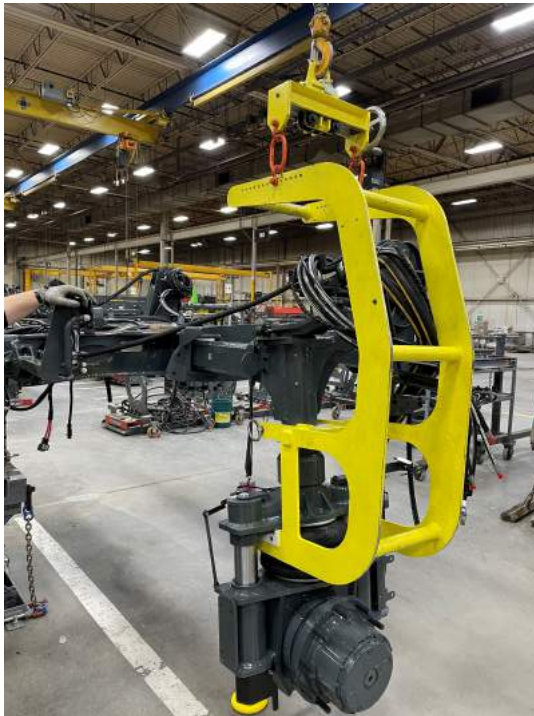
Leg Build Fixture

In previous production, slings were used, and left machine leg unbalanced, and operators had to physically manipulate the side-to-side balance.

The new fixture now hold the machine leg rigidly allowing adjustment so operators can install without manually manipulating alignment.

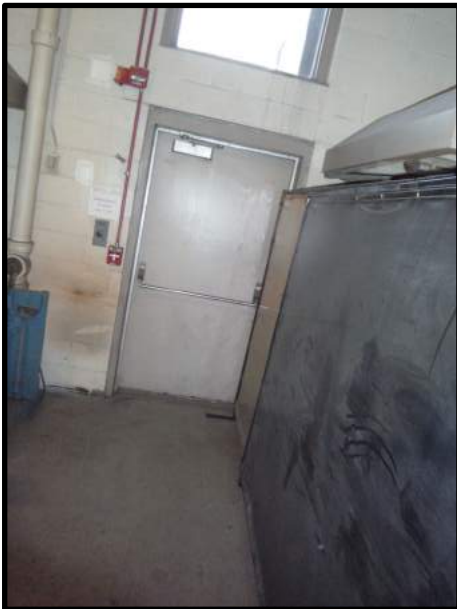
Before: Welding screen would move throughout the day to block the exit/door.

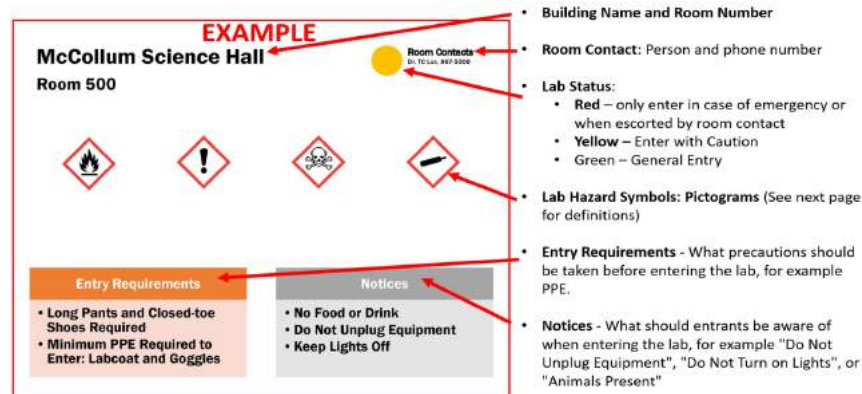
The diagram shows a template for a lab safety sign. It includes fields for building name and room number, room contact information, lab status (Red, Yellow, Green), hazard pictograms, entry requirements, and notices. Red arrows point from text labels on the right to the corresponding fields on the sign template.

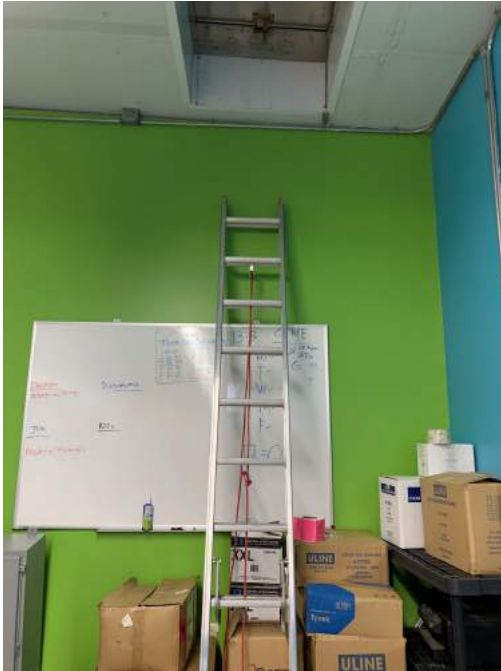
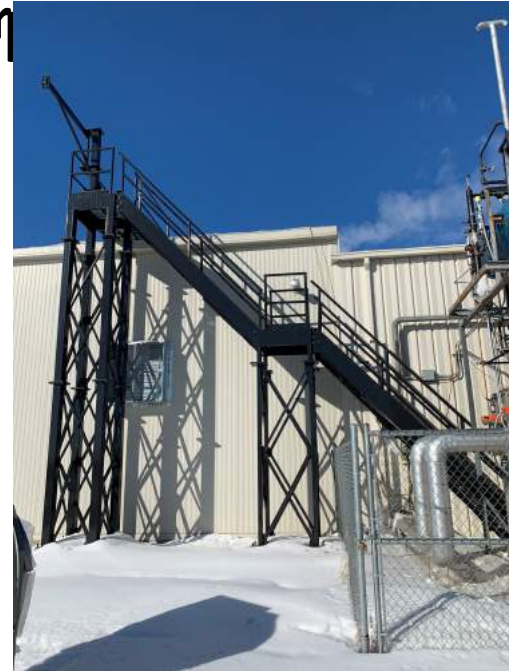
Roof Access – We substituted the extension ladder for fixed stairs to improve accessibility by maintenance and contractor

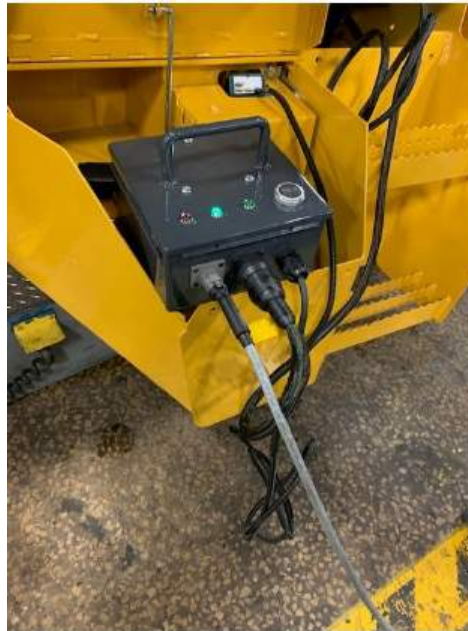
Solution

The assembler must test the hydraulic functions after the backhoe unit is filled with fluids. During this test cycle, the boom control was stuck in the downward position causing the machine to lift and fall off the assembly cart inadvertently. Contamination in the hydraulic system was the root cause of the malfunction. Once the unit was recovered, the repair operator was able to duplicate the issue but after cycling the machine for a short period of time, the contamination was contained within the hydraulic filtration system and operator fine.

The hazard was controlled with the implementation of an external shutdown device. This device is attached to the machine electrical system and detects pressure spikes and the angle of the machine. If the device notices engine speeds exceeding 1200 rpm or a change in angle of 5 degrees, the device shuts power to the machine. In order to ensure the device is used by the operator, the manufacturing team have integrated this with the fluid fill station. If this device is not connected, the machine is unable to be filled with diesel and hydraulic fluid. Contamination is very difficult to control since there are many different suppliers of valves, fittings, hoses, filters and tanks; however, with this innovative solution, we can ensure our operators remain safe.

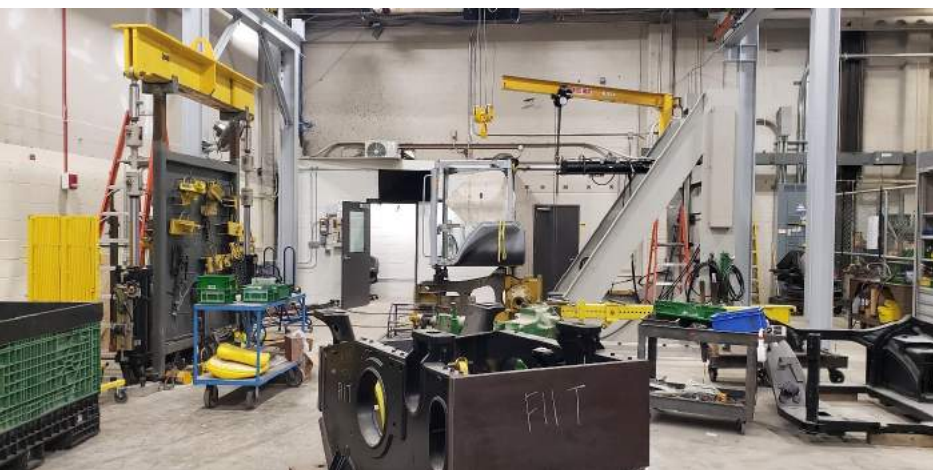
Before

Roll Over Protection System Test Fixture Risk Reduction

Problem: Risk to employees with the old configuration and fixture location had high severity and was a Potentially Severe Injury (PSI) event. There was potential for ejected debris or parts flying off the fixture into walkways or nearby employees due to open area. A 20" high step existed due to the raised platform which was a slip/trip hazard and caused employee fatigue due to frequency. No fencing or barrier was around the original fixture stand and the fixture energy was pushing towards the aisle and employees. Lighting was very dim contributing to trip hazards and lower morale. The process used the overhead door resulting in a cold or hot environment. The bridge crane was a 7.5T crane and was stressed to capacity. Employees were working right next to hydraulic pressure units with fatality fluid injection potential.

Solutions/Benefits: The fixture unit was moved to a segregated room/area. The fixture stand was recessed 20" into the floor eliminating fall hazards and fatigue. All wires/trip hazards are now recessed into the floor around the stand. Guarding and gating was installed around the fixture and an impact resist control room added for employees. A higher capacity 10T bridge crane was installed for handling equipment. The new area has more storage and maneuver room reducing likelihood of ergonomic injuries and material handling errors. The HPU was moved into its own area and employees are no longer exposed to potential hot fluids or injection hazards with fatality potential. A fixture stand was added for 5S to organize the area, reduce wasted time, and eliminate trip hazards.

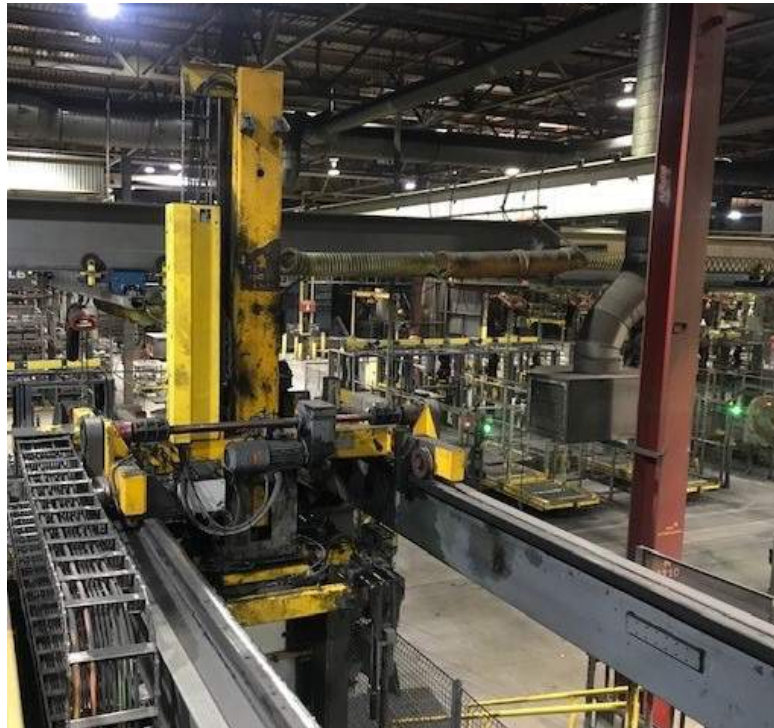
- The safeguarding process for Core Setting Gantries centered around the area of working on an elevated piece of equipment with little to no access.

Total Risk Engineered Out
Working from ladders
Fall hazards
Ergo issue of Sprain Strains
SERA pre-score was a **162**

SERA post-score was a 4 in turn reducing **158** SERA points from the project.

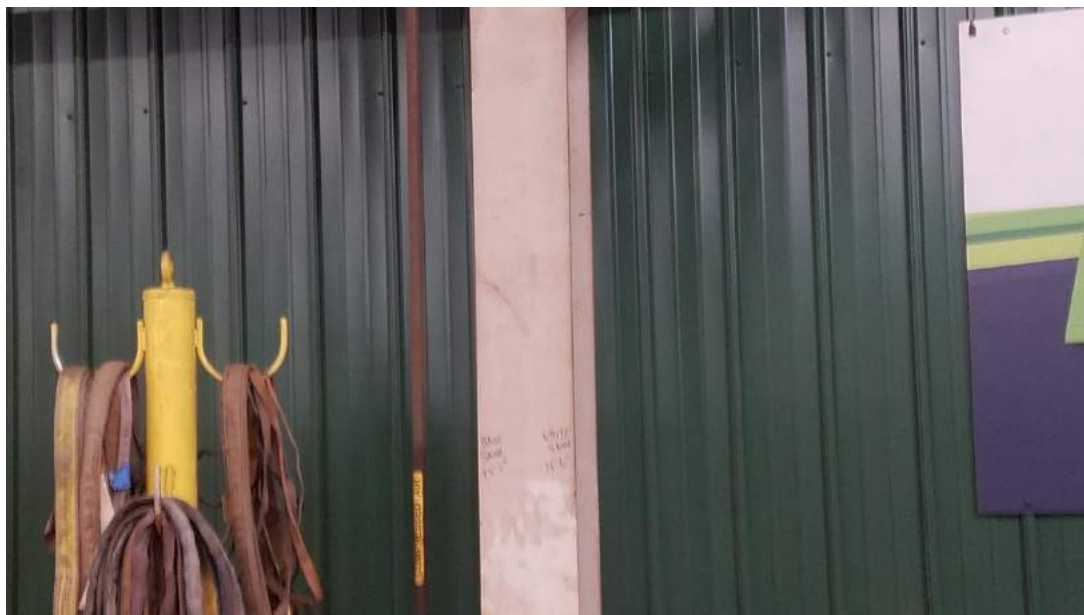
BEFORE

Adding Retractable Hose Reel

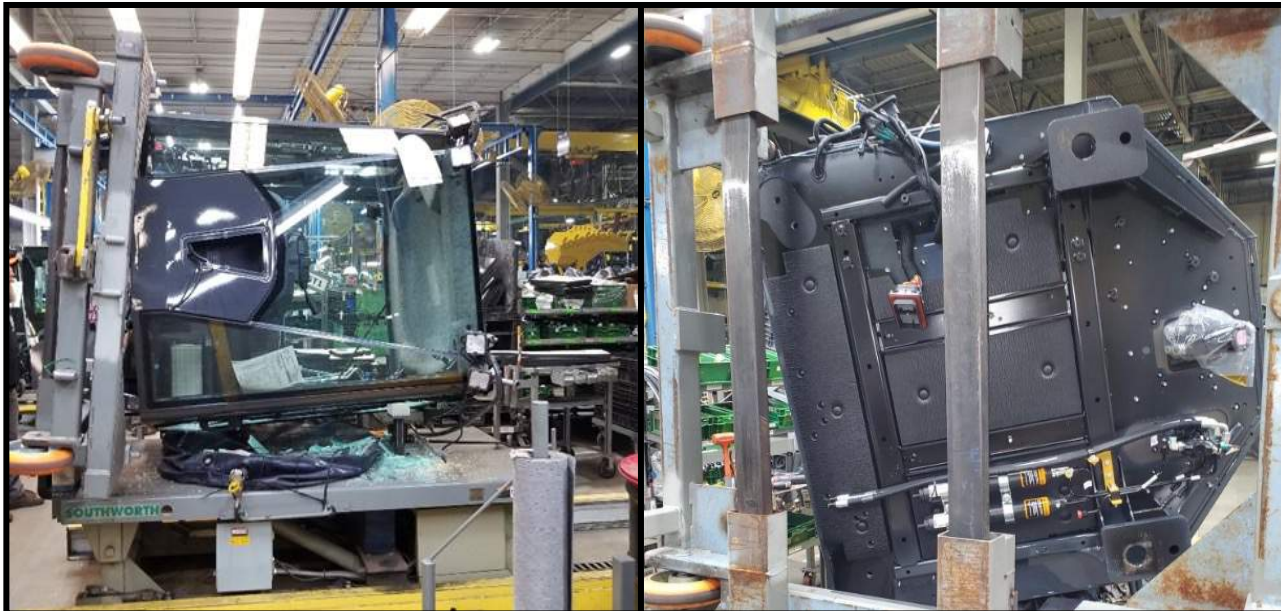
Before

John Deere Davenport Works – Tilt Station Raspberry Pi

Job Description: Cab Assembly 896 - Tilt Station – In this station the cab tilts 90 degrees while on dolly for Ergonomic assembly of the brake accumulators and associated hoses on cabs, up to 28 times per day.

Hazard Description: Cab will fall off cart and possibly tilt table if not pinned properly. This creates potential for operator to be pinned or crushed by the 2800lb cab. 5 Near Misses occurred, cart changes, administrative actions and training corrective actions were previously implemented however potential still existed and near misses continued.

Benefits from Control: Elimination of failure mode, low-cost implementation, mistake proofed solution that does not rely on operator verification. This project exemplifies how lost cost technology is enhancing employee safety and how *Raspberry Pi & CVML can be applied to solve complex safety hazards.*

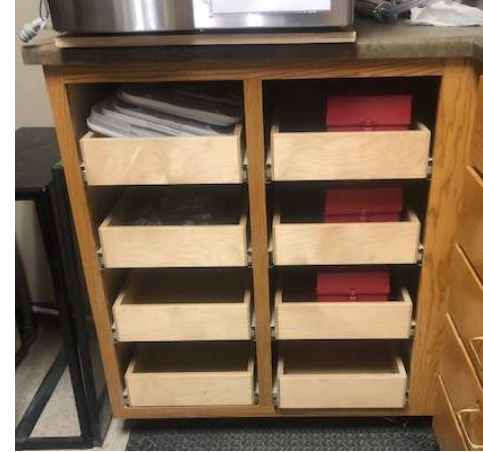
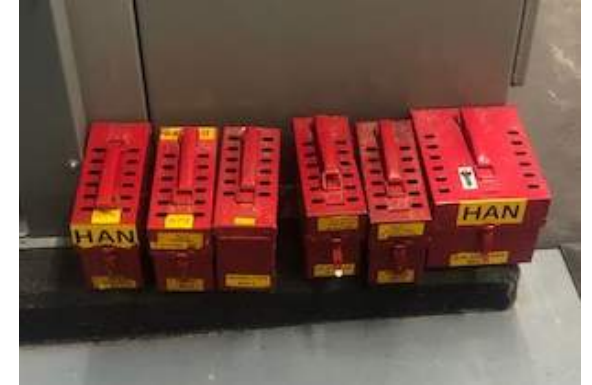
BEFORE

Lockout/Tagout Station & Cart

- Centralized location = One-stop shop
 - Previously boxes, locks, & devices were in safety closet and multiple MCC rooms
- Increased visibility of locked out equipment
 - Active lockouts with labeling of equipment
 - Ease of use during planned shutdown scenarios
- Standardized labels on boxes & locks
- Transportable cart
- Wall mounted boxes for longer term LOTO

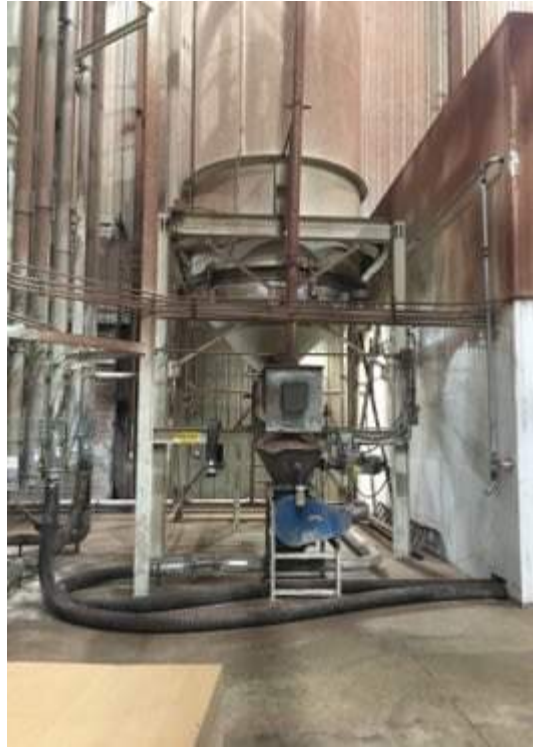
Before - Hoses on floor

- Rerouting bulky flexible hoses that were on the floor and removing the need to connect/disconnect them to transfer products
 - Eliminating trip hazards, pinching of hands/fingers & ergonomics of handling hoses
- Installing pneumatic control valves to replace the bulky flexible hoses, including installing catwalks for the ease of servicing
 - Eliminating trip hazards, pinching of hands/fingers & ergonomics of handling hoses
 - Reducing ergonomic and fall hazards to service equipment
- Development and implementation of software to switch distribution of product from silo to silo
 - Eliminating trip hazards, pinching of hands/fingers & ergonomics of handling hoses
- Relocation of the dust collection system and adding more pick up points for cleaning
 - Improved cleanliness and ergonomic handling of hoses for cleaning
 - Reduction in noise levels

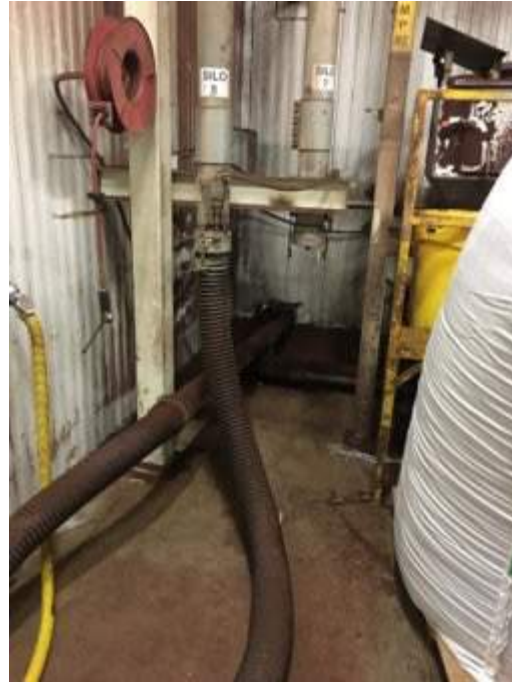
Before - Hoses manual connection

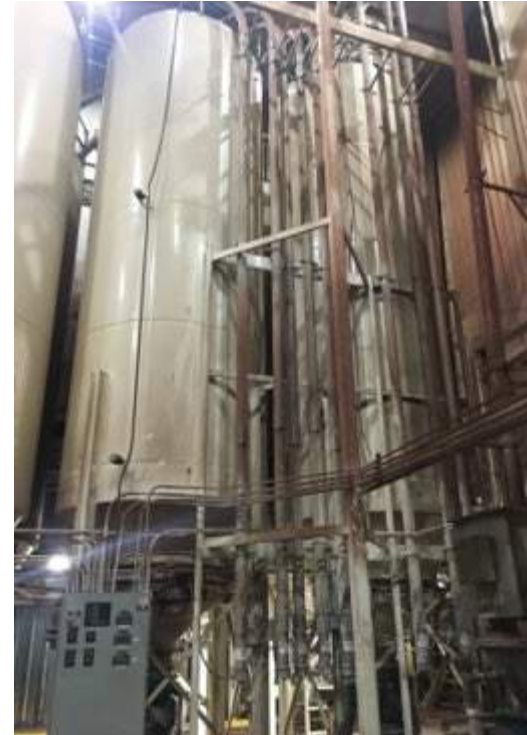
Piping

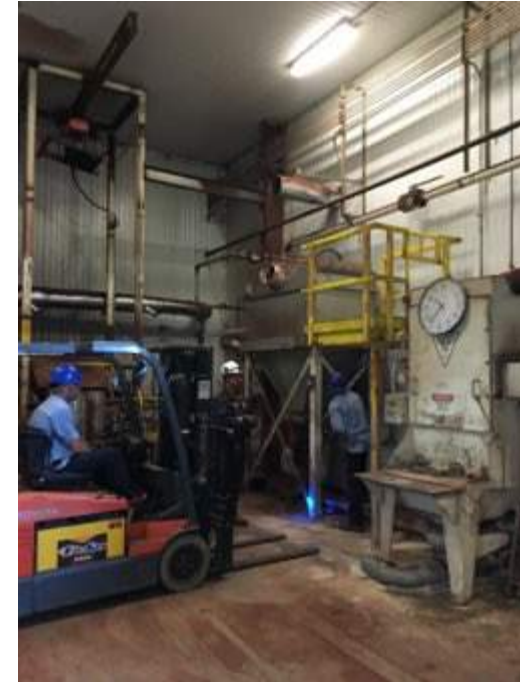
Relocation of dust collection

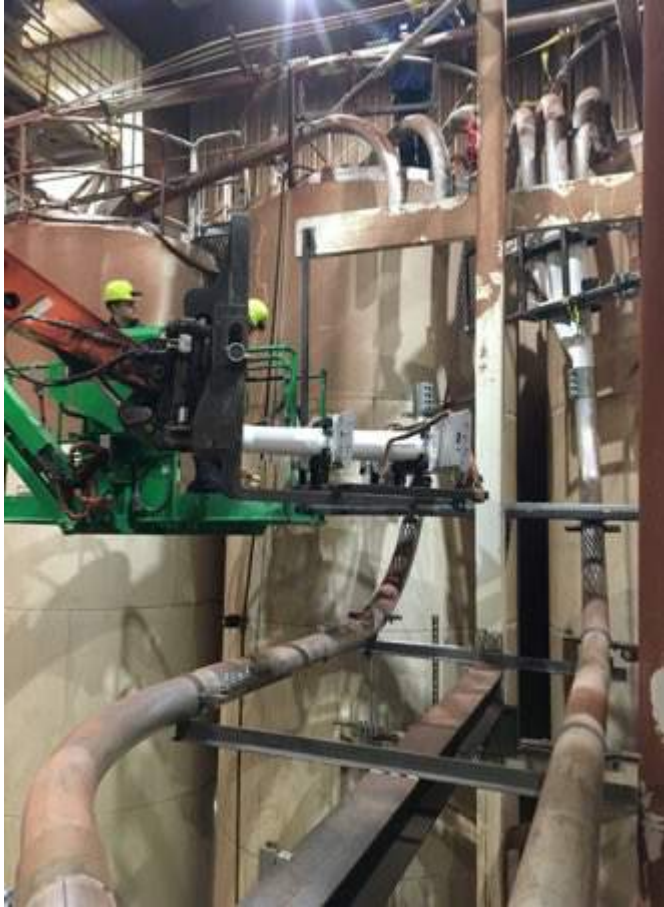
Pneumatic Valve installation

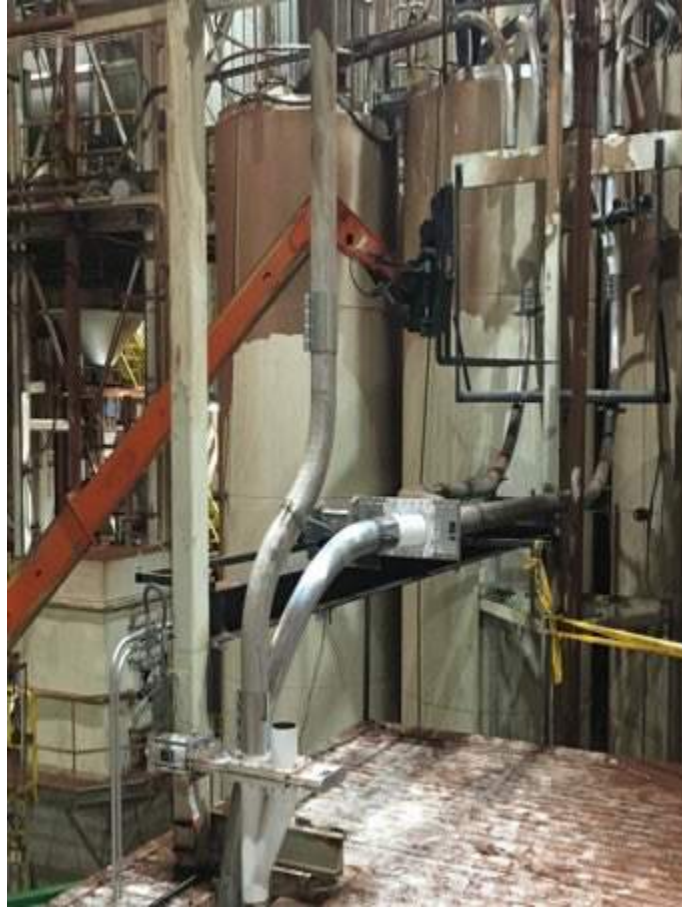
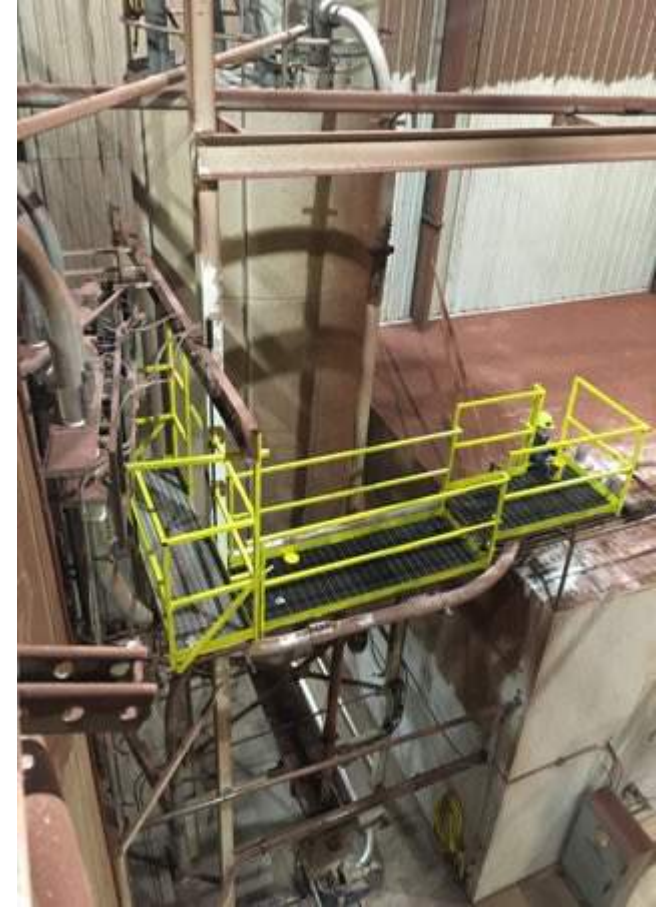
Catwalk install

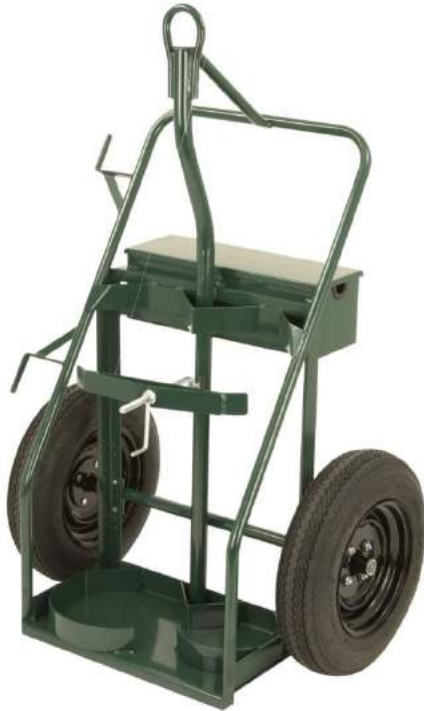
- A cart was modified to make loading easier. More robust securing clamps were added, and a hitch was modified to allow towing.

Lip was removed to make loading easier.

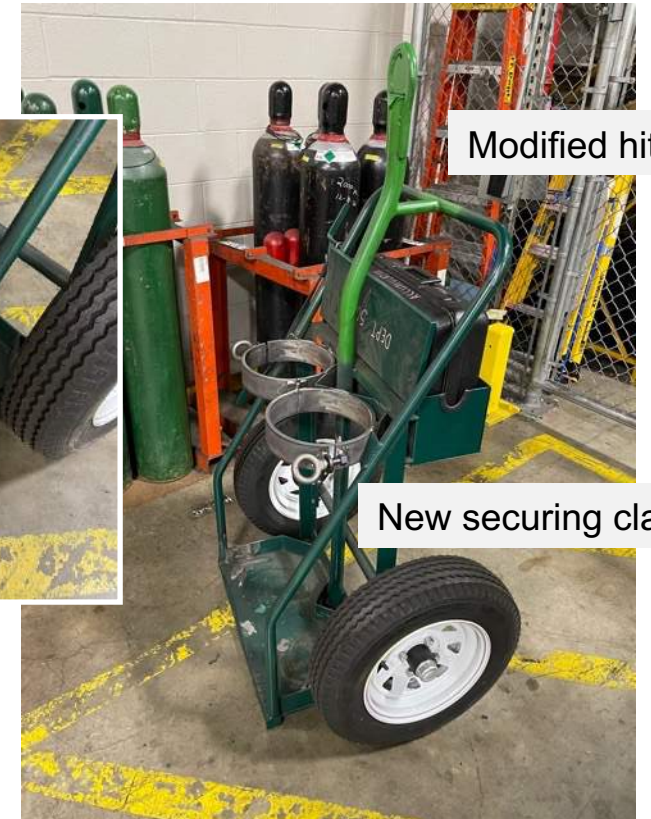
D537 Stickers

- After discovering issues, certain loads of cranks needed to be identified. The loads had already been sent to a storage area where they were closely arranged. Employees were walking on top of the loads to identify the cranks with issues.
- Loads were inspected and identified as they came off trailers. A label helped truckers keep the loads with issues separated.

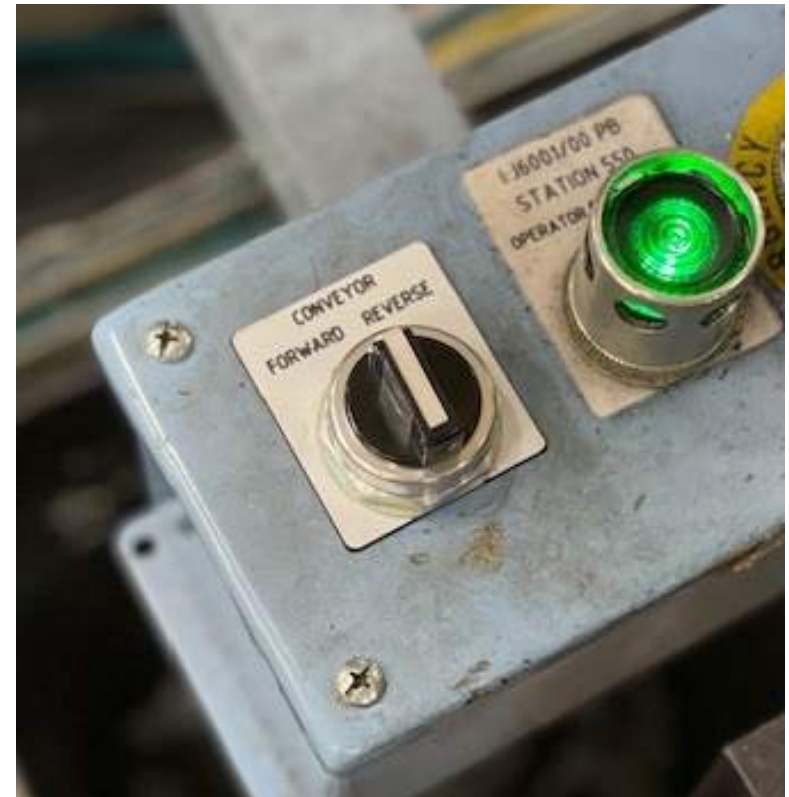
Conveyor Jogging

- An operator strained multiple muscles trying to manually move an engine to the correct assembly position.
- A jog button was added to allow the operator to move the engine to precise locations on the conveyor.

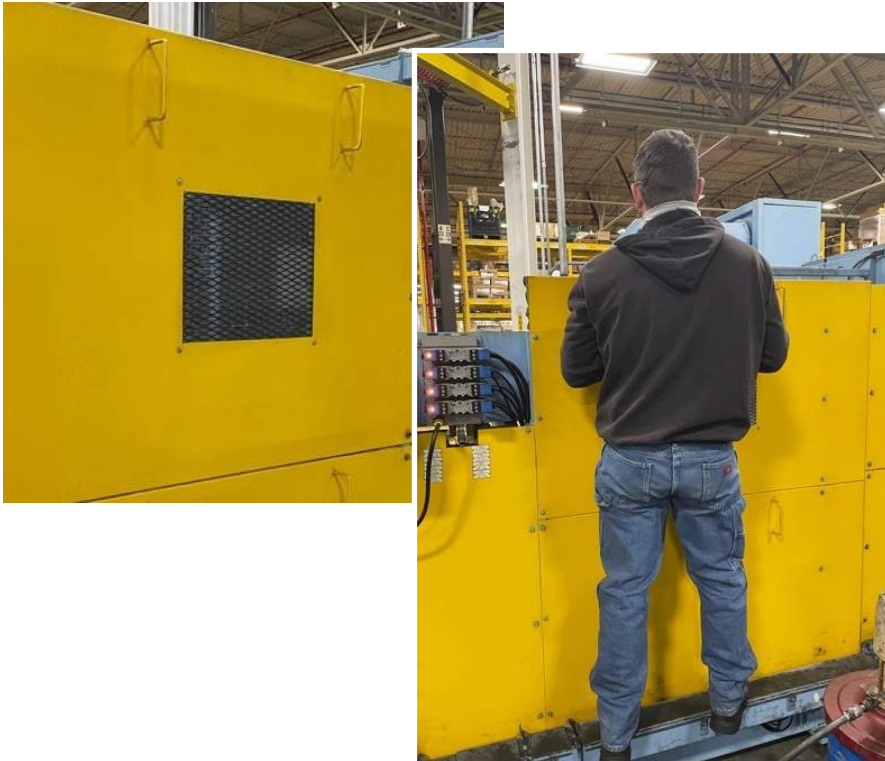
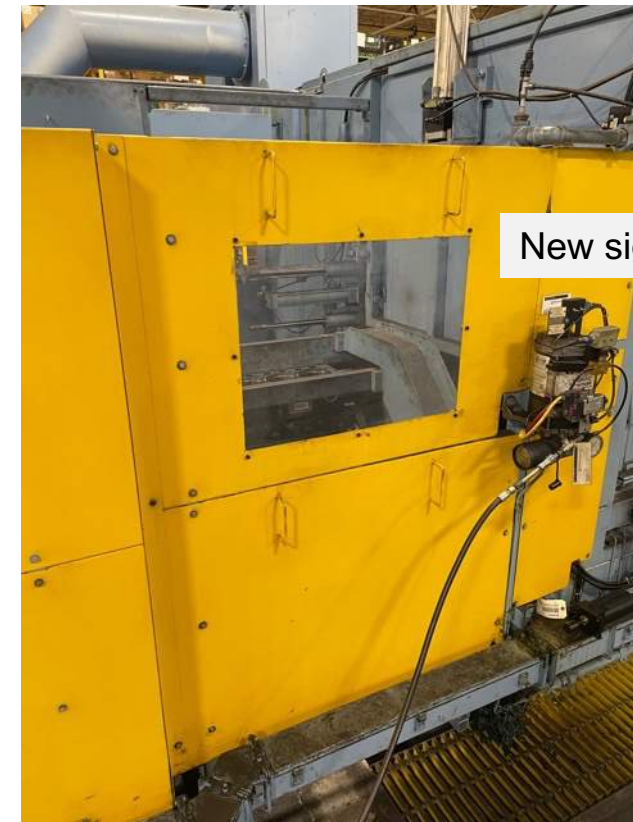
D524 Conveyor Guarding

- Sight windows with metal mesh were constantly dirty resulting in operators standing on electrical housing to view machinery. Guarding was occasionally removed.
- Large openings plexiglass were added to allow visibility. Plexiglass sight windows stay cleaner longer.

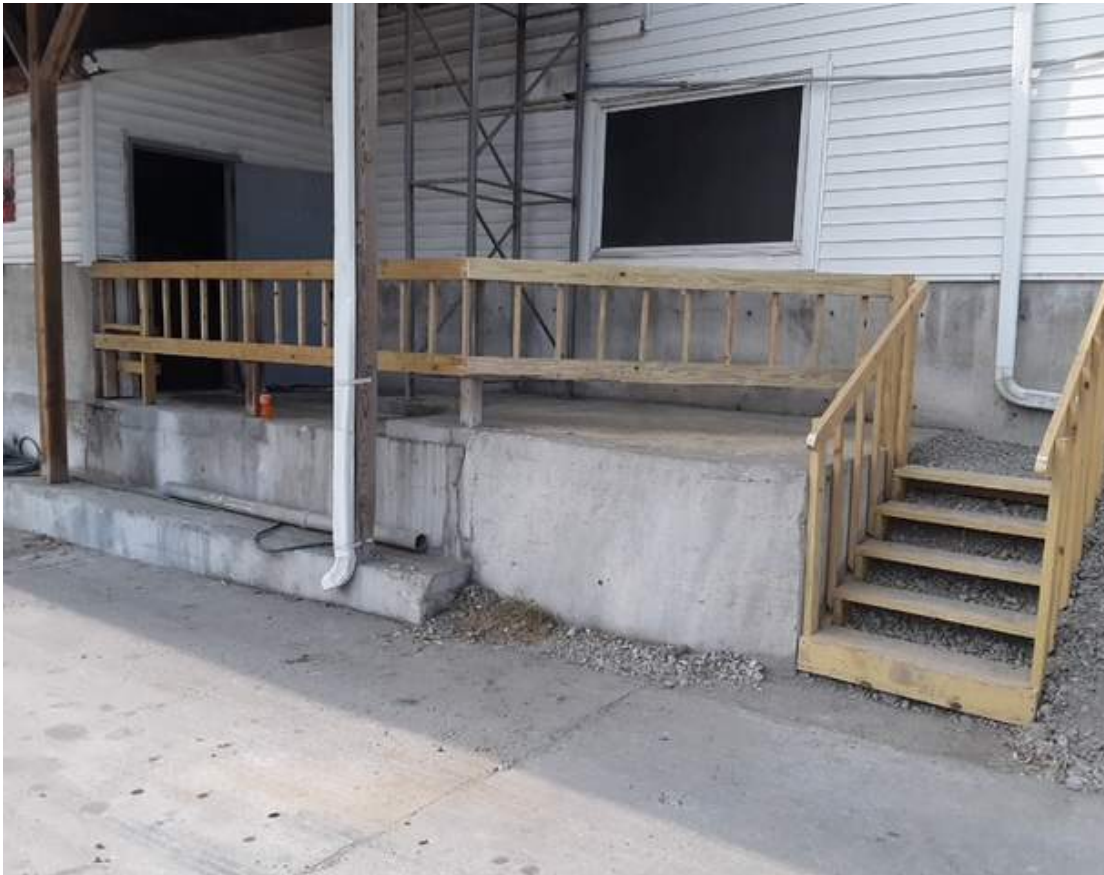
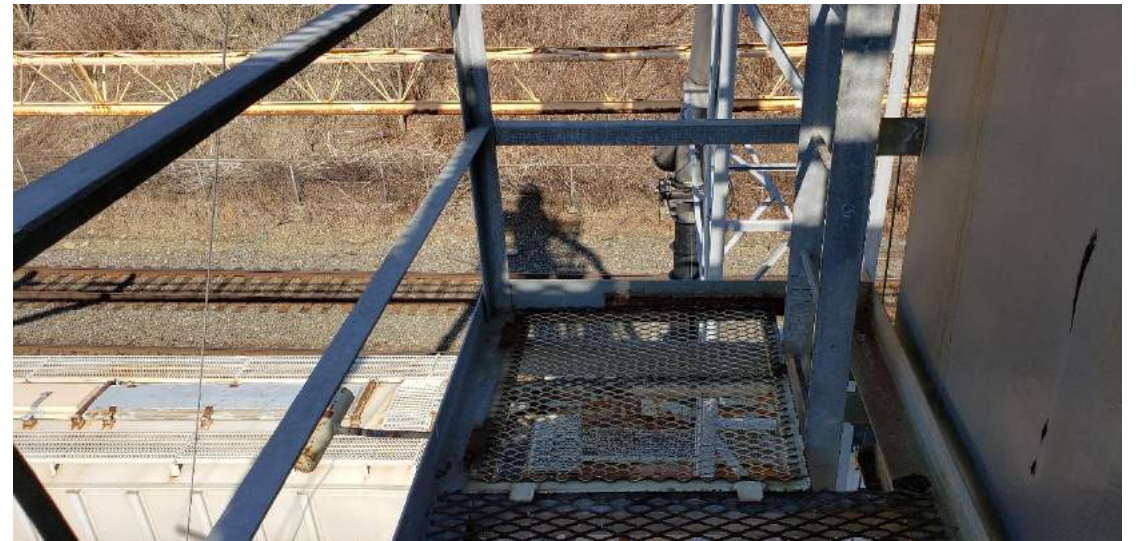
Installed new self-closing swing gate at catwalk access ladder system and built new guardrails at terminal office entry.

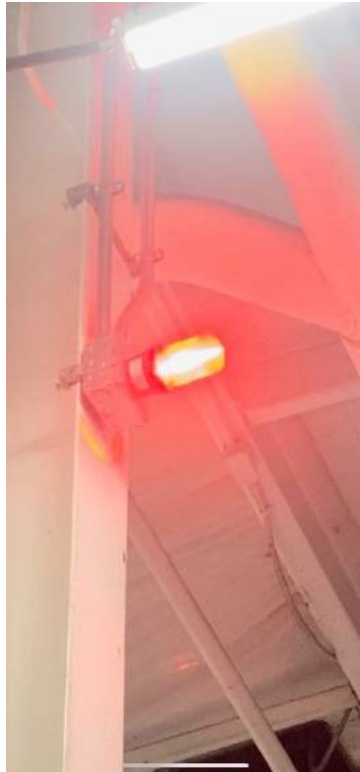
Strobe lights installed in the shop. The lights are to be turned on when any vehicle is brought into the shop with product. When the light is on, no hot work is allowed.

Strobe on:
No hot work
allowed

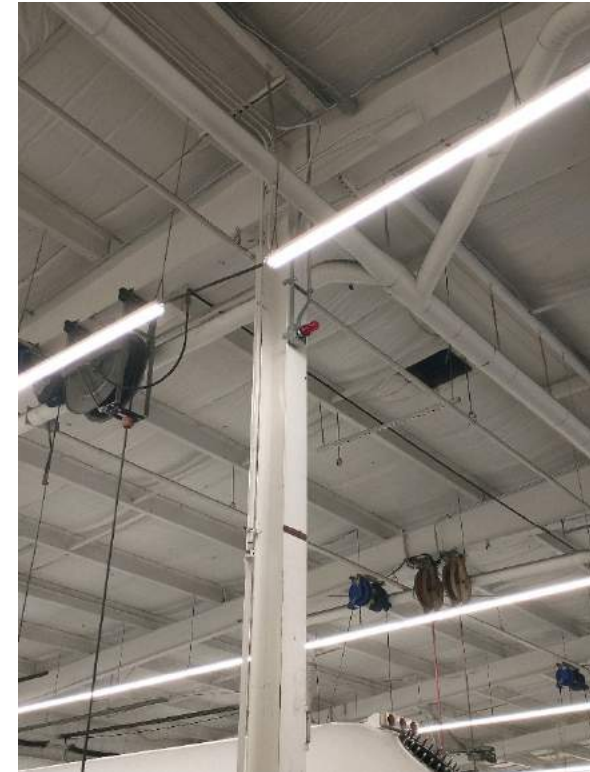
Strobe off:
Hot work
allowed
