2019 Hazard Control Awards

an **nsc** chapter

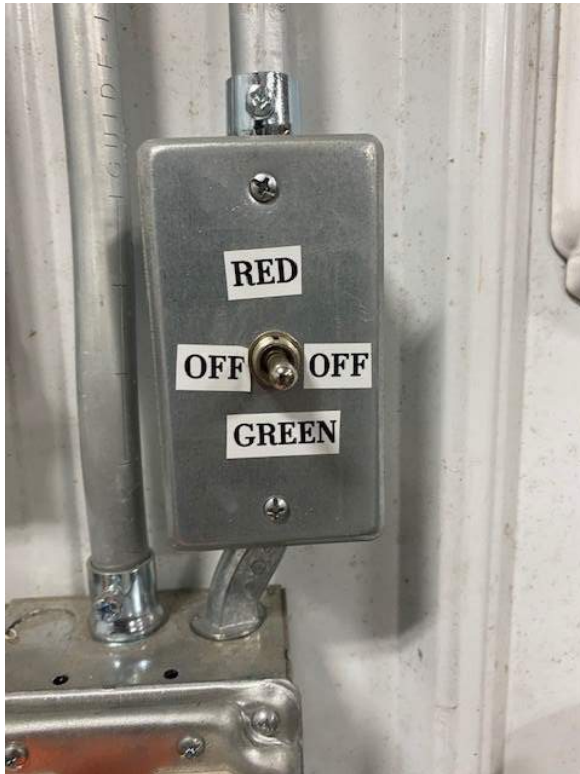
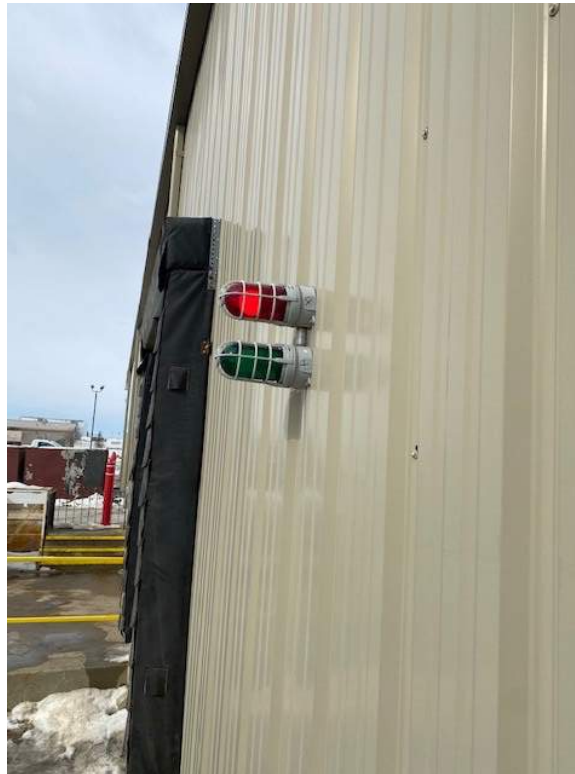
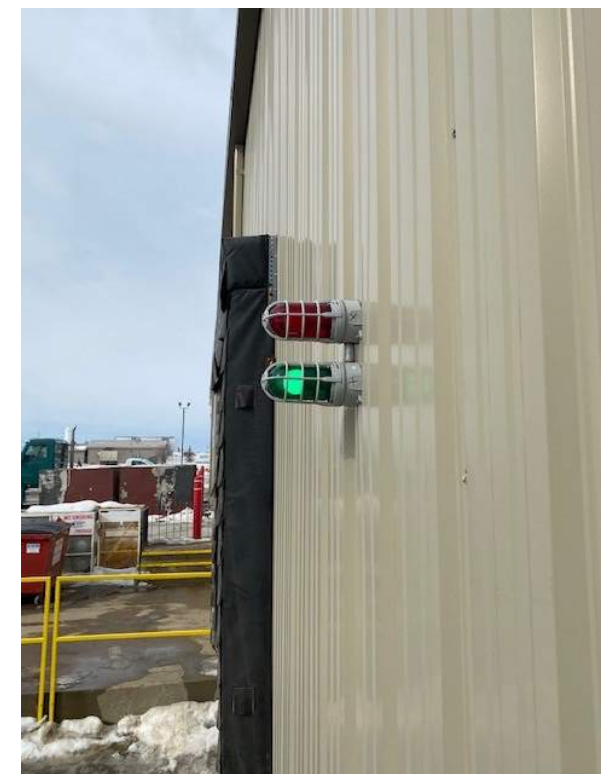
Light system installed to alert drivers to whether a worker is handling material inside a trailer and when it is safe to pull trailer away from dock.

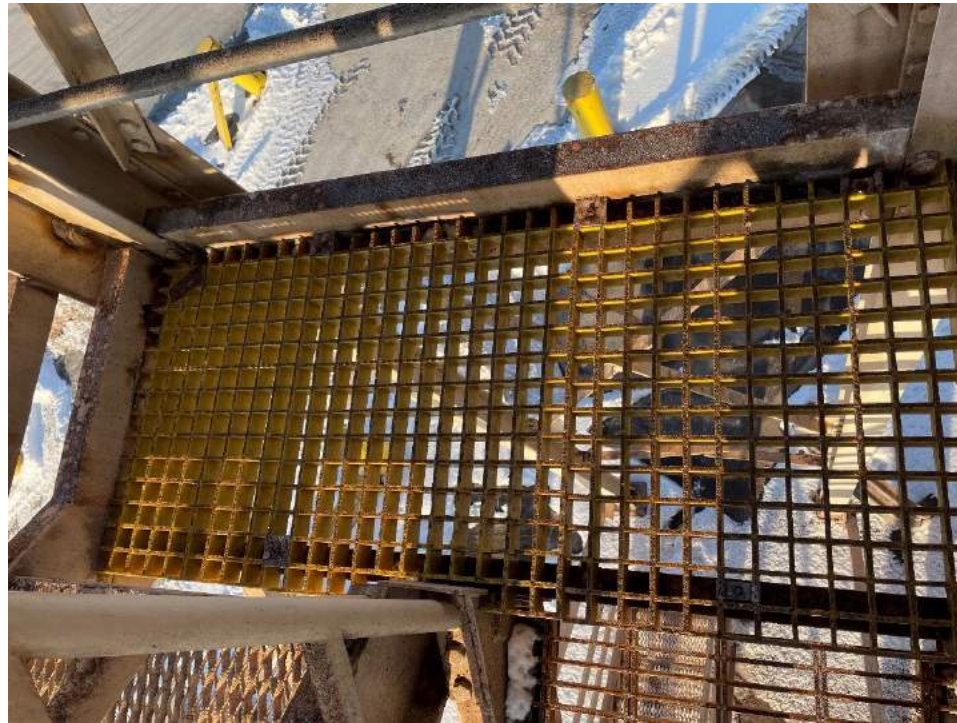
Engineering control, redesign

Corrosion from urea and potash fertilizers had weakened the walking surfaces of loadout towers. Fiberglass grating installed that is resistant to corrosion.

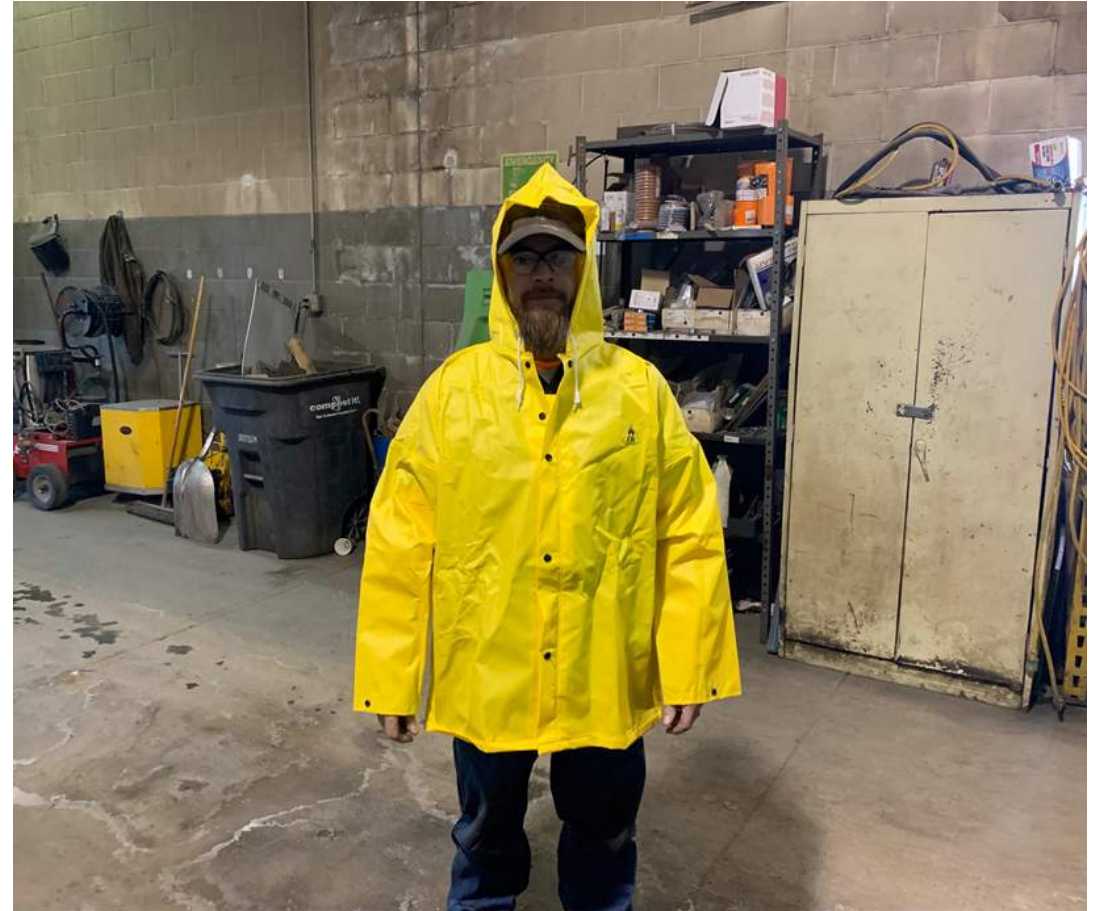
When removing hoses from propane and anhydrous transport trucks, product—or rusted metal from connections seeped with product—can land on employees' arms above the gloves. PVC raincoats were purchased for wear when removing hoses.

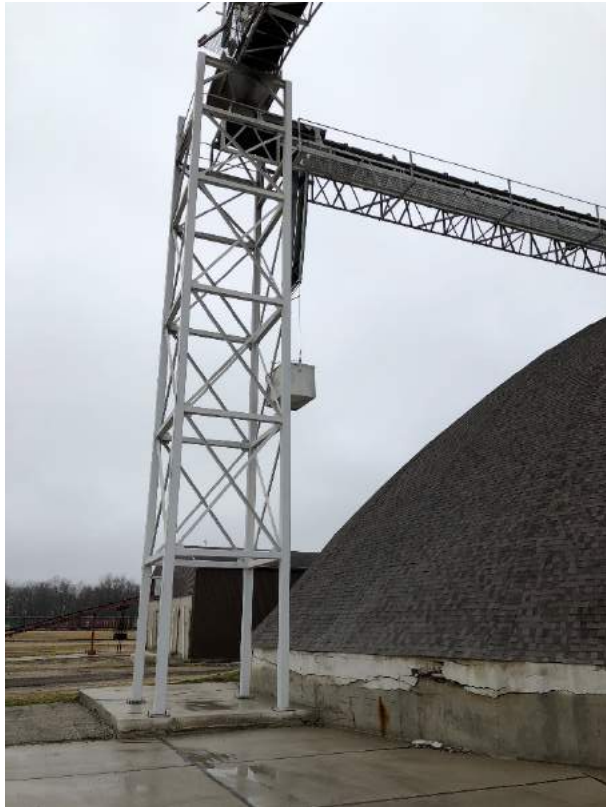
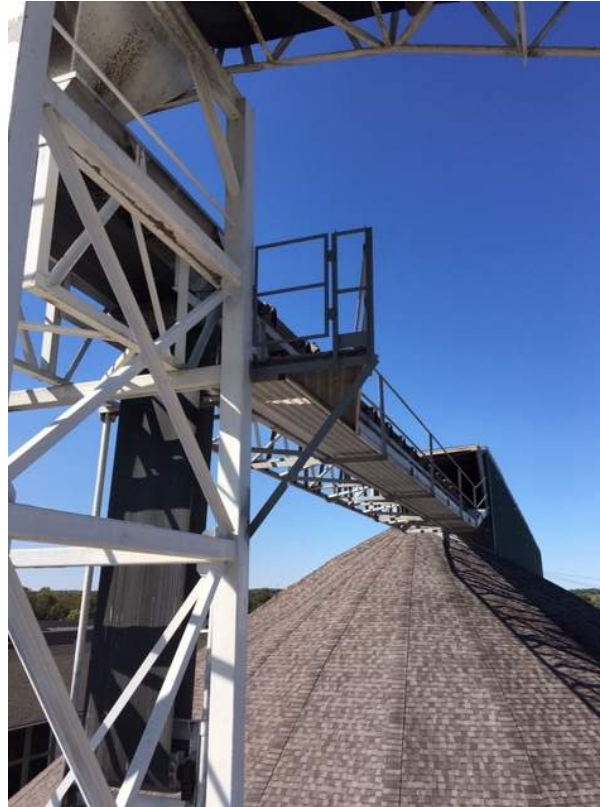
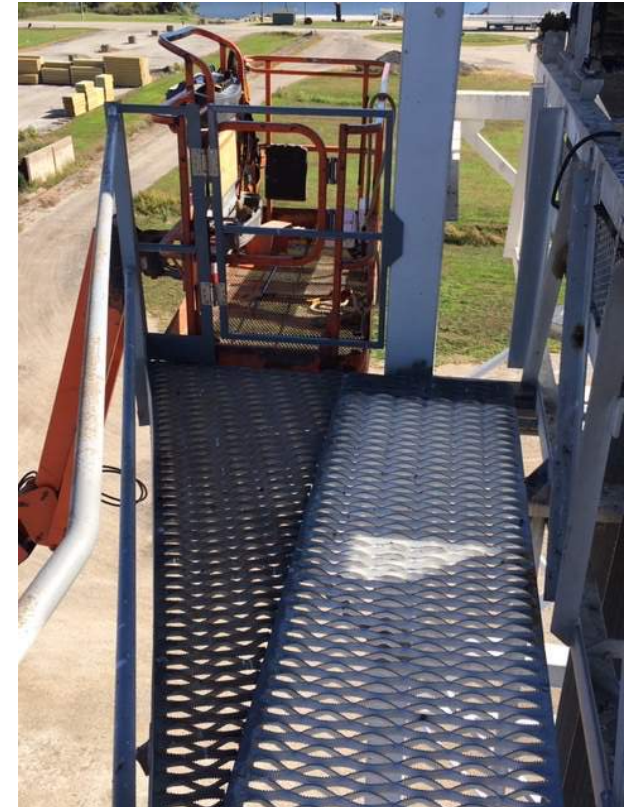
Engineering control, redesign, guarding

With no ladders or stairs, a manlift is used to access the catwalk. Previously, workers strapped their lanyards to the catwalk and climbed over the catwalk rail to get onto the walkway. The walkway has now been widened and the end of the walkway and manlift cage have had gates installed. Now, the manlift is taken up to the gate and workers are able to stay within fall protection the entire time.

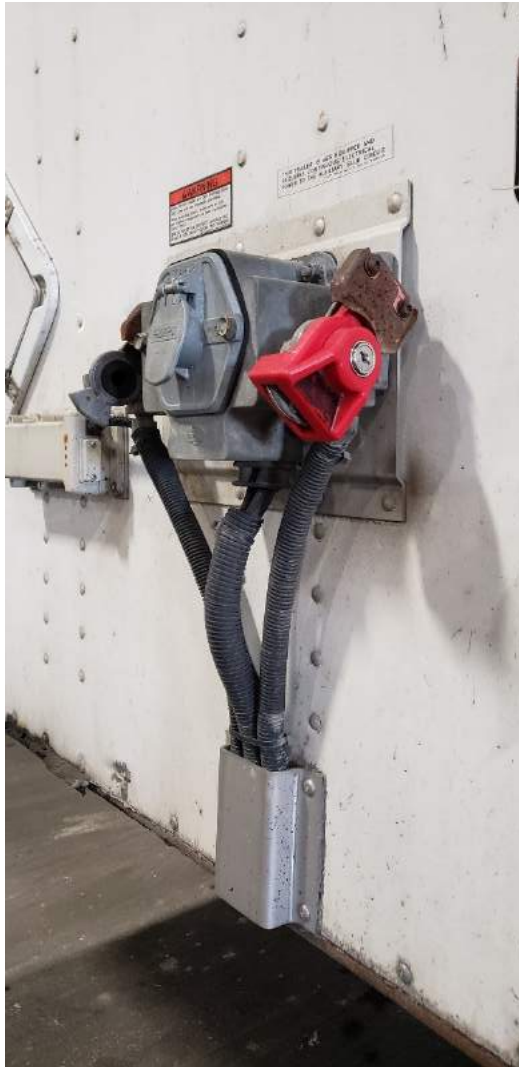
A driver hooked up to the wrong trailer and dropped the forklift and driver from the back. A new protocol using glad hand locks was adopted. It is required of all material handlers to check and make sure a parked trailer has a glad hand lock on it before entering it. This is whether they are loading or unloading. Keys for locks will be held by the leadman and spotter for each shift.

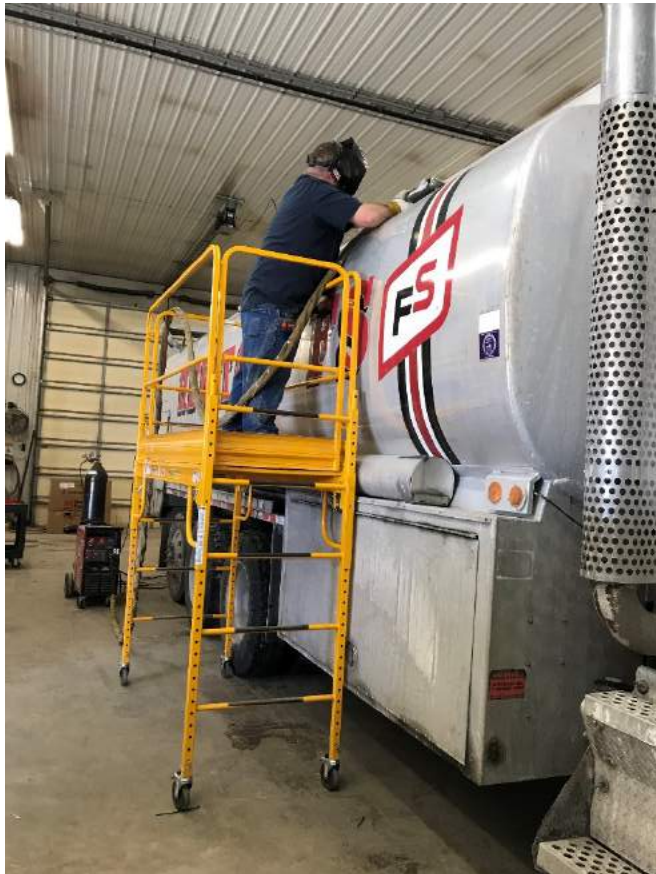
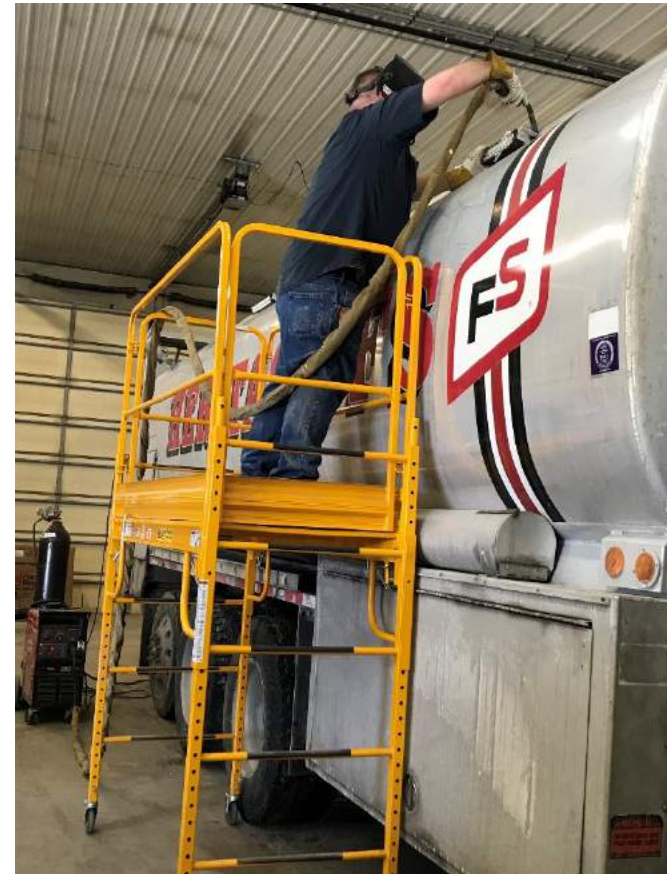
Workers previously had to climb up and down a ladder to carry equipment and perform tasks on truck tanks and bottles. A mobile scaffolding system was purchased to use as a work platform and store equipment—eliminating the need for constant climbing.

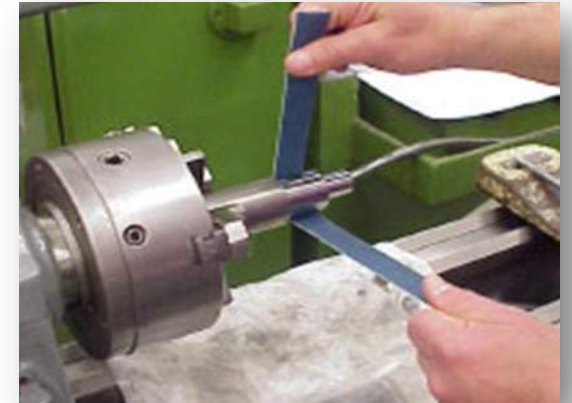
Entanglement in Manual Lathe

While sanding/polishing a part with emery cloth, emery cloth caught & pulled operator into the rotating part. Luckily, the operator only suffered minor injuries from incident.

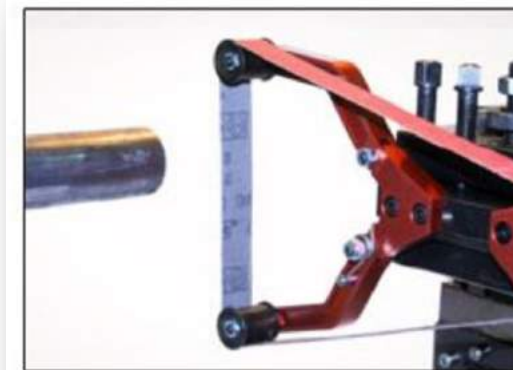
Long term corrective action: Operators researched & found hands-free tooling that holds sandpaper. Eliminating any need to have hands near rotating parts or tooling.

Initial position

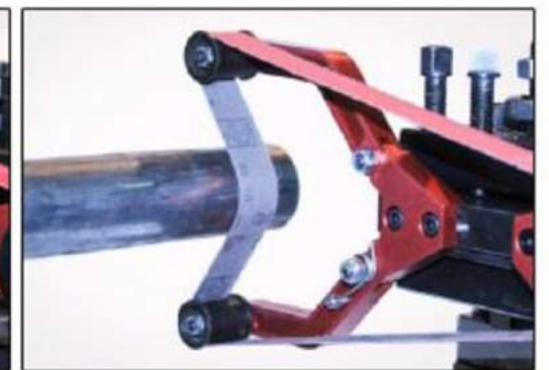
Working position

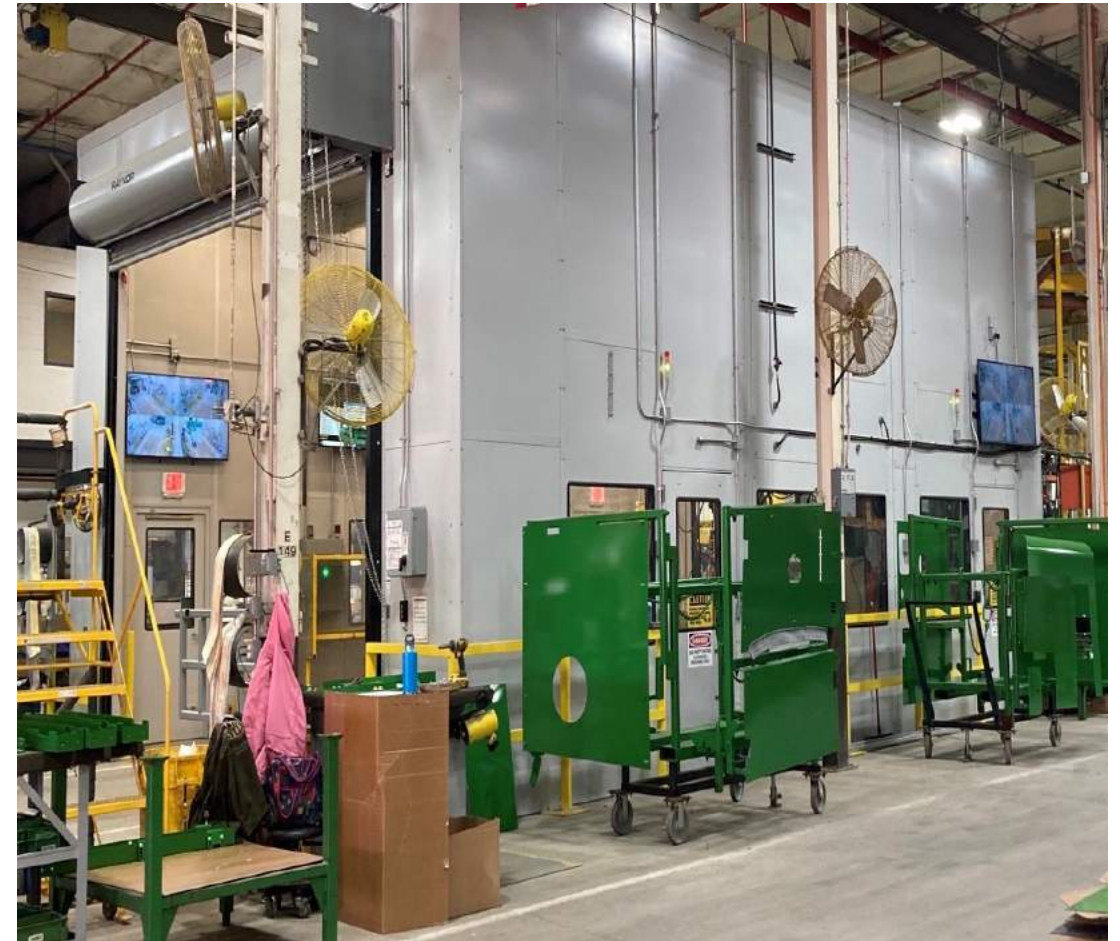
26 X32 enclosed sound booth is installed that allows Windrower to be driven into to perform try-out runoff task. Post booth dB levels remain in the 80 dB level outside the booth during try-out operation. Employees in booth are required to wear dual hearing protection during runoff. The booth is designed with acoustical walls and ceilings that help absorb sound which assist to control the dB level inside the booth as well as preventing exposure to those outside the booth.

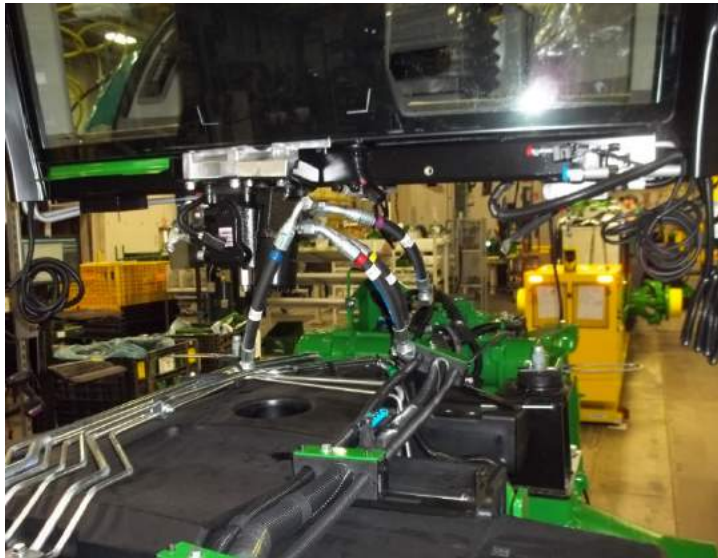
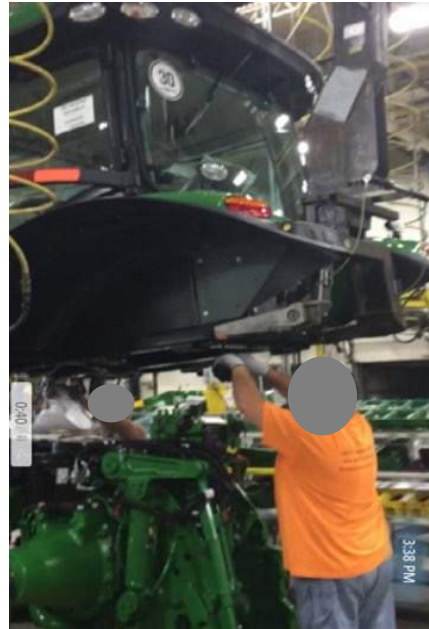
Before:

Previous tractor cab design had many connections located under the cab and in a location which required brief periods of time working under a suspended load, with potential of injury if the hoist system failed or the cab was unexpectedly lowered.

In addition to the hazard stated above, the location of these connections also presented ergonomic challenges which required operators to work with their arms extended outward and over shoulder height.

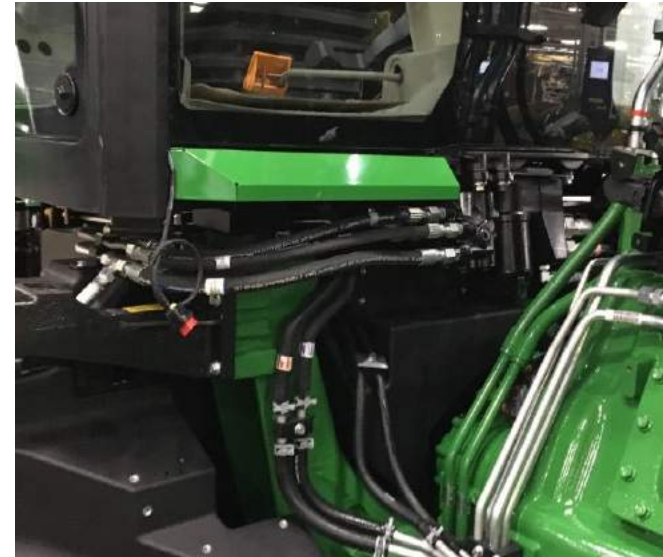
After:

- Cab connections were redesigned and relocated from beneath the cab to improve the ergonomics and eliminate the need to work beneath a suspended load.
- Area scanners, tied to the hoist system, were installed to keep operators outside of the cab “drop zone” until lowered into a safe position.

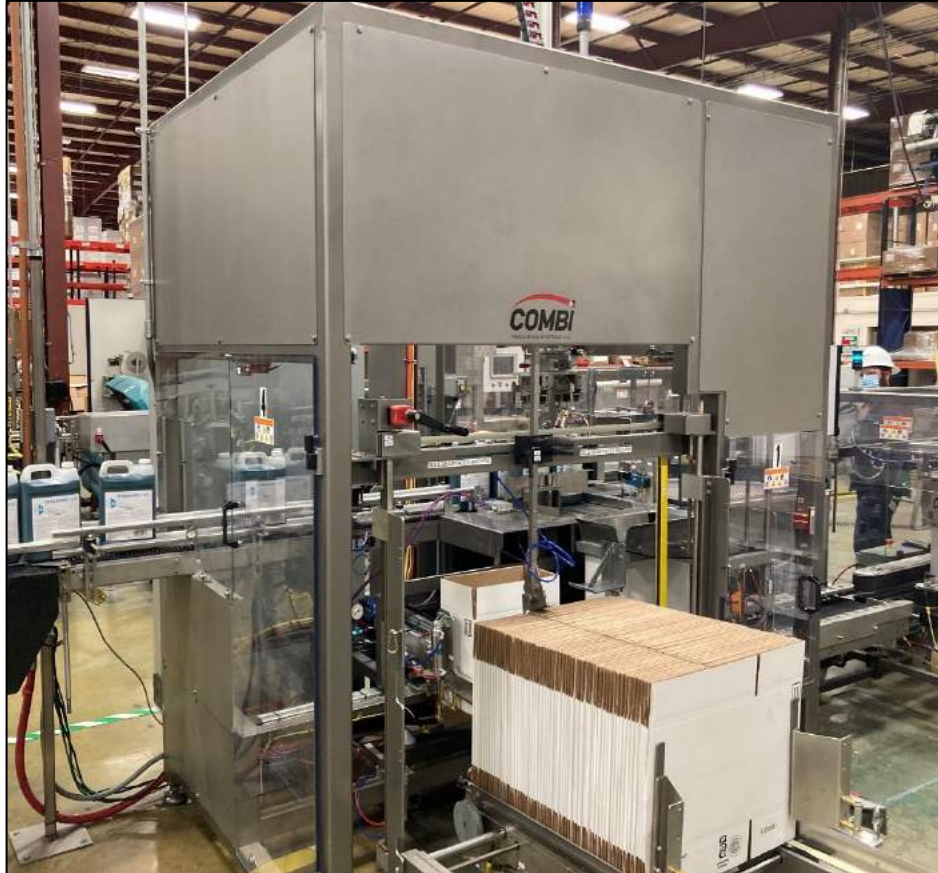
BASF Ames Hazard Control Award Project: Automated Case Packaging Line Upgrade

The BASF Ames manufacturing facility completed an upgrade to all chemical packaging lines that produce seed coatings and turf colorants in various pack sizes for the agricultural industry across the world.

The automated case packaging upgrades were part of an overhaul of the lines resulting in tremendous hazard exposure reduction and ergonomic improvements. Prior to the automated case packer, line operators would be tasked daily to manually load 500 - 1500 bottles of varying weights (5-30 pounds) into cardboard cases. The new equipment is programmed by operators for the various fill sizes and cardboard cases are loaded for automated case packing. Beyond the tremendous hazard reduction, operators have increased quality defect detection capabilities and operate the lines more efficiently overall.

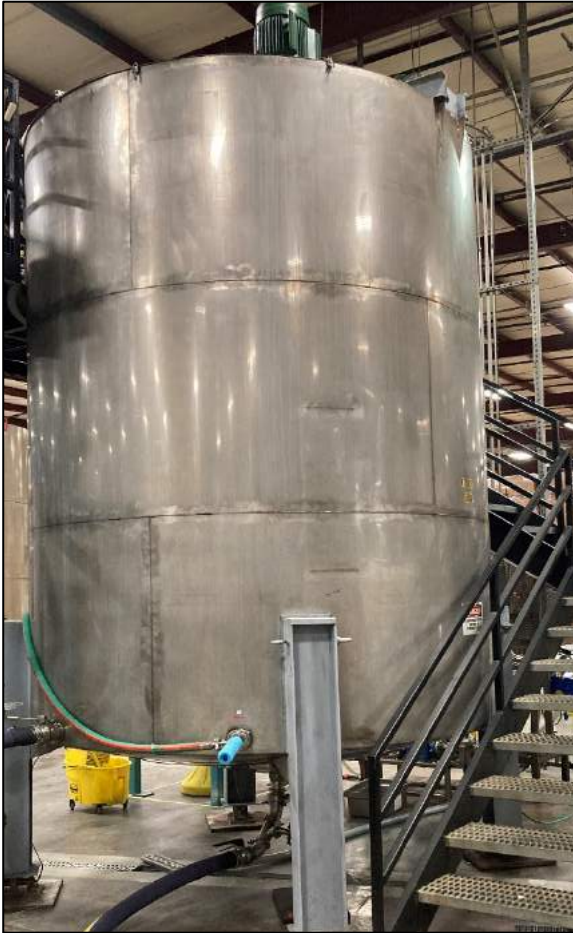
BASF Ames Hazard Control Award Project: Chemical Mix Tank Mixer Shaft Upgrade

The BASF Ames manufacturing facility upgraded a mixer shaft on a chemical mix tank that previously featured bolted components such as the mix blades. The upgraded mixer shaft is a completely welded together shaft. Prior to the upgrade, employees were required to enter the permit required confined space 10 or more times throughout a production season to disassemble the bolted shaft components for tank sanitization, sterilization, and microbial swab testing. The welded mixer shaft upgrade eliminated the need to disassemble the shaft for cleaning and sterilization between each batch and allowed the tank to be cleaned with the automated cleaning process instead of by hand, during a confined space entry. The tank only needed to be entered a total of 3 times during the last production season, meaning this project reduced confined space entries by 70%! The project also reduced the hazards of the confined space entry by eliminating the use of hand tools for disassembly of the mixer components. This project was completed by an inter-departmental team at the site and was viewed as a major win for hazard exposure reduction and a gain in efficiency.

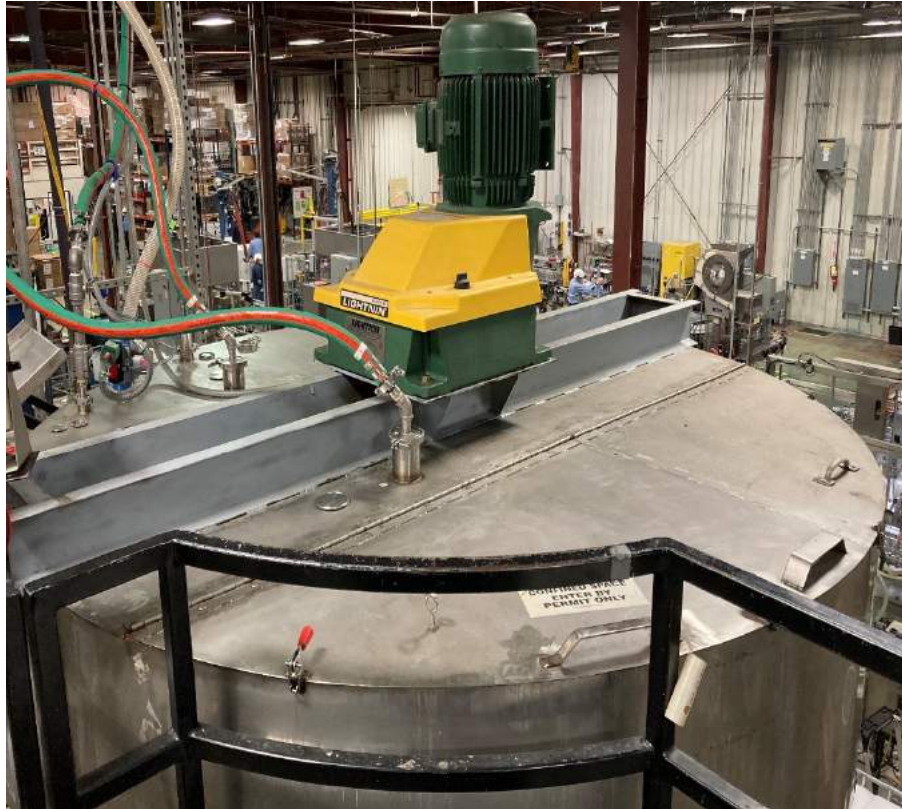
BASF Ames Hazard Control Award Project: Auto Retractable Mix Tank Cleaning Nozzles

The BASF Ames manufacturing facility upgraded its chemical mix tanks' cleaning equipment by installing automatic retractable tank cleaning nozzles, known as "spray balls". Prior to the upgrade when tanks needed to be cleaned between batches, it required operators to manually install the spray nozzle equipment onto the lid of the tank. Depending on the location of the nozzle port, the design created a need for operators to utilize a fall harness and anchor point while working on top of the tanks and barricade off the areas below the tank to protect from dropped objects as nozzles were installed.

The new auto retracting spray nozzles remain installed on the lids of mix tanks across the site and allow operators to simply activate a switch to engage the nozzles inside of the tank for the cleaning process, then disengage when cleaning processes are complete. This project was managed by an inter-departmental team of employees and was a major win for hazard exposure reduction and a gain in process efficiency.

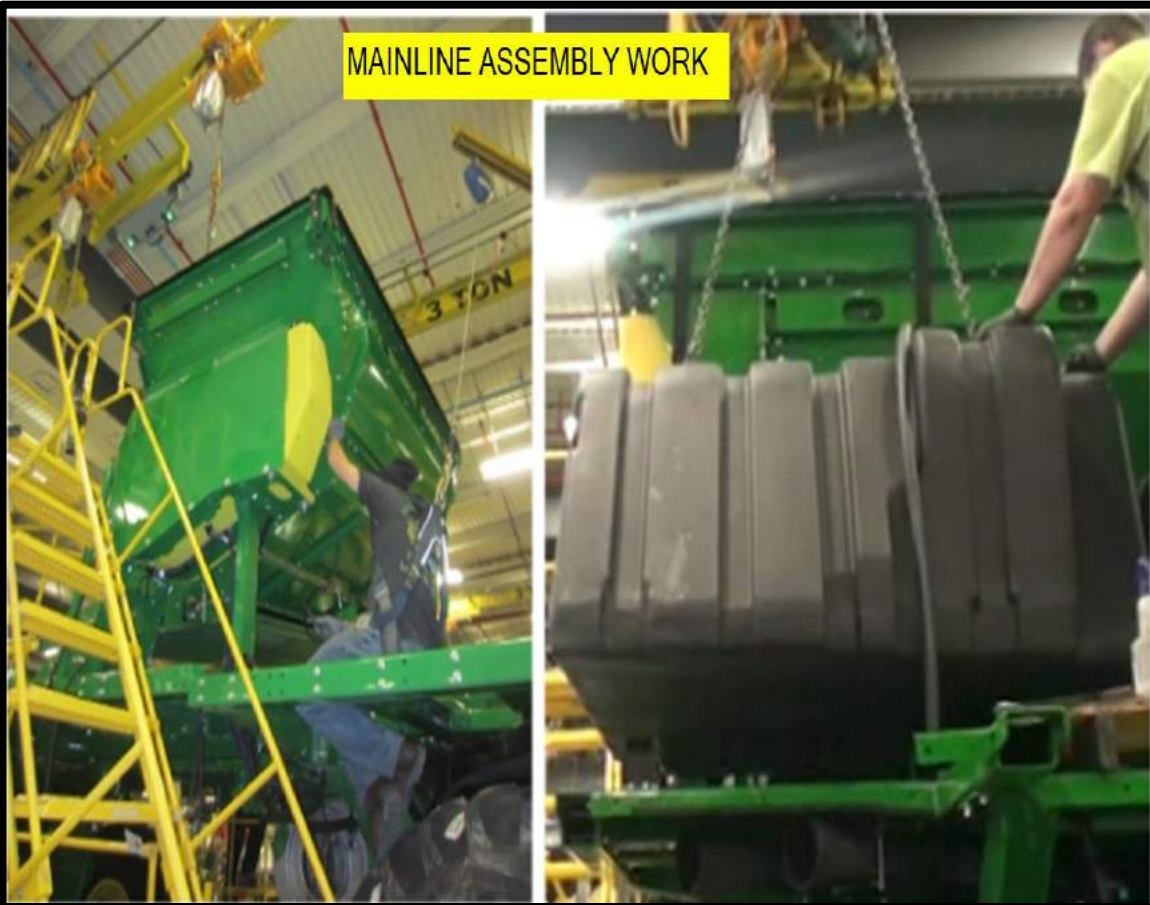
Before

Hazards – Risk of Fall from 7' while using fall restraints & Ergonomics – operators reaching too low & too far

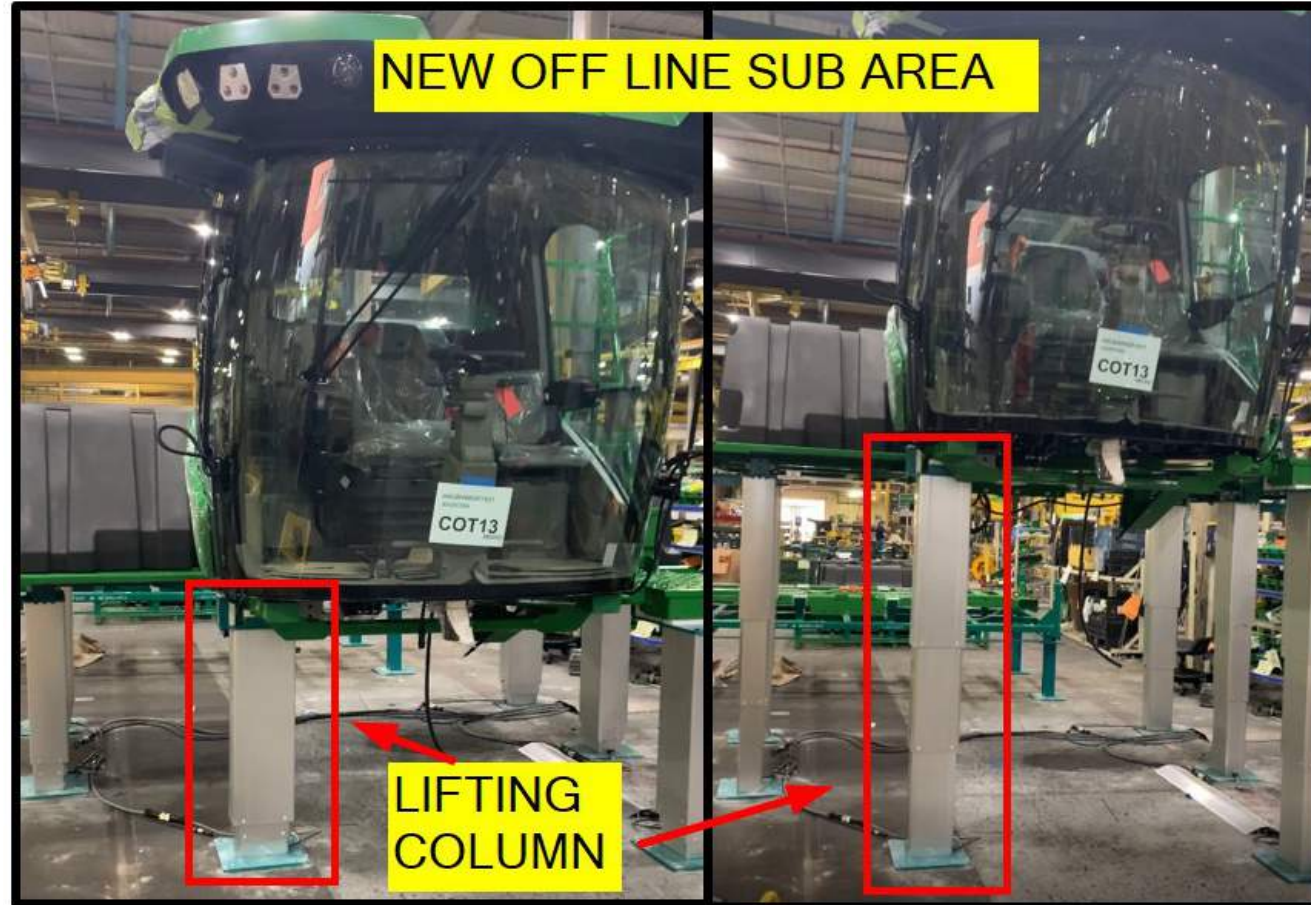
After

Control – Eliminated all hazards by moving the work from mainline to a sub area. By using lifting columns, the operator can stand on the ground with no fall restraint

Unique – The standard at Des Moines Works (common across John Deere) is to use positioners when processes require work to be raised up. This situation required some out-of-the-box thinking due to not having enough floor space for positioners. The team succeeded at syncing 6 lifting columns together. The innovative new solution applies existing technology (lifting column used in medical industry) in a new way which has never been achieved before at any other John Deere factory.

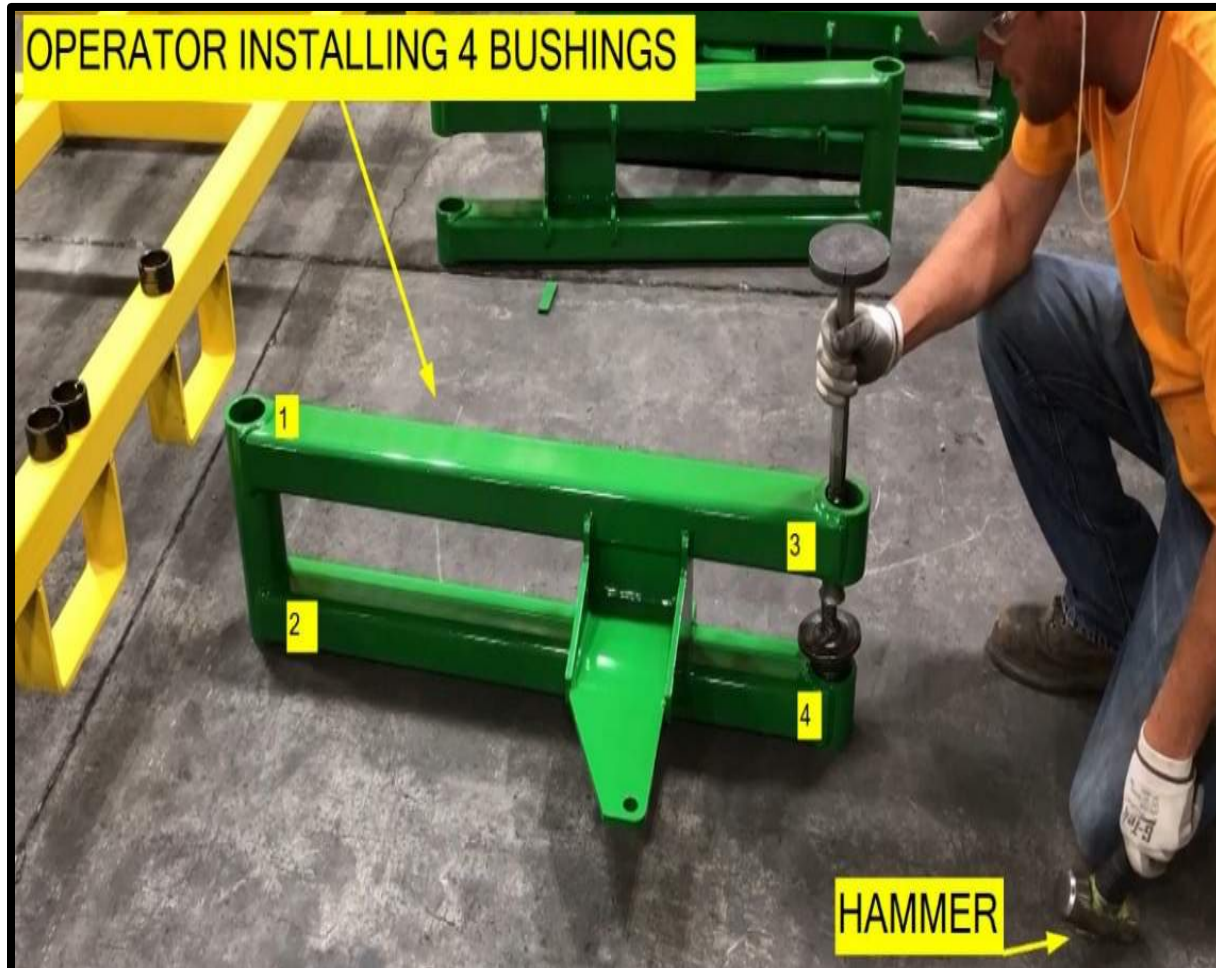
Before

Hazards – Hand & Finger Pinch Points & Ergonomics – impact fatigue (16 hammer strikes per a part)

Control – Eliminated all hazards by creating a new bushing press fixture. The operator's hands are in a safe place and eliminated 48,000 hammer swings per year. The operator's body is in a more ergo friendly position by being able to stand. There was a 75% efficiency gain by eliminating the non-value-added work of flipping part and pressing in all 4 bushing at one time.

Unique – This team used out-of-the-box thinking to solve the challenges. Pressing in 2 bushings from the inside instead of outside was a big challenge never done before at Paton; thus, allowing all 4 bushing to be pressed in at once. Additionally, the fixture is safely designed to withstand the high 4,500 lbs. of force required to push in a single bushing while making the tool work for 6 different options.

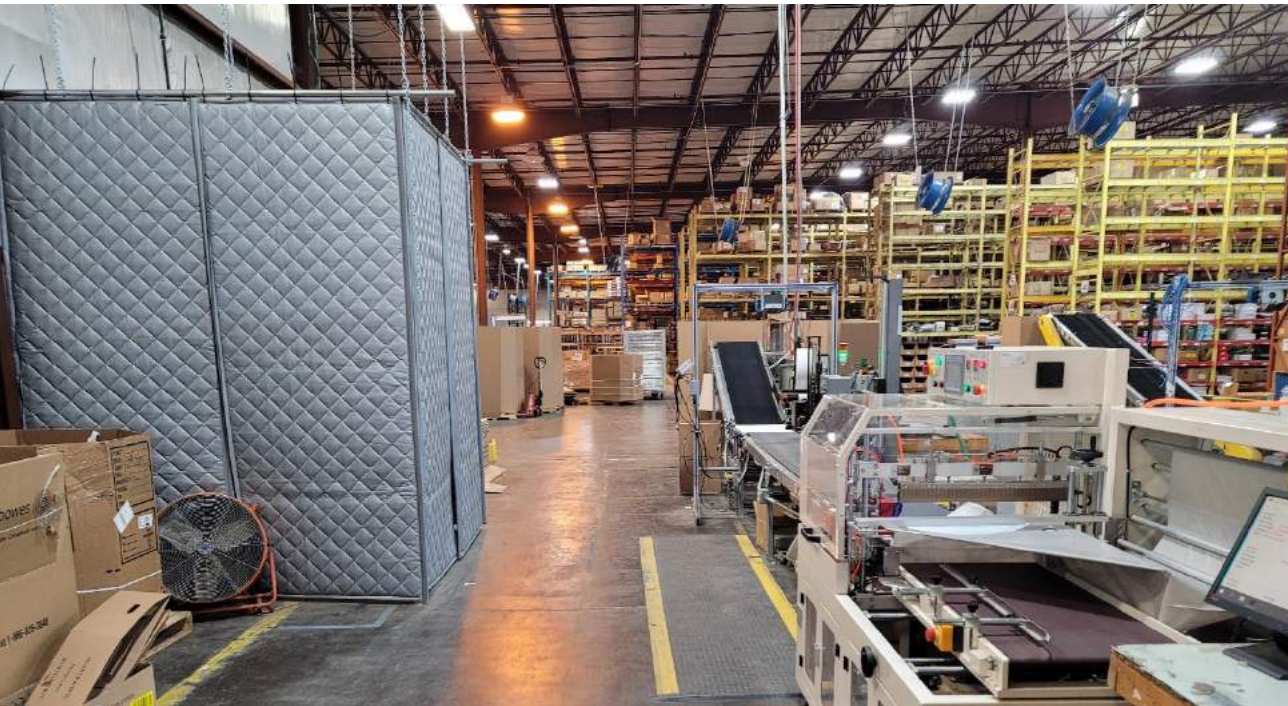
Facility Redesign – Auto Bagger Operations

- **Before:** The space pictured was utilized for pallet storage. Forklifts would pull pallets out of the trailers seen in the background and place where the Auto bagging line is now.

- **Hazards Mitigated:**
 - **Noise Reduction:** 4' wide by 10' tall by 4" thick noise absorbing blankets were installed around the front and sides of the air compressors shown. These were hung to be touching the floor so any noise that wasn't absorbed by the blankets would be above the employees.

- **Ergonomics:** This line has allowed the facility to reduce the need for manual packing of product. Now a line ergonomically set will automatically take product set on the line, bag it, seal it, label it and drop it into a gaylord for shipping.

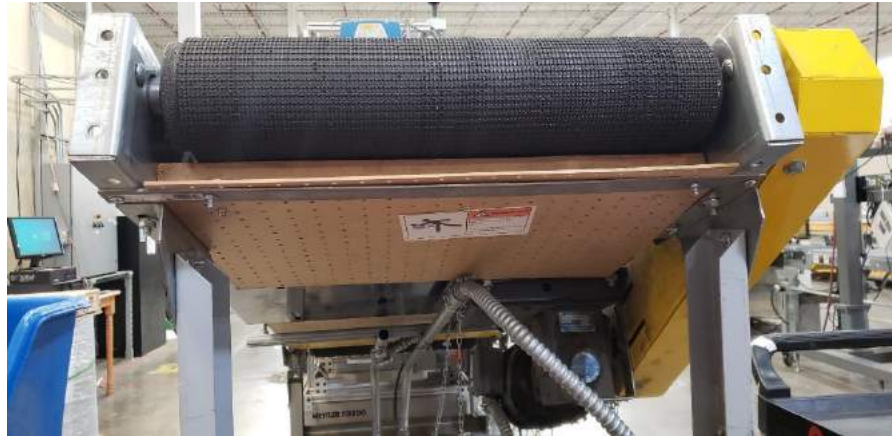
Guarding Audits and Guarding Implementation

Colony Brands instituted a guarding audit, where equipment guarding is the only item being audited. During this process it was noticed that the underside of the conveyor was guarded on a new conveyor and not on an older style of the same model. To remove the pinch and nip points a conveyor guard was added to the old model to the same dimensions as the newer model of conveyor, and the same warning labels were printed and applied.

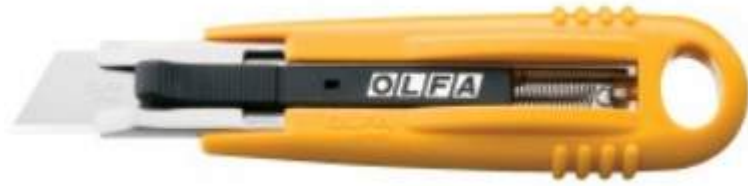
Before: This facility was previously utilizing self retracting knives, so if the lever was pressed the blade stayed exposed. This did account for quite a few cuts over the years at Colony Brands.

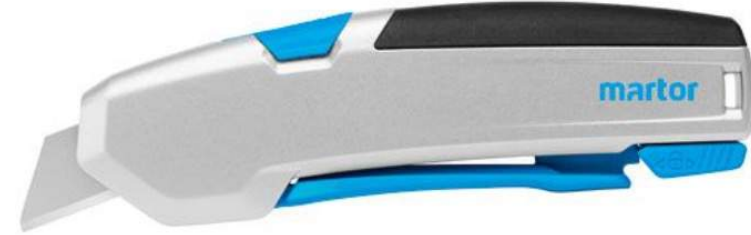
After: The facility now is utilizing automatic retracting utility knives so once contact with the surface is lost the blade will retract

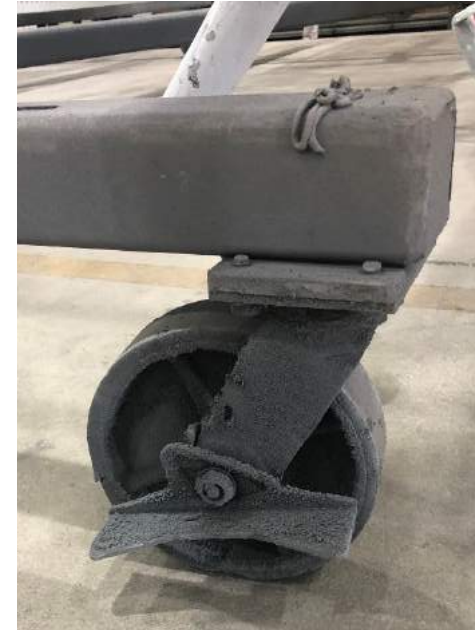
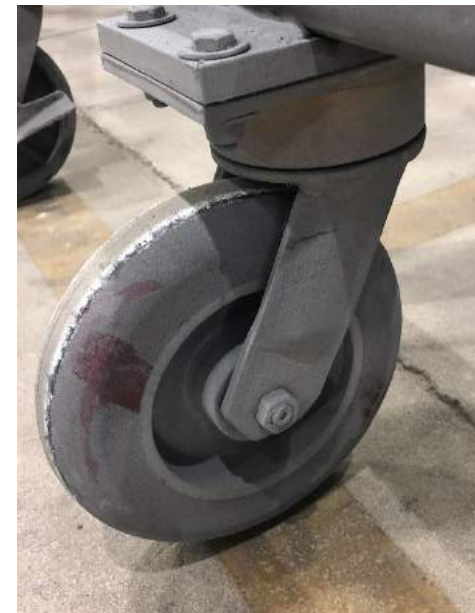
Stellar Industries Paint Line Caster Improvements

- Strain/sprain injuries were an issue in our paint department
- The old casters (above) created too much resistance to be pushed by employees
- Engineers found a sealed-bearing caster and our welding department installed new mounting brackets
- This has greatly reduced rolling resistance and our paint employees have no issues maneuvering paint carts

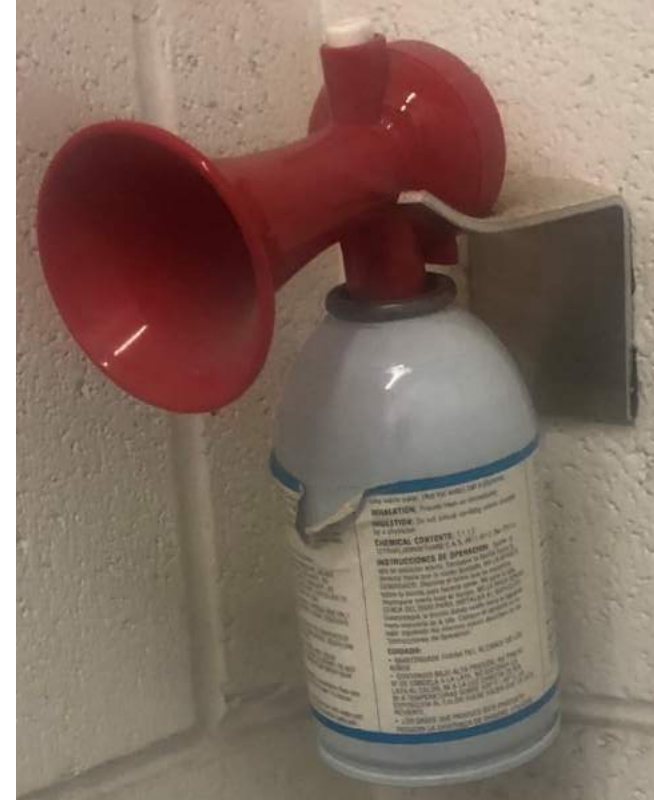
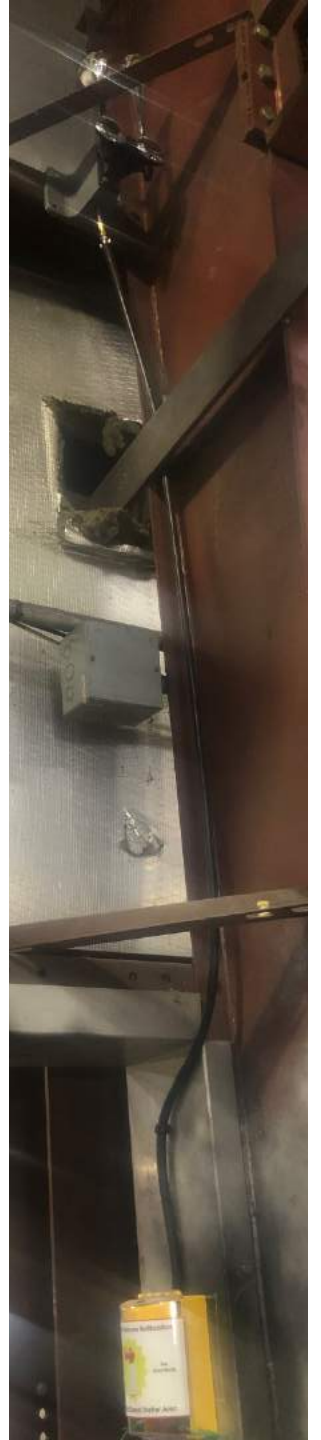
Stellar Emergency Alert Enhancement

- We needed to improve our emergency alert system
- Before we had handheld air horns located throughout the buildings
- We mounted train horns throughout the company in centrally located spots, hooking them up to our existing air lines
- These can be heard throughout each plant, greatly increasing our emergency alert capabilities

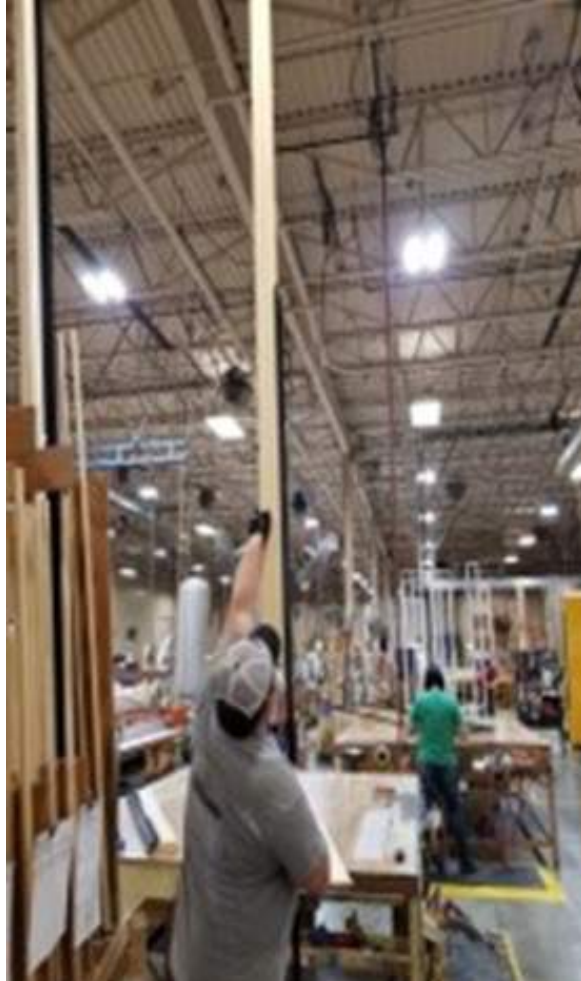
Before

Team member would apply 120(+)” frame metal to the wood part by sliding the frame metal as far as they could horizontally, then stand the parts up to pull the metal down. The last 30-50% of the part, the team member would need to bounce the part off the concrete while pulling the metal on.

A jig was 3D printed allowing the team member to place the wood part on the frame cut table and tap the clad onto the wood part. A jig was necessary to disperse the energy of the dead-blow hammer evenly across the clad parts to prevent damage. This has eliminated the need to manually force the clad on by gripping/pulling.

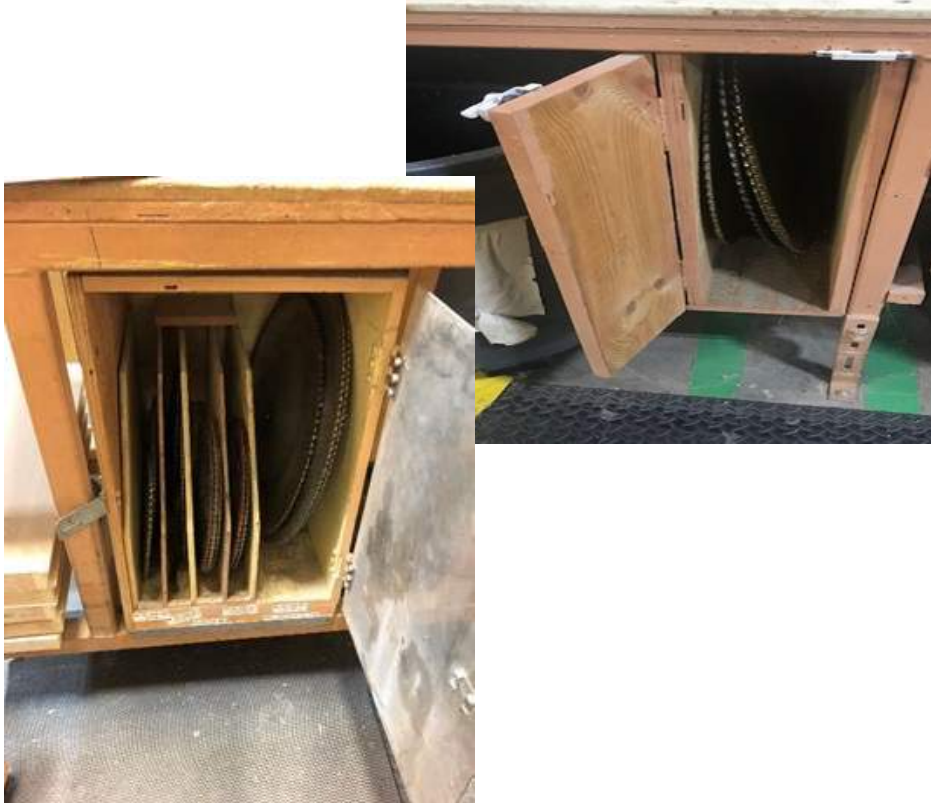
Before

9 different location that the blades were kept. 334 blades were on hand for 56 pieces of equipment that take a saw blade. Changing the saw blades is a maintenance function, but the saw blades were unmanaged and could be accessed by anyone.
