2019 Hazard Control Awards

an **nsc** chapter

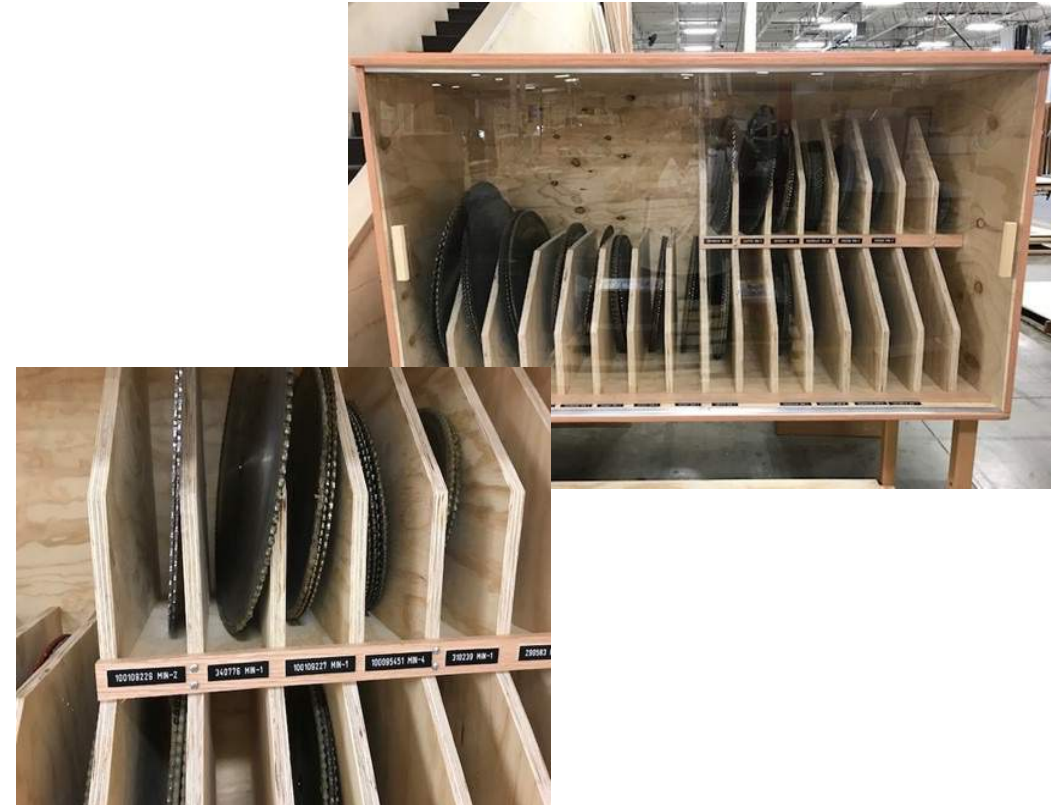
After

A centralized blade box was built, and all blades were consolidated to this area. The new box was elevated for better ergonomics. Saw blade inventory went from 334 to 118. The new system has the teams calling maintenance with the blade number needed. This reduces the people exposed to the blades and ensures the correct PPE is worn.

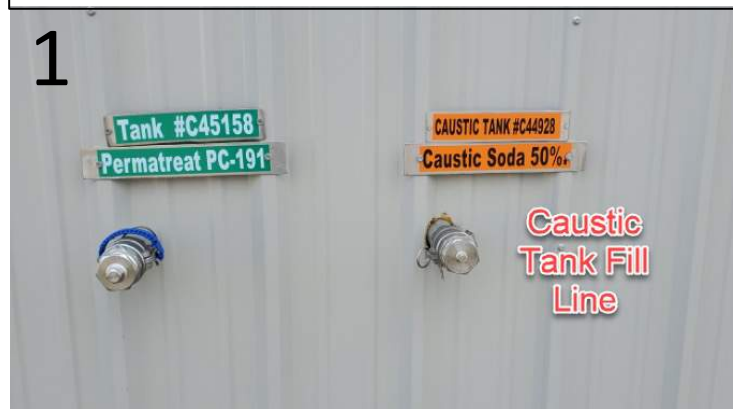
1. Labeled fill line for caustic system

- As a part of EDNF's water treatment program, caustic is added to the boiler feed water for pH adjustment.
- Caustic is a corrosive chemical that can cause serious chemical burns to the skin and eyes.
- It was identified that the old method for adding caustic manually to the system was unsafe. The process required employees to fill a 5-gallon bucket and carry it 50 yards to be dumped into a tank. This exposed the employee to the potential injury from caustic splash or a spill.
- To correct this situation, EDNF installed an automatic caustic injection system.
- This system consists of a fill line, a bulk tank, injection pumps, and an injection line. The tank is filled by a contract supplier.
- This eliminated the hazards to employees associated with the manual filling of caustic chemicals injection.

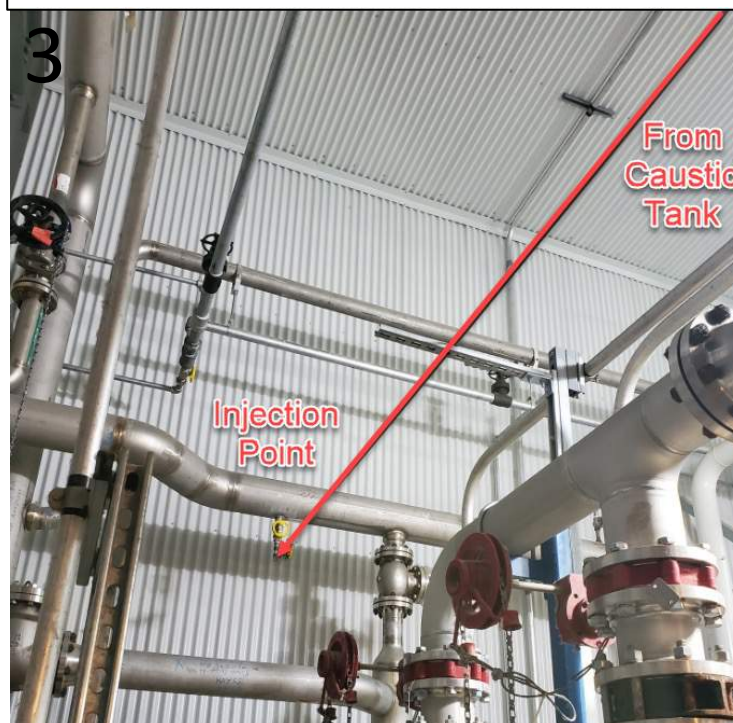
3. Caustic Injection Point

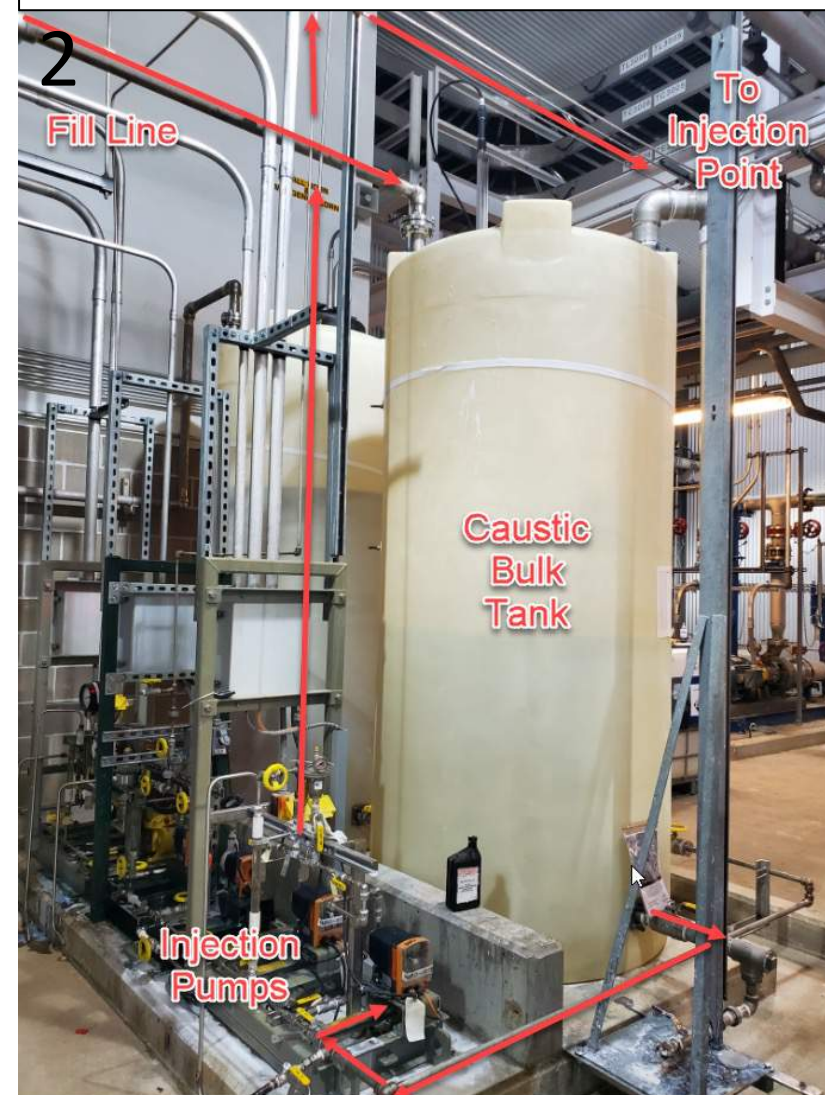
2. Caustic fill line, bulk tank, injection pumps, and pump discharge to the injection point.

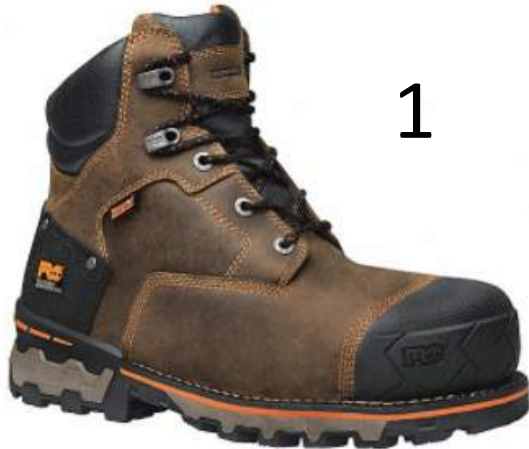
1. Timberland PRO, Boondock, oil and slip resistant sole, 600grams of Thermolite

- In September of 2020, the East Dubuque Nitrogen plant management decide to purchase each employee a pair of winter boots. The Plant reviewed many types of boots and decided on two types of boots. The boots were chosen on the traction provided by the sole on snow & ice and the thermal properties of the boots. A vendor was chosen and all employees were fitted by October of 2020.

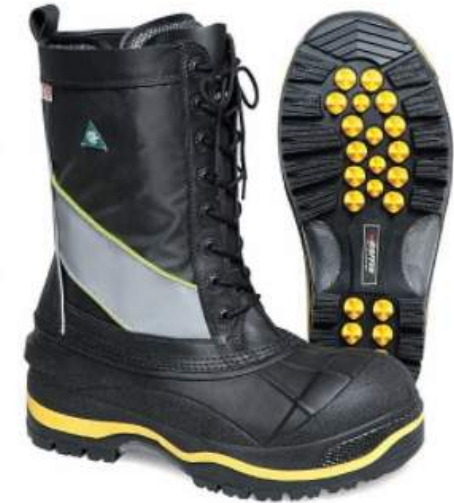
2. Baffin Constructor, oil and slip resistant, 800grams of Thermolite

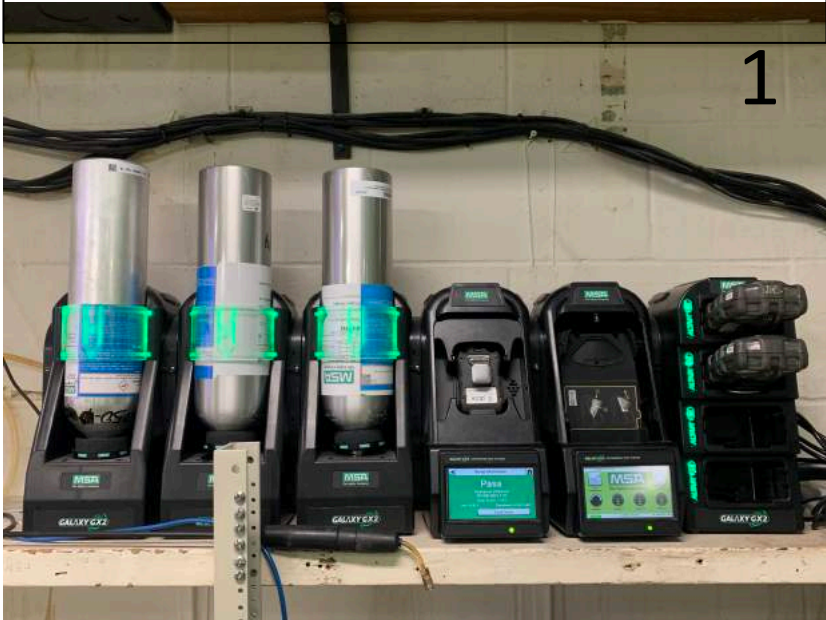
1. Altair 2X & 5X gas detectors

- With the addition of Safety IO, a cloud-based gas detection management software connected to each docking station in the plant, personnel are alerted for the need to bump test and calibrate their instruments prior to use. This information is downloaded from each detector and the Safety Department is then alerted when there is a potential employee exposure, or if an instrument has recorded an event of significance.

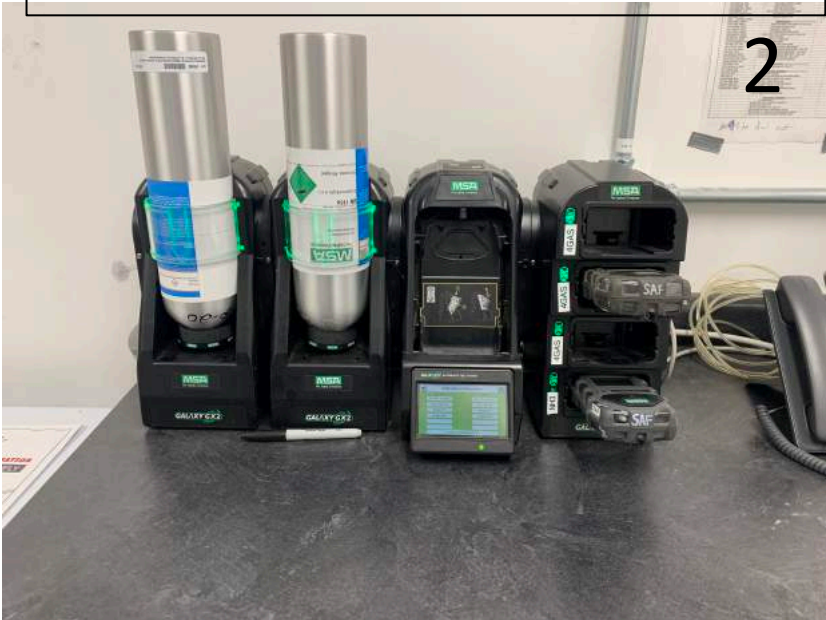
2. MSA Galaxy GX2 Altair 5X Automated Gas Detector Test System

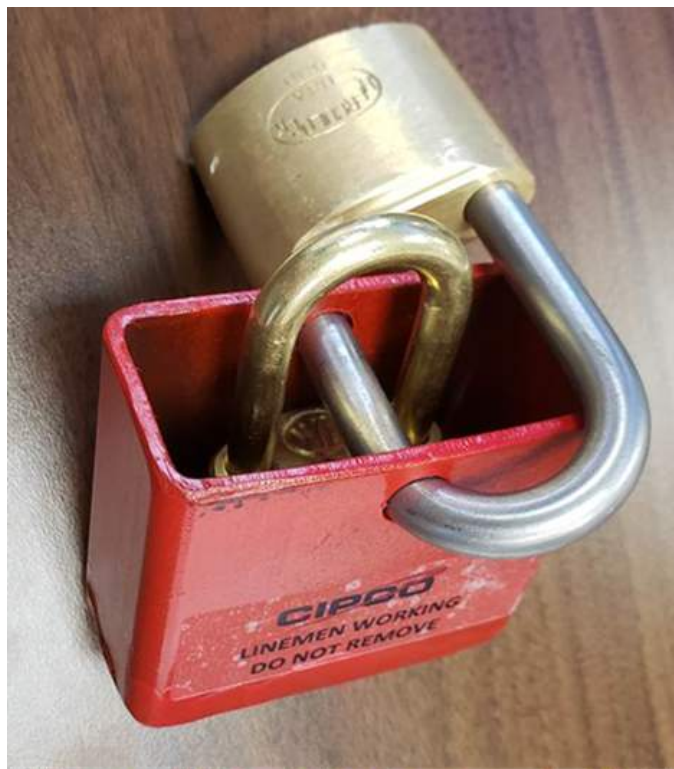
Before

Pole switches are used to break a power connection in a power line when you open them. When closed, electricity flows freely on the line. During derecho 2020, a communication error resulted in a switch being closed on the line where a crew was working. Because they had placed their personal grounds, nobody was injured.

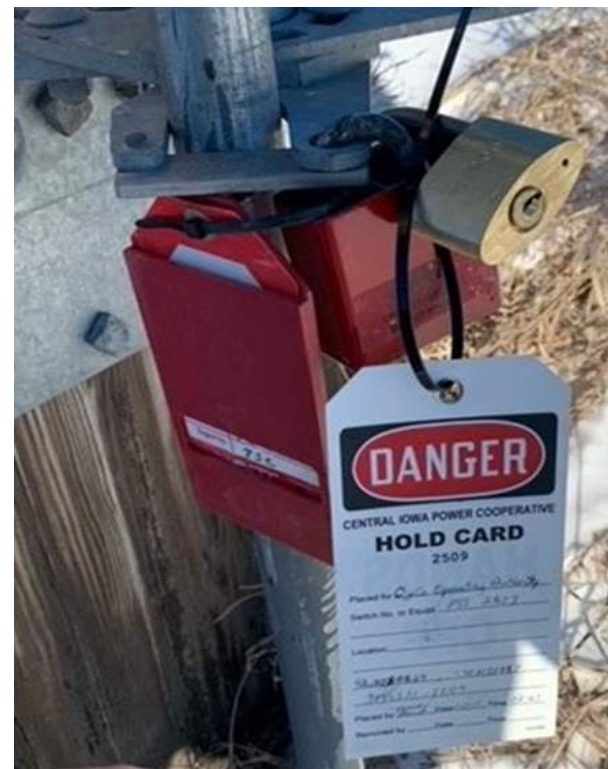
After

Pictured above is the engineering control developed by Utility Operations CIPCO staff that enables a lock to be placed over another lock which prevents the owner of the switch from removing their lock and closing a switch while CIPCO works on the line it serves. No lockout device like this is currently available commercially.

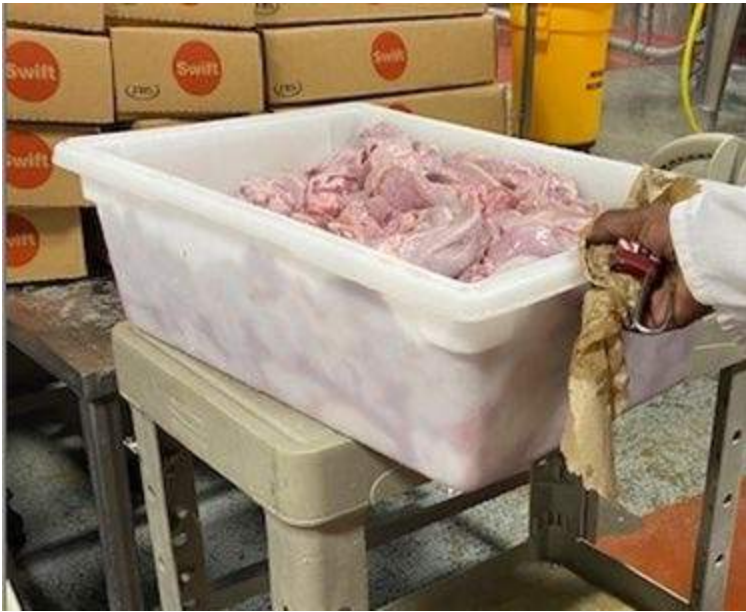
Variety Meat Blender Dumper

Before used tubs to transport product from one room to another weighing excess of 100lbs. We would put 16 of them on a cart and transport them to be dumped. We now utilize a rolling tub that is automatically dumped eliminating the carts and the tubs.

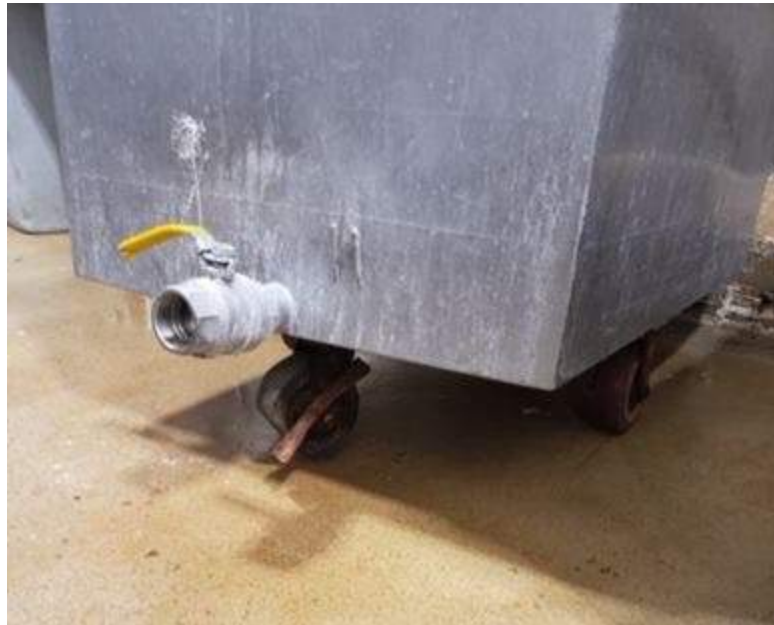
We replaced the wheels on the carts that transport casings to the salt room, the larger wheels require much less force to move the tubs greatly reducing the stress on the body.

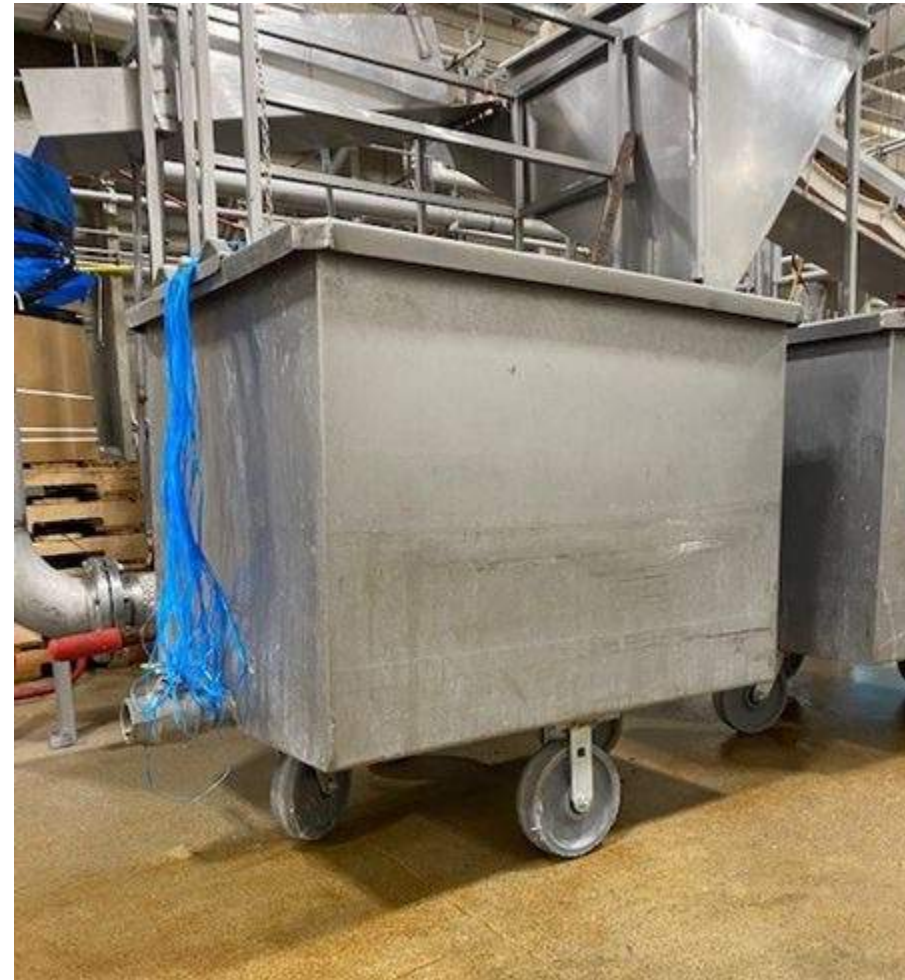
AFTER

Wheels on Casings carts

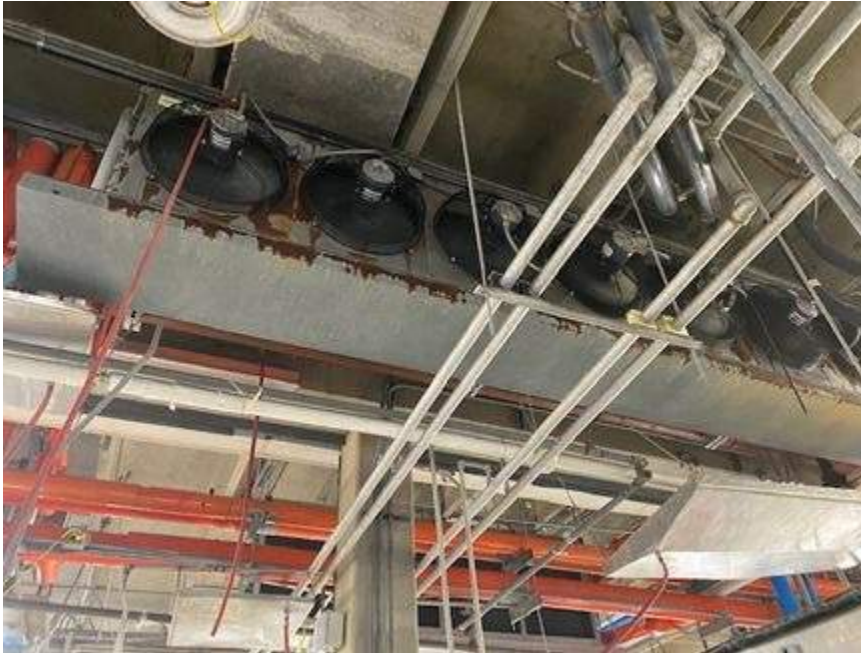
Before

Catwalks over Cut Cryovac Refrigeration Units

Prior to the catwalk our employees would have to climb over equipment with extension ladders to try and service the fans on refrigeration units. This catwalk makes the work much safer with full guardrails to protect our workers.
