**IOWA-ILLINOIS  
SAFETY COUNCIL**

# **2023 Hazard Award Submissions**

## **Part 2**

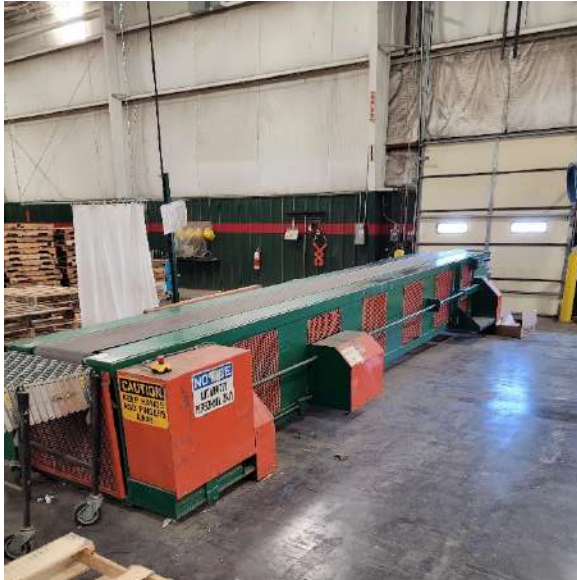
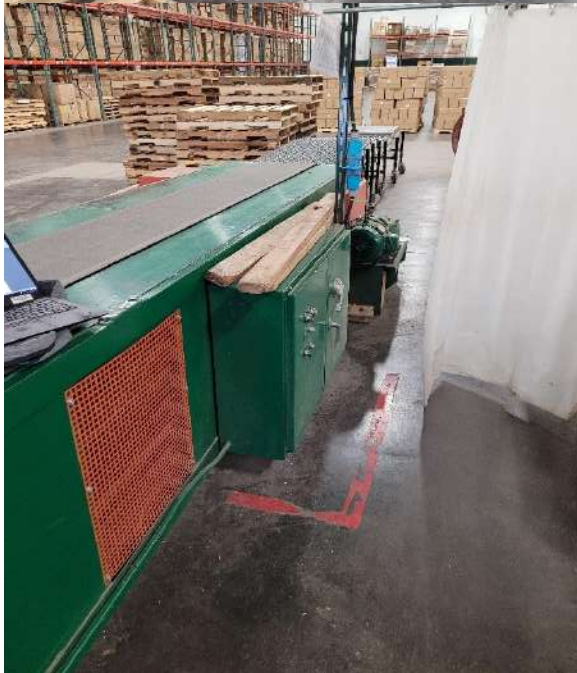
## Before Photos:

**Before:** The original truck conveyor was a stationary unit. Trucks either needed to wait to be placed in this door or skate track was added to other doors for unloading. The original unit also had the operating components on the outside of the conveyor creating tripping and struck by hazards. Being an old unit more pinch points were present or had to have specialized guarding made to protect against them.

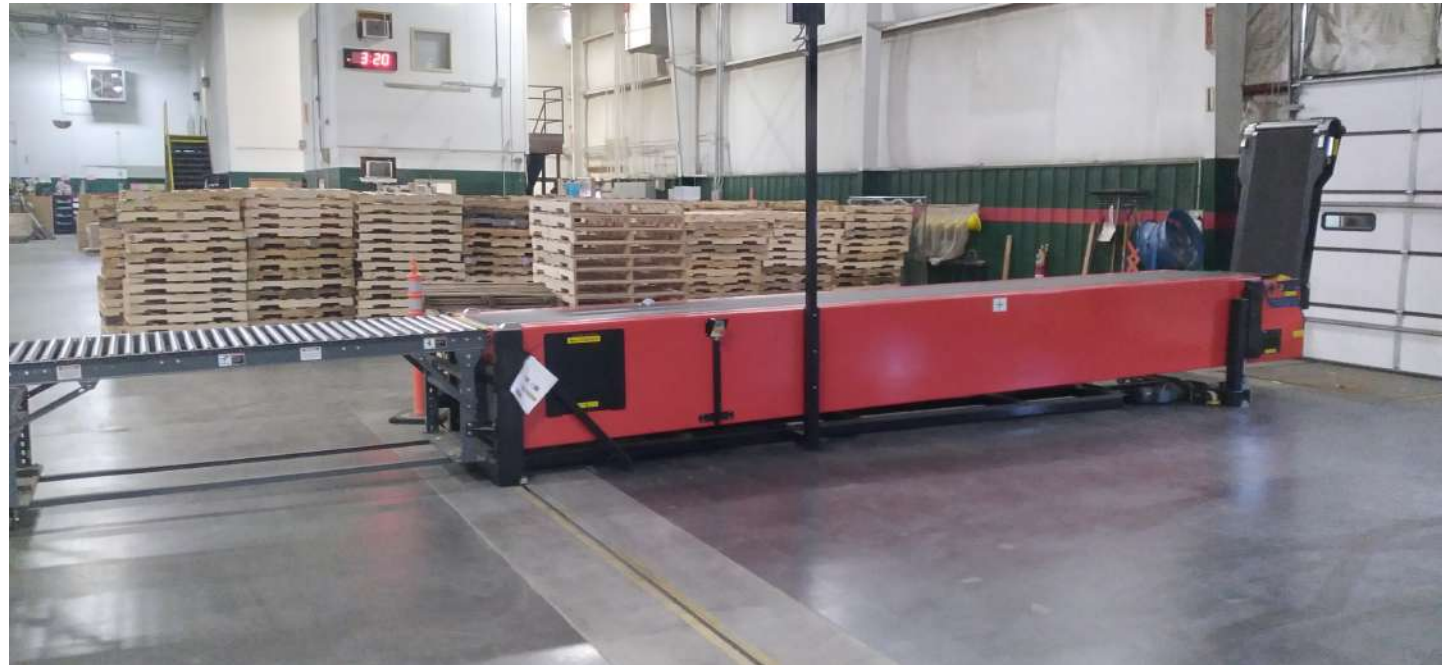
## After Photo

**After:** The new truck conveyor traverses across three truck doors eliminating the need to utilize skate track. All operating components are under the unit eliminating trip and fall hazards, reducing struck by hazards and reducing potential pinch points. The front of the new conveyor has an extendable snoot that is height adjustable making it ergonomically sound for the employees unloading the containers. It also has improved lighting to make it easier to see inside of the container reducing the chance to trip and fall over materials not seen.

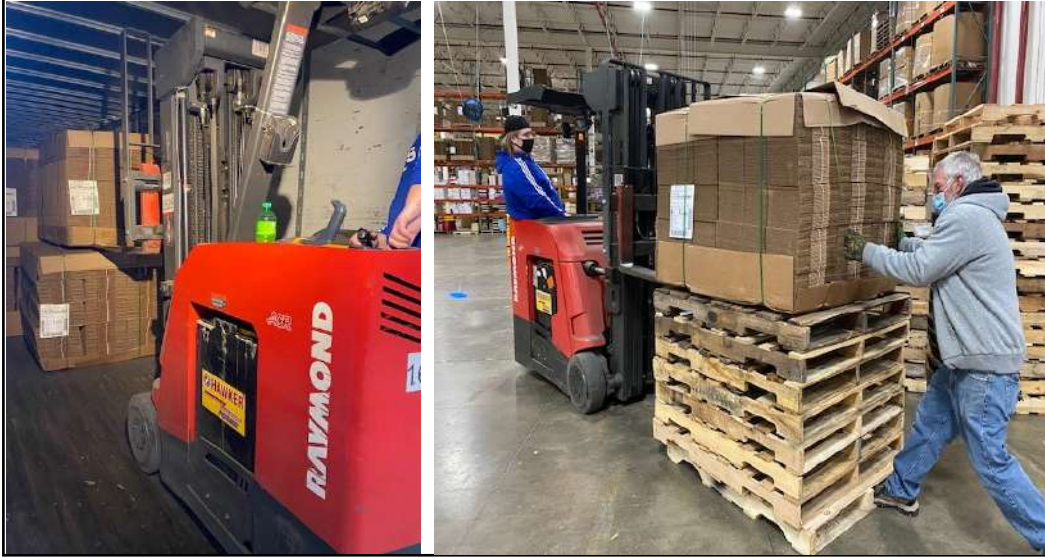
Before Photos

Prior to the purchase of a cardboard clamp, loads of cardboard boxes were picked up with a forklift from inside a shipping container without a pallet. The cardboard would then be placed on a pallet where second employee would hold the cardboard by the metal or plastic banding while the driver tried to remove the forks. This had risk of a forklift and pedestrian collision, a struck by hazard of a 1,000 lbs. or more of cardboard, and a hand cut hazard from holding the banding.

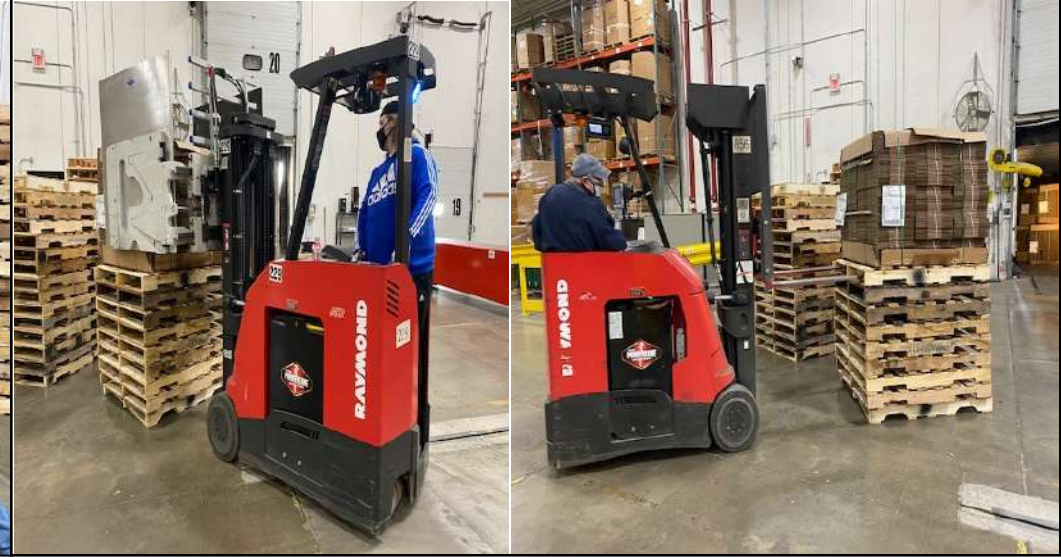
After Photos

With the purchase of a cardboard clamp on a designated forklift, the manual portion of this process is removed as well as all 3 hazards associated with it. We also removed the potential hazards of putting on and removing the cardboard clamp by dedicating a forklift to this process only.

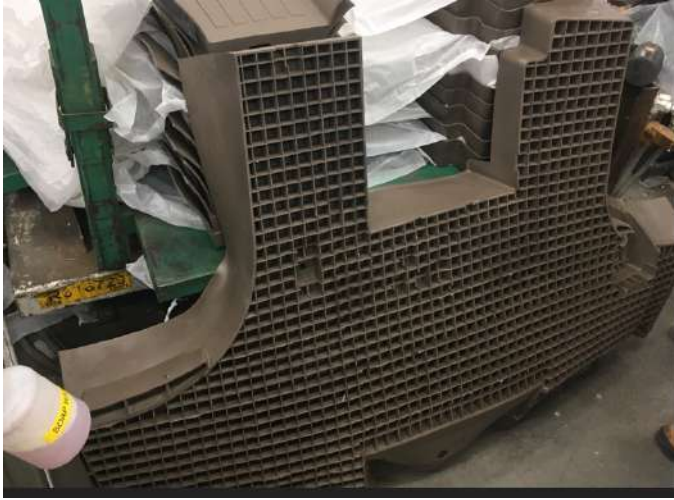
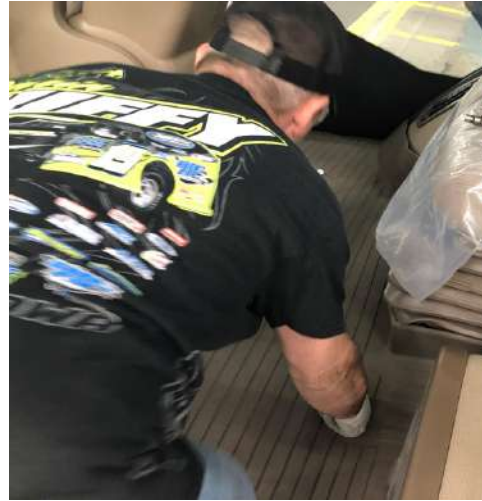
Before Photo

- Floormat installation on large tractors has been an ergonomic challenge on all platforms for many years. Previous assembly aids and manipulators have not been able to mitigate ergonomic risks such as excessive force, bending, twisting, and awkward body positions.
- The one-piece floor mat weighed approximately 40 lbs. and was large and awkward to install into the tractor cab creating ergonomic risks to the back and shoulders.

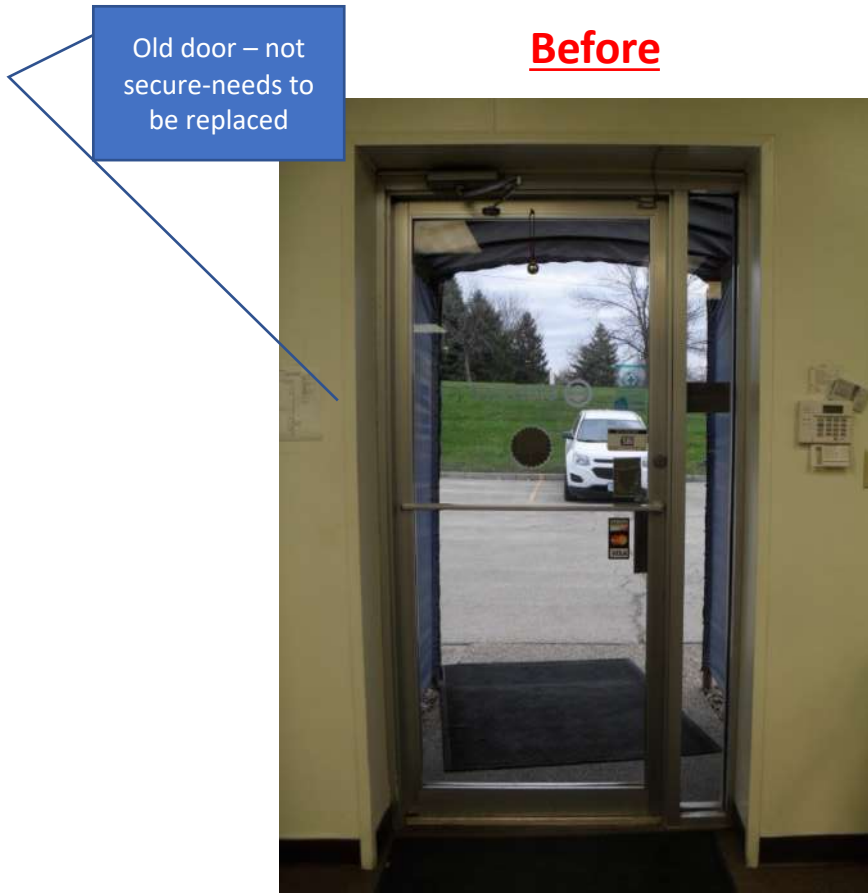
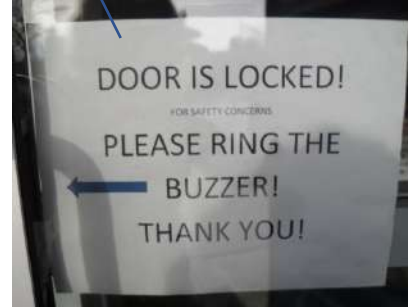
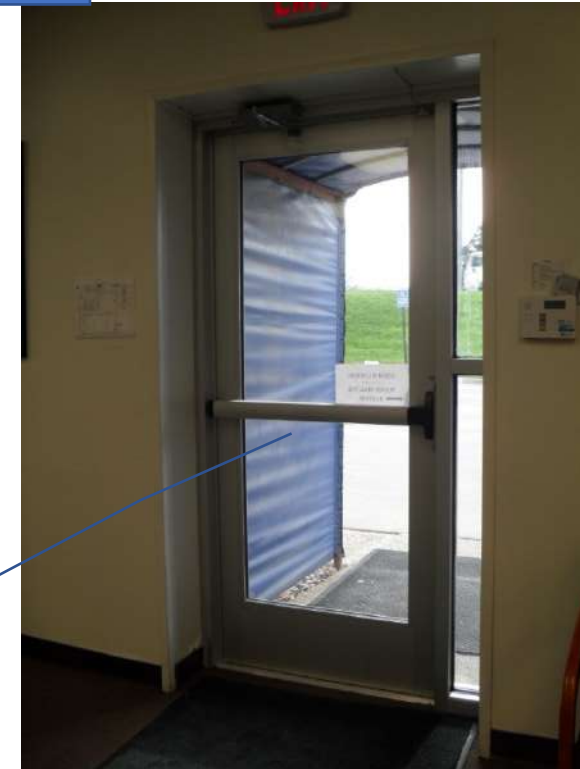
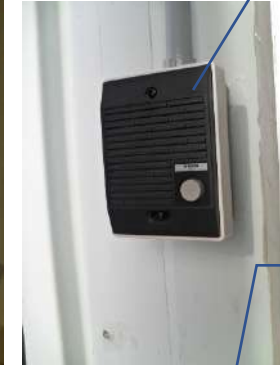
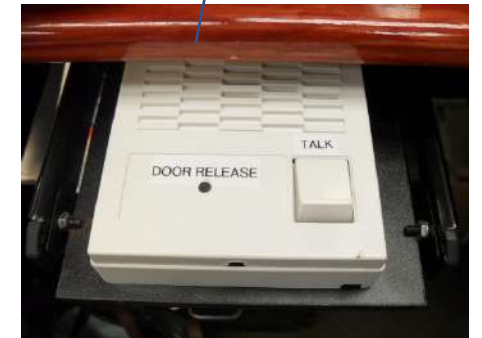
- Building Security & Safety- a couple of times people have entered the building that have raised safety concerns
- The door frame, construction & lock needed to be replaced
- The wind would blow door open-hard to secure it during the day

Sort: received various bids on door replacement & security intercom system  
Set in Order: scheduled door install & ordered security intercom on Amazon-we installed the security intercom system ourselves instead of using \$1600 quote  
Shine: removed tarp protection & put back, new door-cleaned debris inside & out  
Standardize: sign on the door explaining procedure –door locked, push buzzer  
Sustain: door & security intercom buzzer working, shared procedure w/employees  
Savings: we bought & Brian M. installed security & Nate installed button drawer

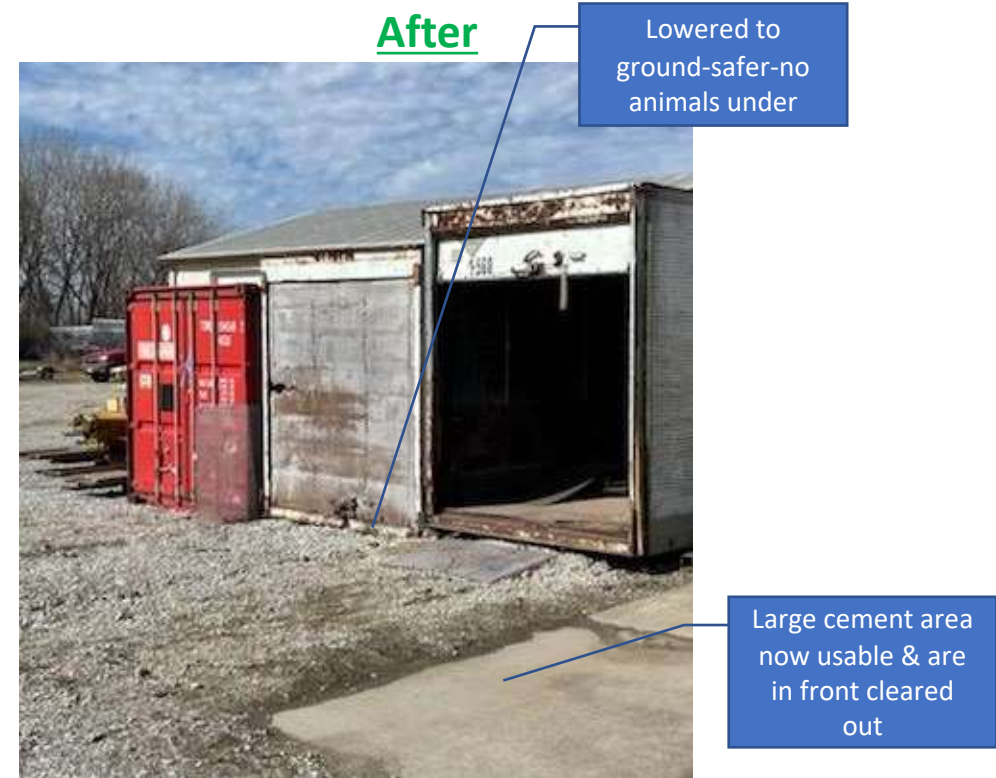
- The old semi trailers had become a dumping ground.
- Not safe to get in and out of them
- Haphazardly placed west of the building
- Wind-Farm trailer removed from property –far left off-white
- Safety – animals in and around the trailers

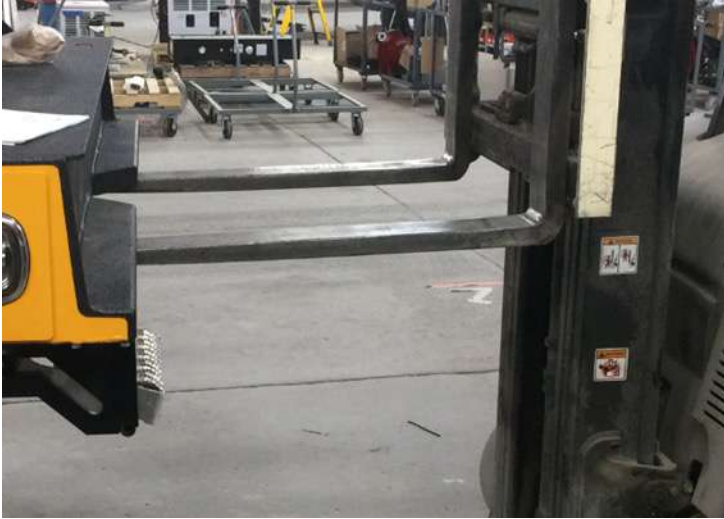
Before Photo

Before the addition of an overhead hoist, we were loading bodies on chassis with one hoist in the front and a forklift on the back. This took tremendous coordination and skill from everyone involved to accomplish loading bodies. It also increased the chances of injury due to skill needed.

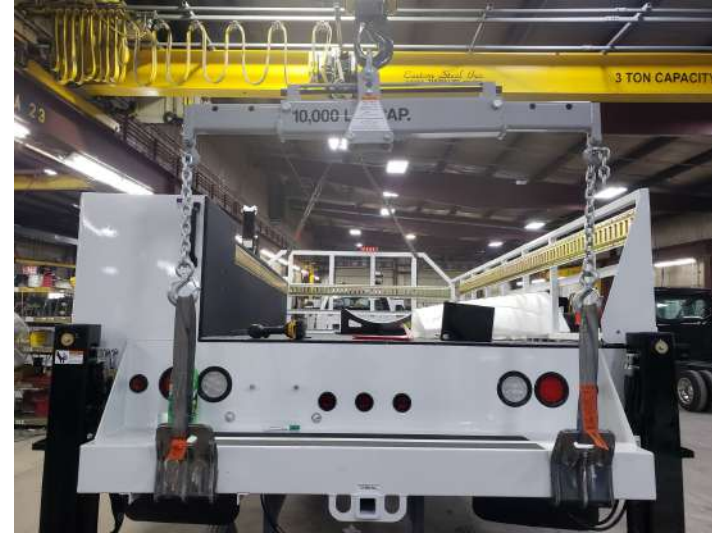
After Photo

With the addition of the second hoist, we now use a spreader bar on the back end of the truck to lift and position the body over the chassis. These lifts can be linked by a controller as well, enhancing the predictability and leading to less incidents with this multiple times a day process.

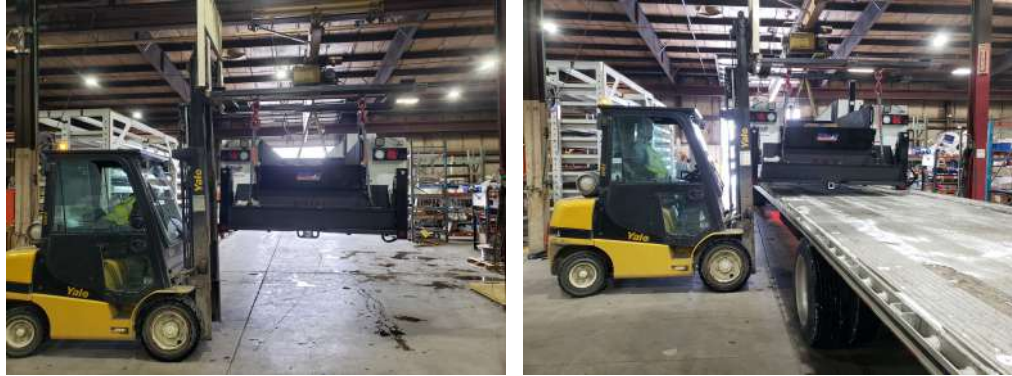
Before Photo

Before this lifting device, we were using an overhead and a forklift in combination. This required a lot of coordination and multiple spotters for a successful unload and load. We would then have to back the trailer into the shop while the load was suspended to position it on the trailer. It created potential lifting and transport hazards.

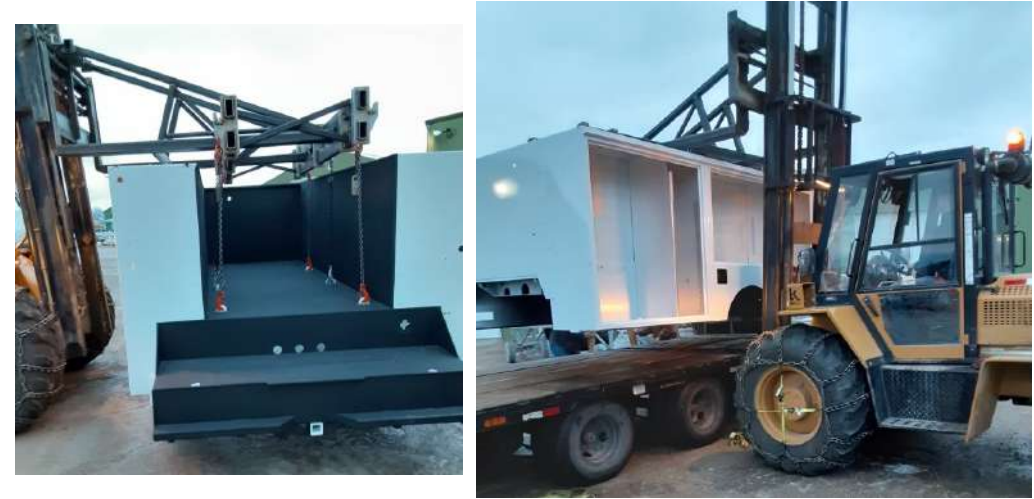
After Photo

Our manufacturing engineers designed a device that attaches to the forklift and hooks into the D-rings of our bodies. The updated process has made for a much more consistent lift and eliminated the need to back a trailer into the shop to load/unload the trailer. It is a more safe and efficient process with the new lifting device.

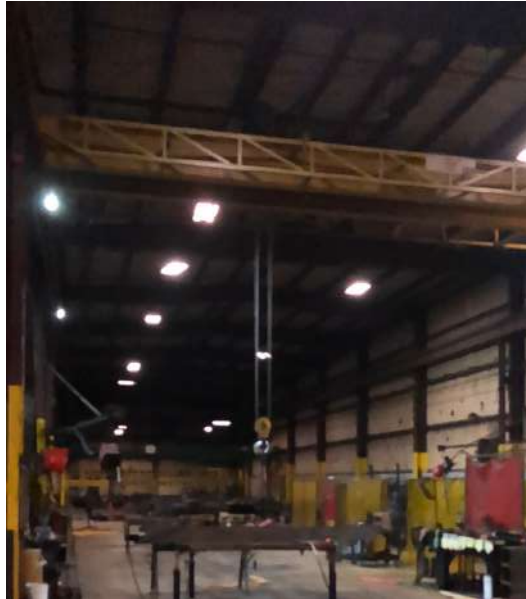
Before Photo

We purchased a new Mason City facility in June. After purchase, we needed to address the lighting throughout the plant. Some of the lights didn't work, and the ones that did were inadequate for a proper manufacturing facility.

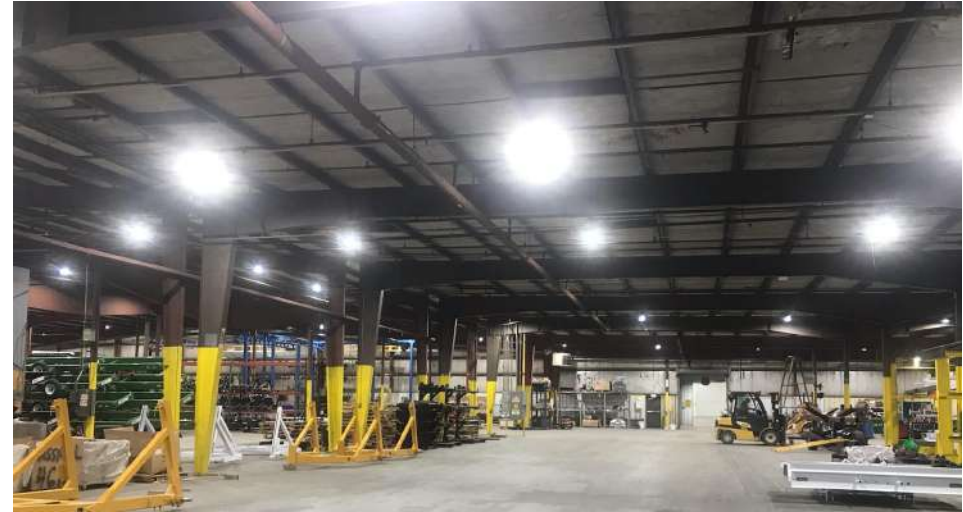
After Photo

We worked with an outside vendor to replace all the lights on the production floor. We upgraded all the old fluorescent tube bulbs for energy-efficient LED lights. This not only enhanced visibility throughout the plant, but improved plant morale.

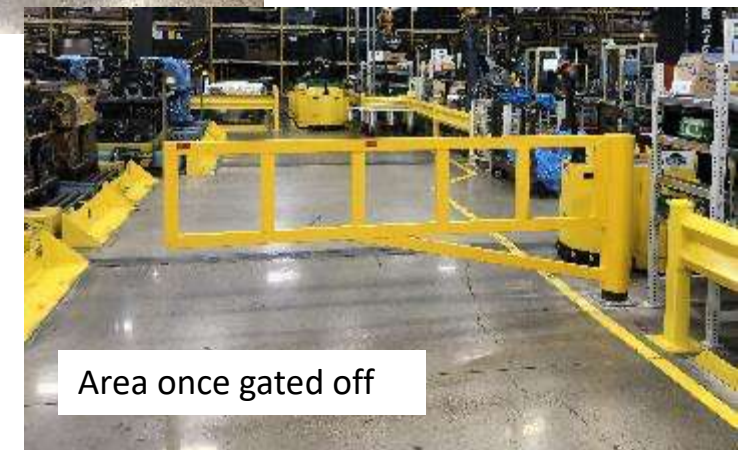
- Gate was installed to allow movement within traveled area. This keeps fork trucks from entering & creating a possible vehicle/pedestrian hazard while tow motors are outside of 566 work area

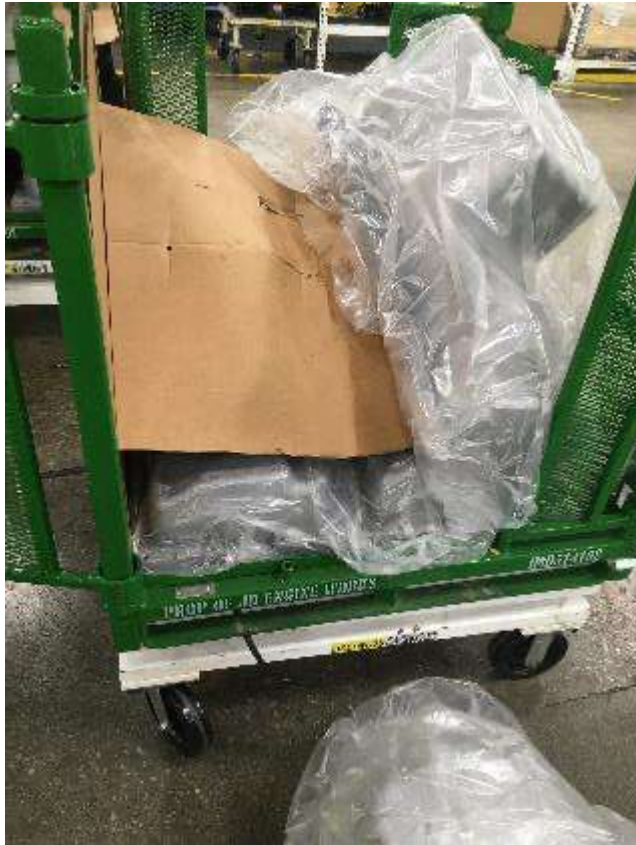
- Pans would shift during transport and fall against container gates. When gates were opened pans could fall out onto operators.

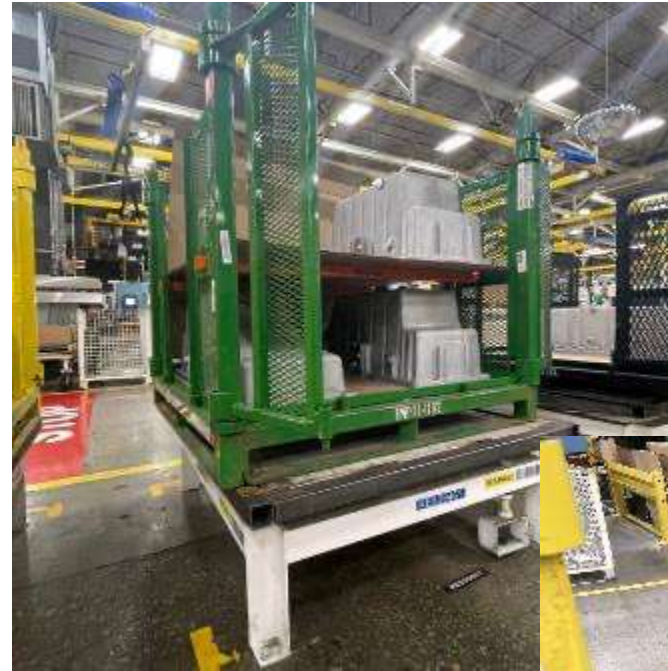
- Designed new rack system that holds pans and prevents shifting during transport.

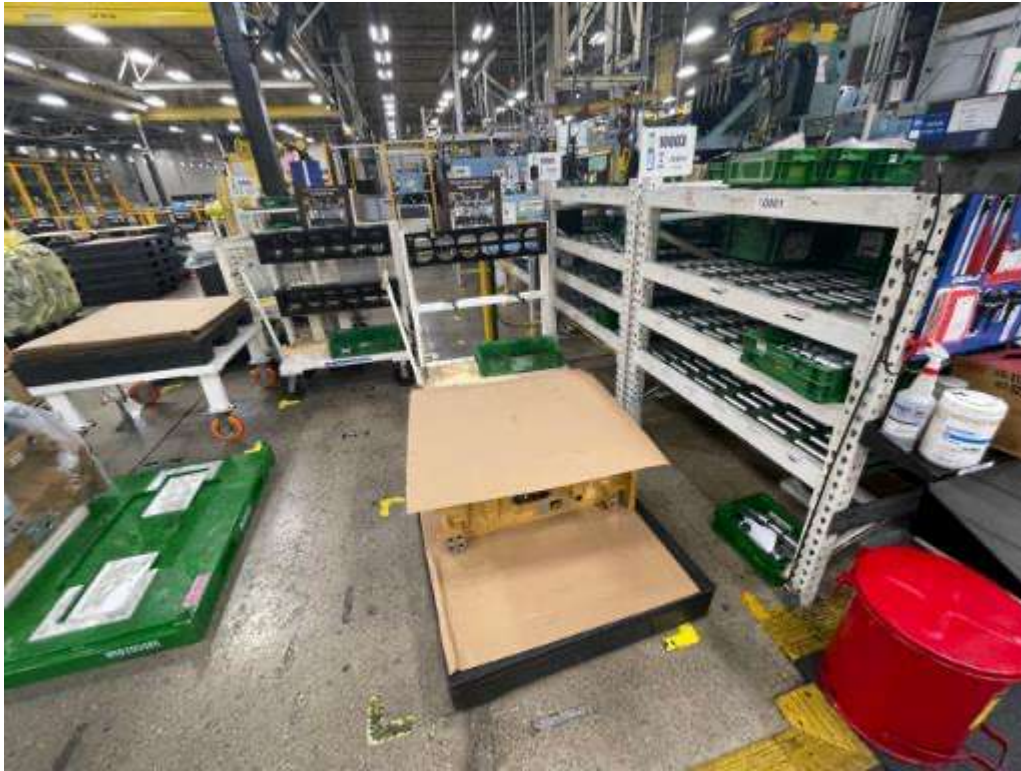
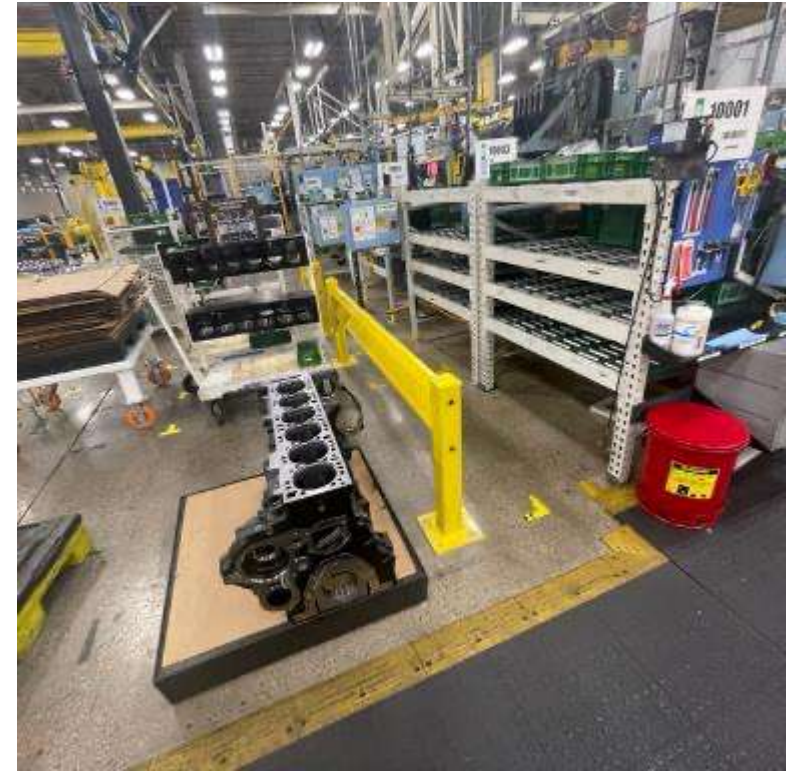
- 53 racks were identified that did not have enough space for operators to deliver parts.
- To improve the areas, guard rails have been added and overflow parts have been relocated or eliminated. Additionally, at least 30 inches of walking space was provided.

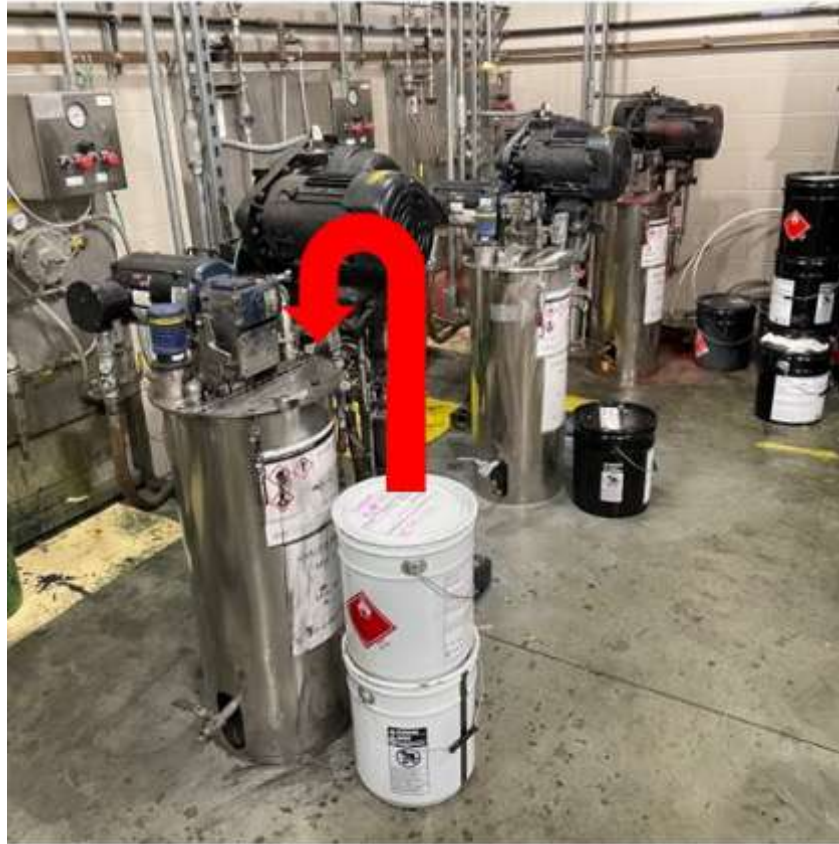
- Operators manually lifted 5-gallon paint buckets into tank, some weighing up to 50lbs.

- Had supplier reduce paint volume to 4-gallons. Designed fixture that buckets are hoisted into and that paint pours can be safely controlled from.

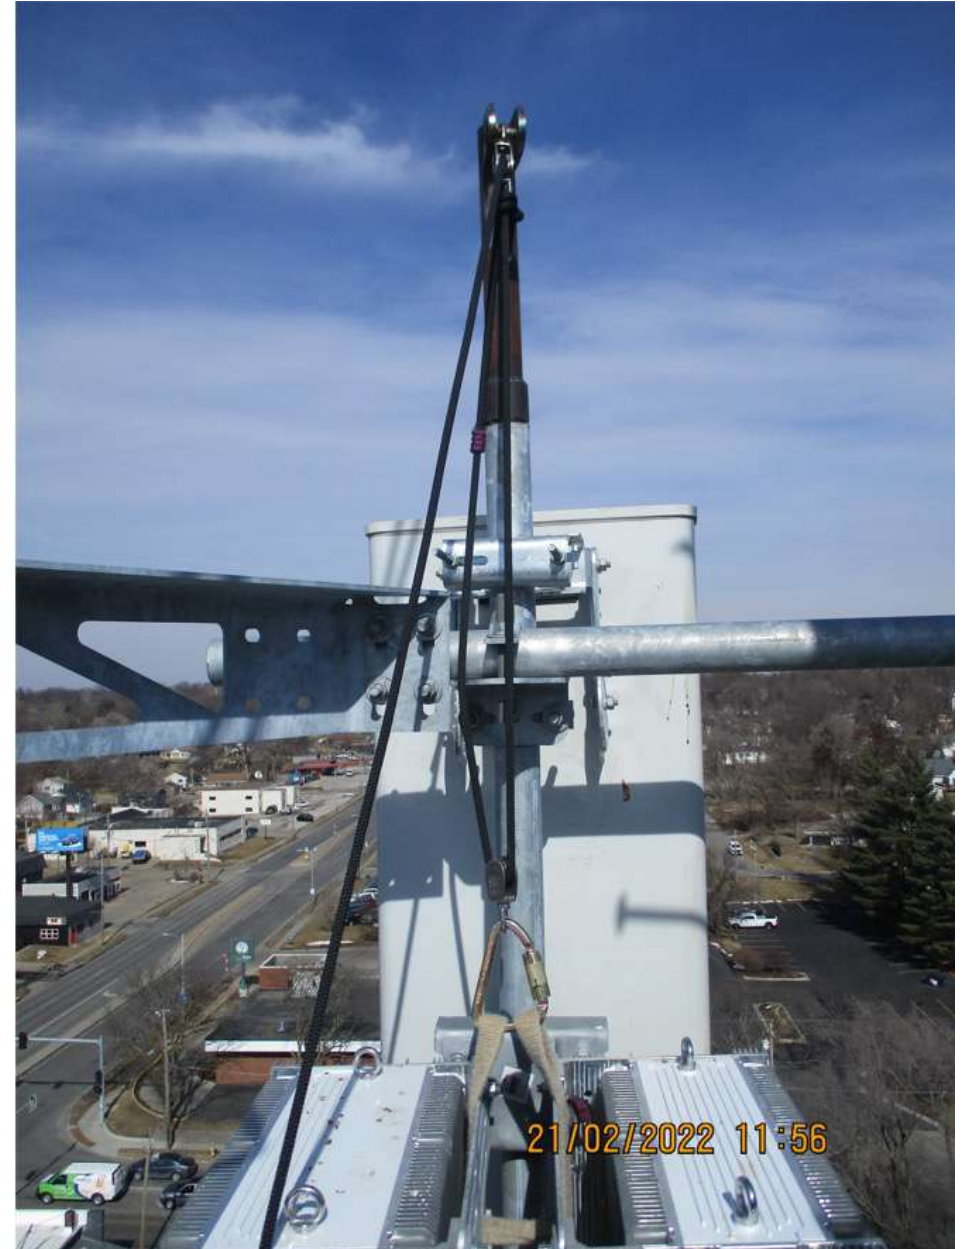
We have designed and built a prototype device that is considered a weight transfer device. It is used to take the weight of the equipment using a 2:1 pulley and a self capturing prusik knot. This device allows for a single employee to mount and or remove a radio or antenna without having to overexert themselves.

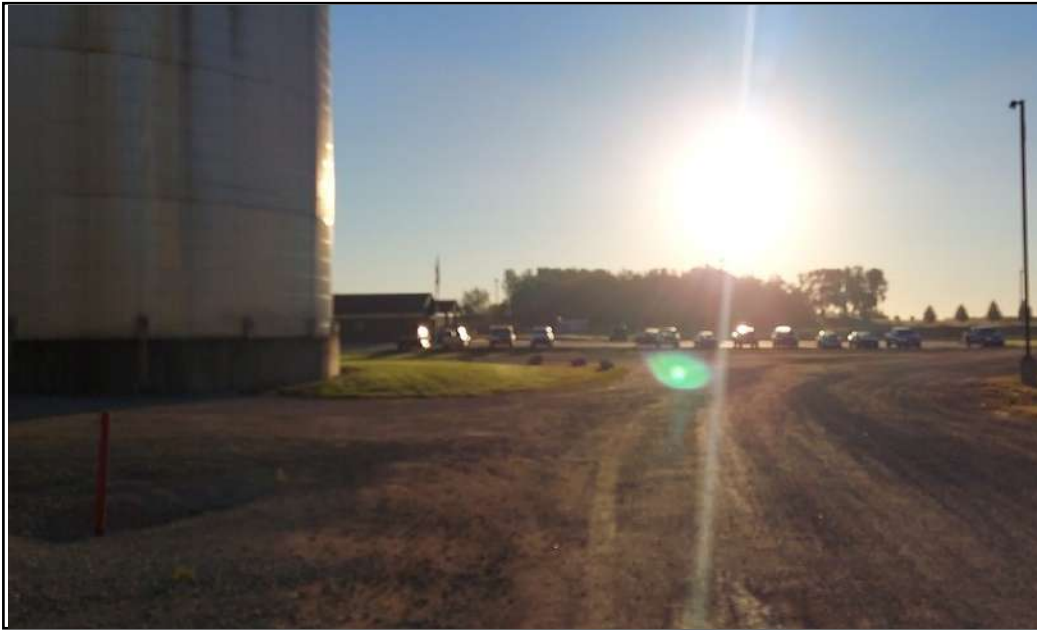
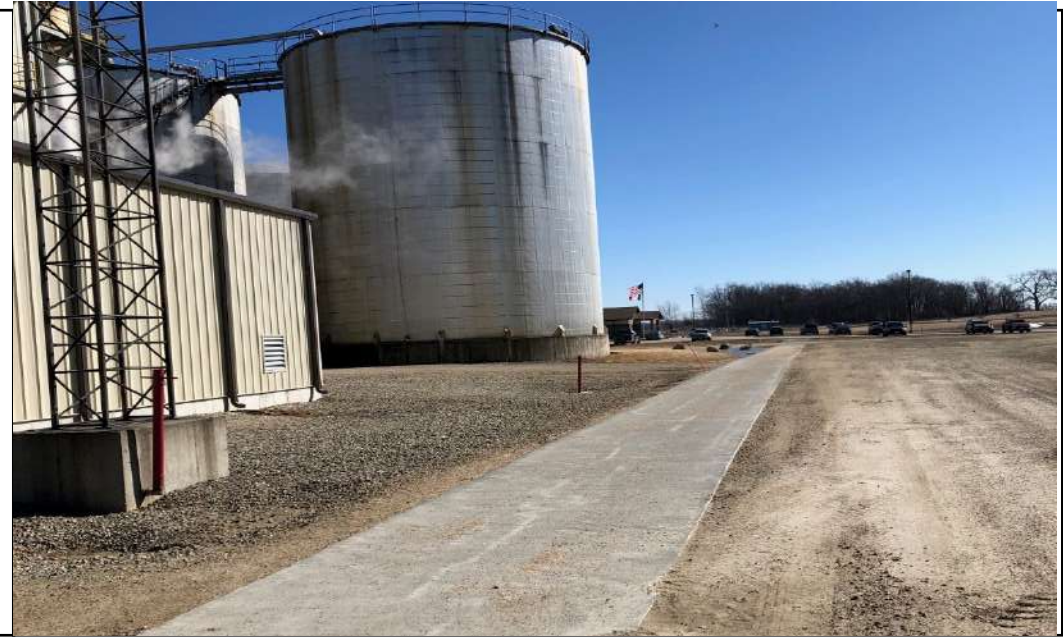
- Previously, employees would use the roadway to walk between the parking lot and the process building entrance.
- This posed a continued slip, trip, fall hazard during winter months with inclement weather.
- Additionally, intermittent truck traffic occurs on the roadway causing an added hazard of collision.

- A sidewalk was constructed to act as the designated walkway between the parking lot and process building for all employees & visitors.
- The walkway provides improved footing coupled with additional attention to snow & ice removal during the winter season.
- Also, it provides separation of paths for personnel and roadway use.

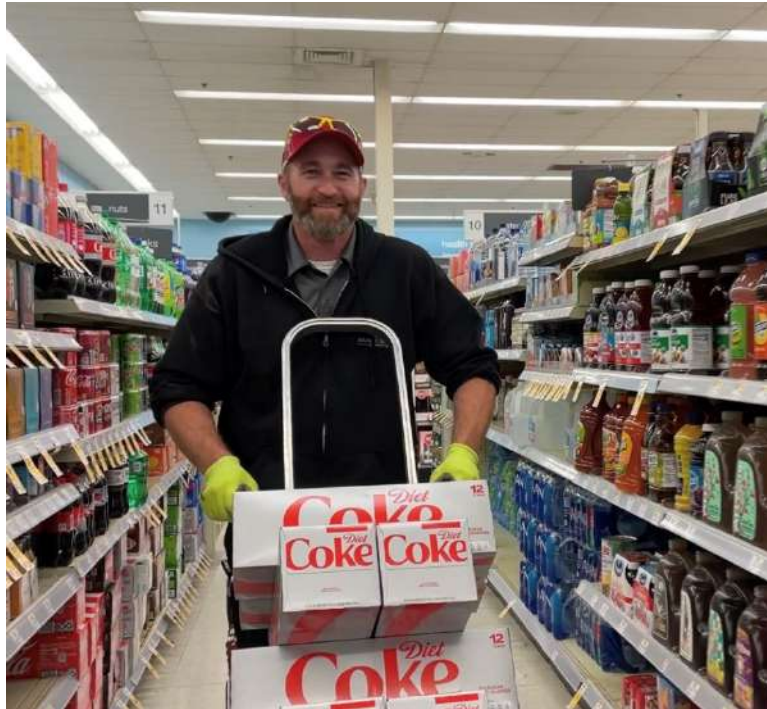
## Before

We have been looking for a way to drastically reduce the use of two-wheel carts in our delivery operation. In 2021 we began switching to the Rehrig DSD Geobox system. This allows us to build onto our pallet in our distribution center. Instead of down stacking one to two times at the customer, we can now wheel in pallets directly from our trailer to a cooler in a store, saving wear and tear on employee's bodies.

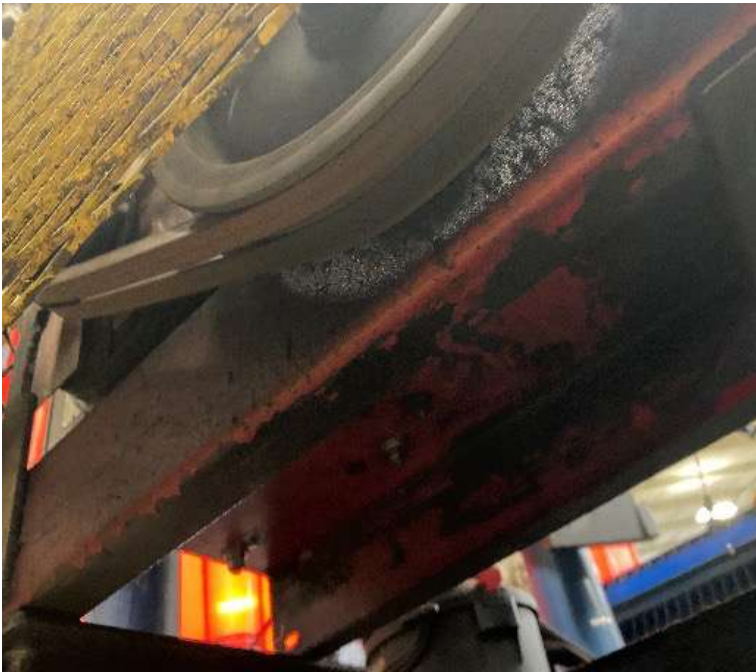
Before:

The bottom of the pulley was exposed.

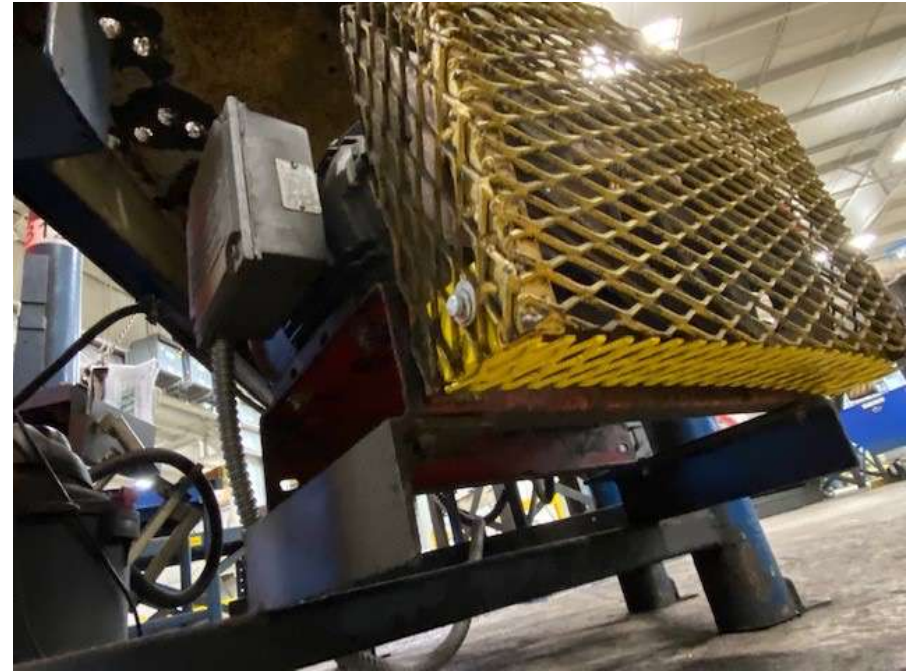
After:

We added a removeable guard that will cover the pulley during operation and open when maintenance needs to access.

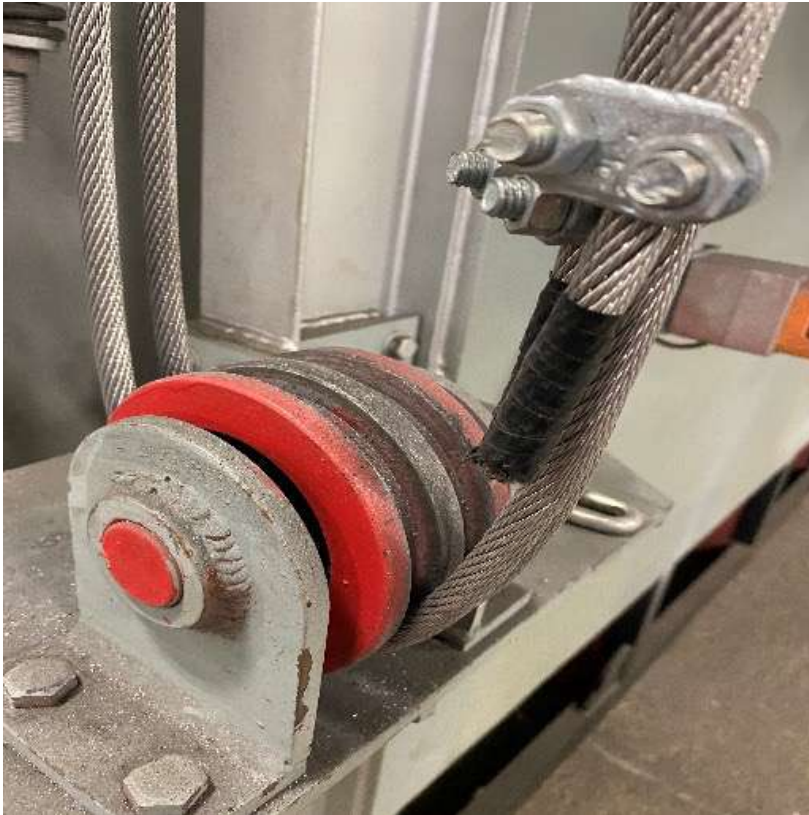
There was a large pulley that was exposed on our new tempering furnace.

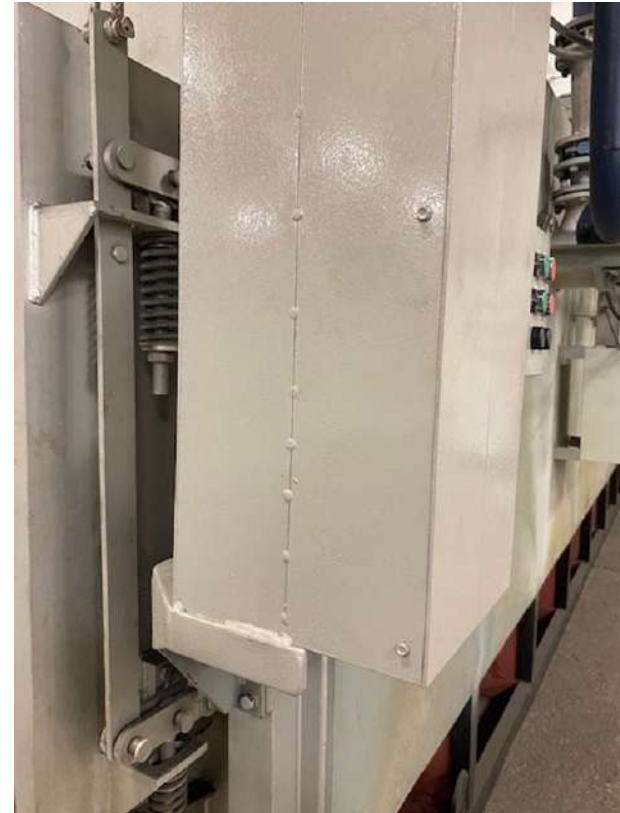
We added a removeable guard that will cover the pulley during operation and open when maintenance needs to access.

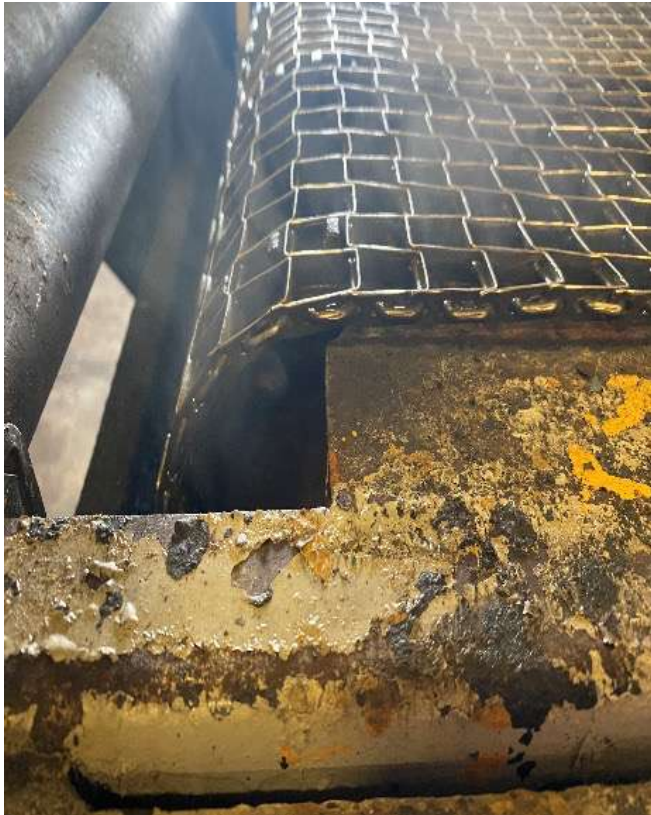
Before:

There was a pinch point on the opening of our wash tank.

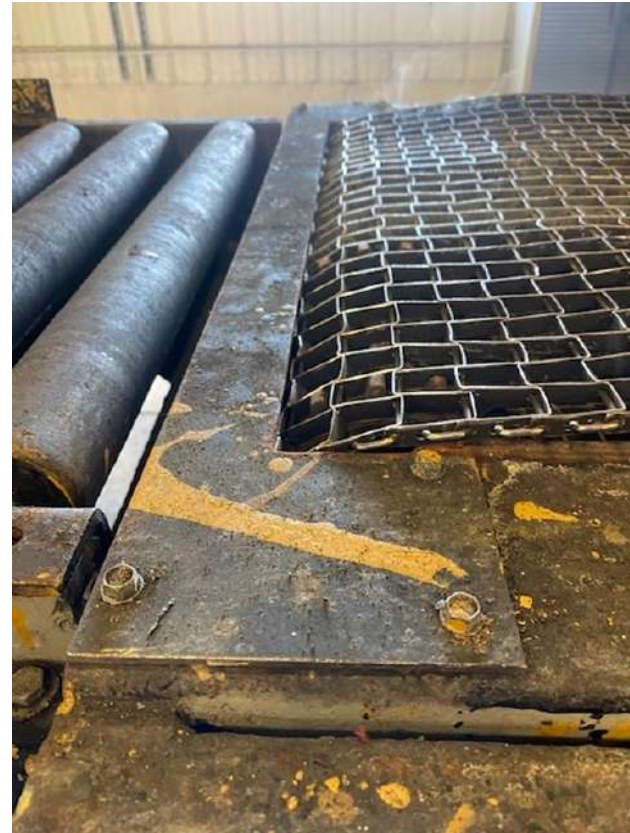
After:

We added a guard that could be removed for maintenance purposes that would protect the operator when the wash tank is in operation.

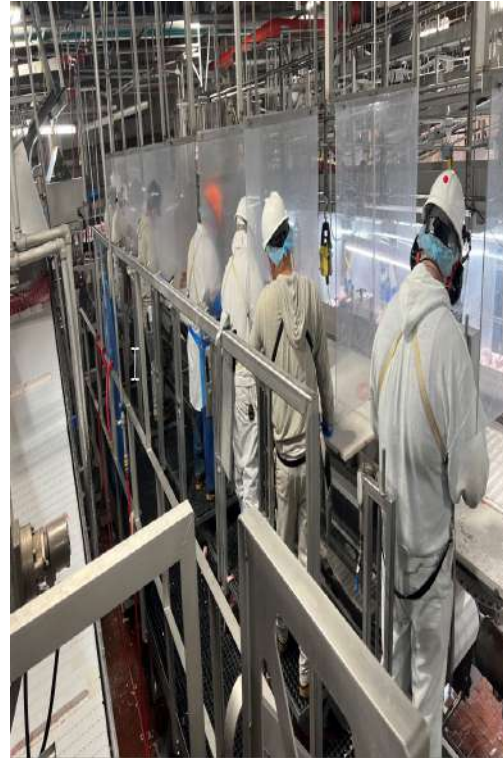
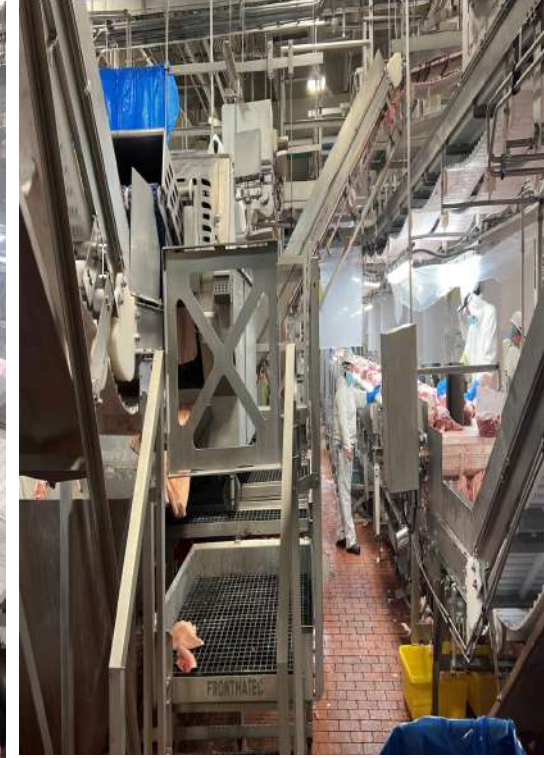
We have completely rebuilt are Butt line from the ground up here in Marshalltown. This project replaced the main pace conveyor adding adjustable ergo stands for every job also replacing the old neck bone line with a new one making the job more ergonomic, reducing stress on the employee.

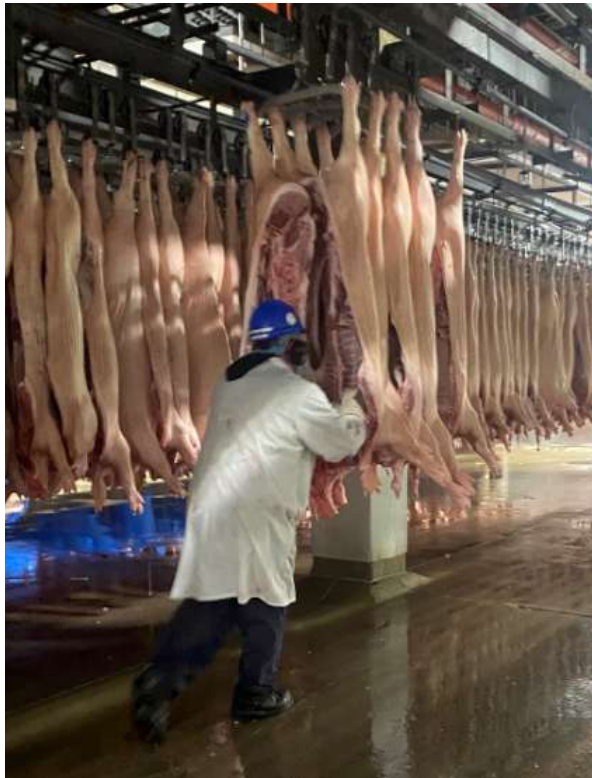
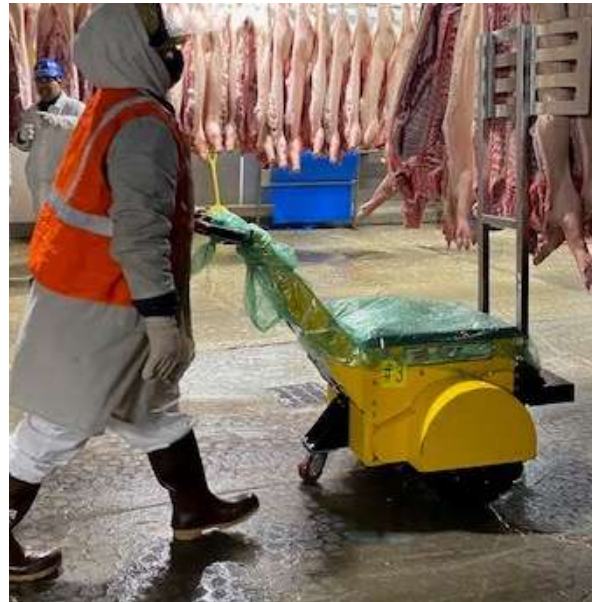
We purchased new Electric hog pushers for loading and unloading coolers reducing physical strain/exertion to the employee. This pusher can push up to 8 hogs at a time with minimal effort of the employee. Reduces stress on arms, shoulders, back and legs by decreasing force used to push Hogs along the rails.

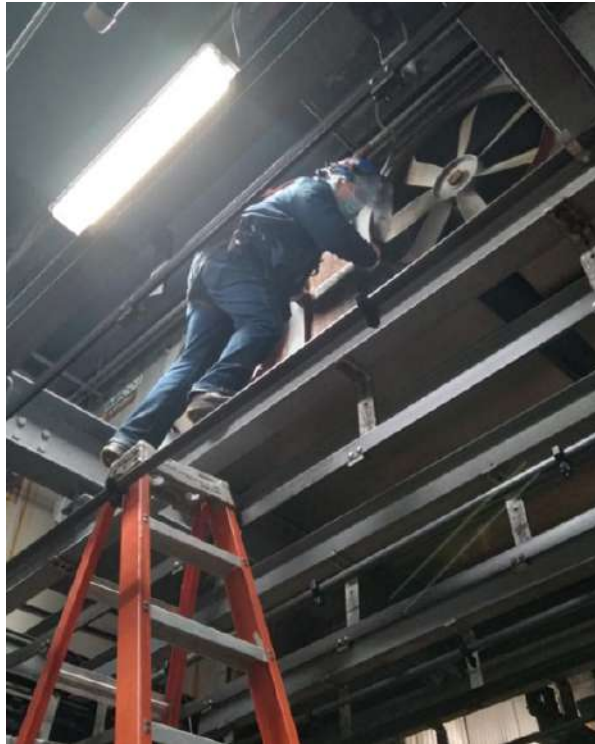
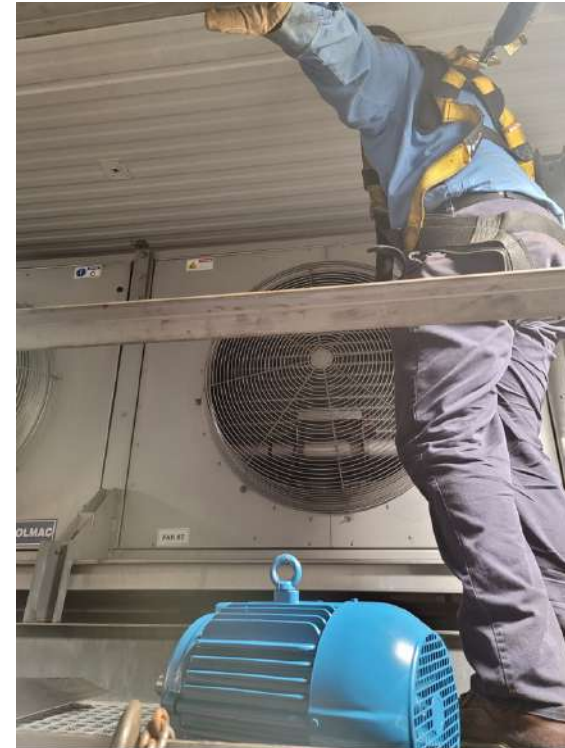
Reduces stress by providing a secure/safe working platform. Less awkward.  
Reduces stress to neck/back/shoulders/hips.
