**IOWA-ILLINOIS  
SAFETY COUNCIL**

# **2023 Hazard Award Submissions**

## **Part 2**

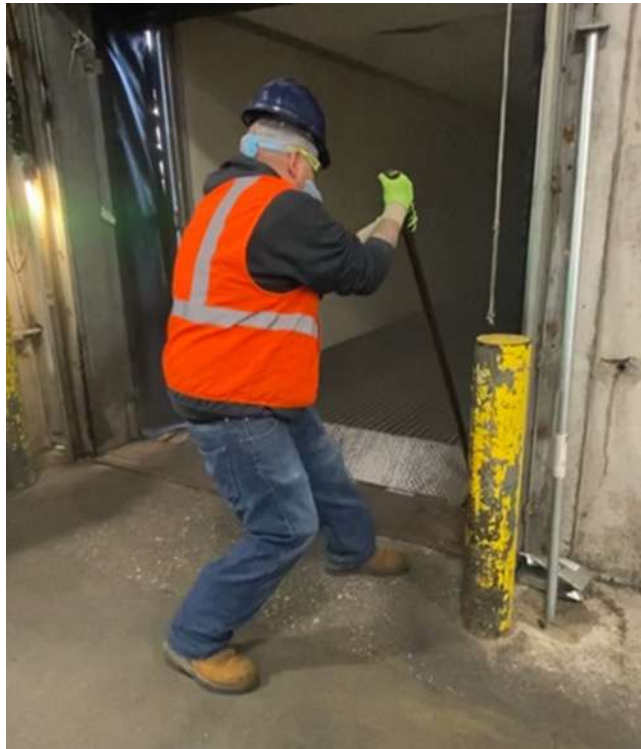
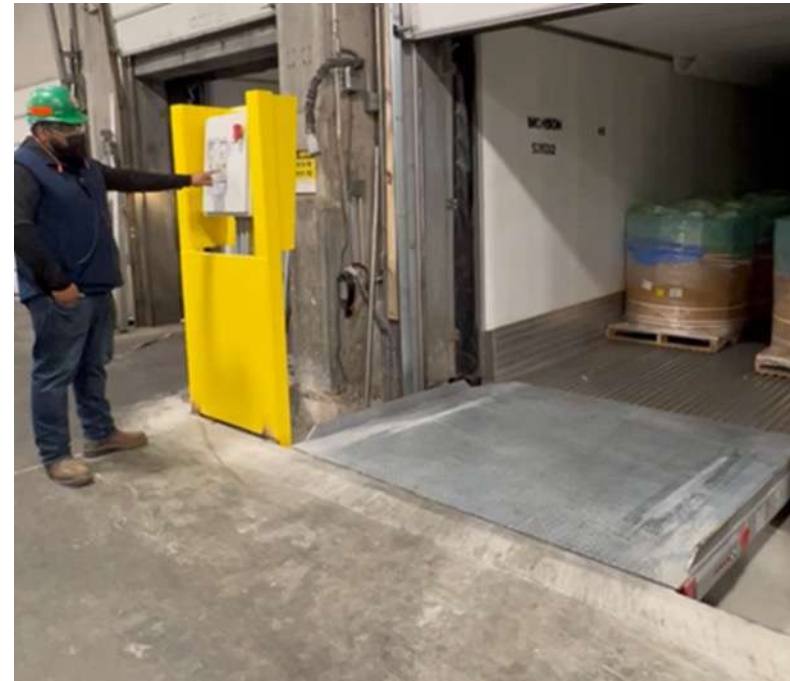
## Automatic Dock Levelers

Replaced Two Dock Plates with Automatic Dock Levelers for CVA.  
Eliminates using a pry bar to manually lift/lower dock plate. Reduces stress to neck/shoulder/arms and back.

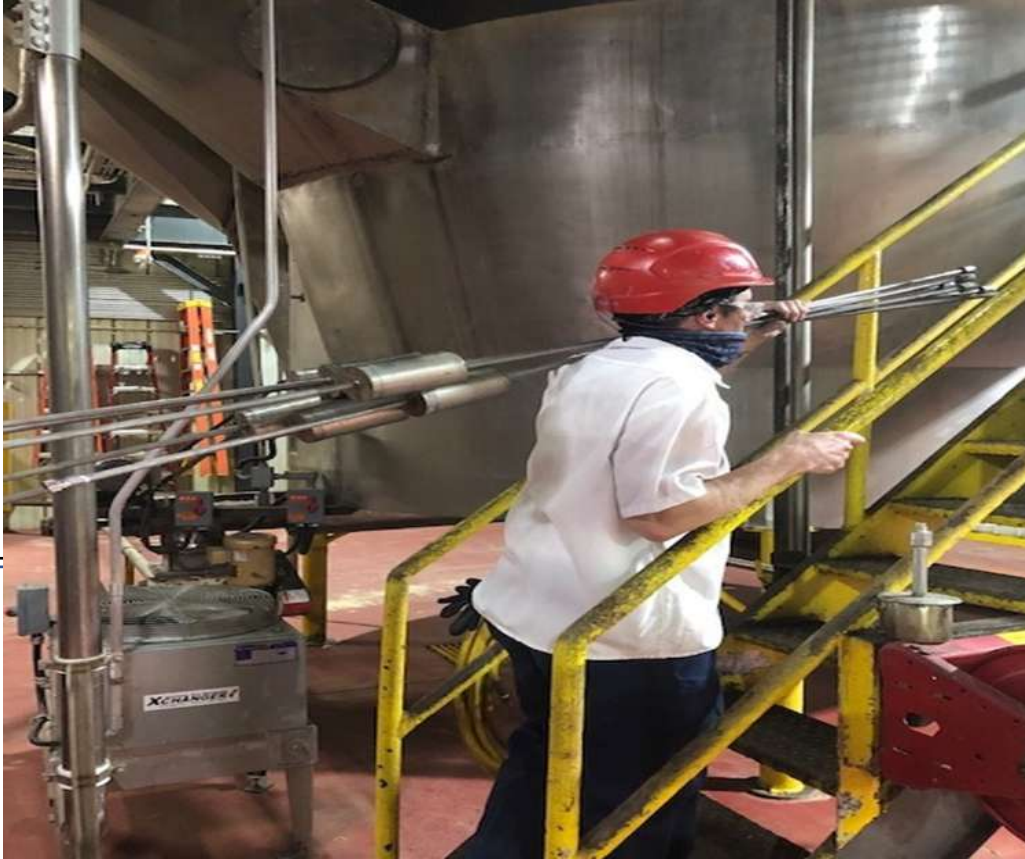
Before Photo

Employee carried nozzles on shoulder up 2 flights of stairs

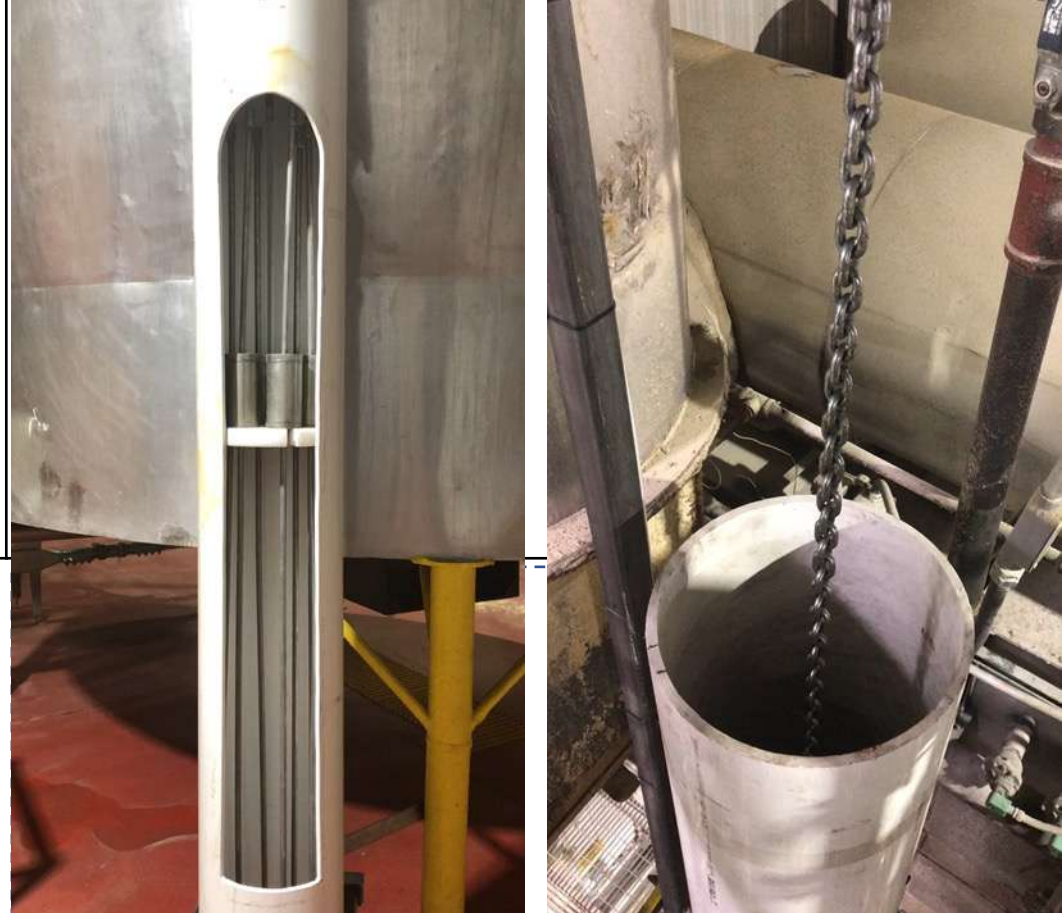
After Photo

Nozzle lift was made to hoist nozzles to the top of the dryer. Eliminating the need to carry them

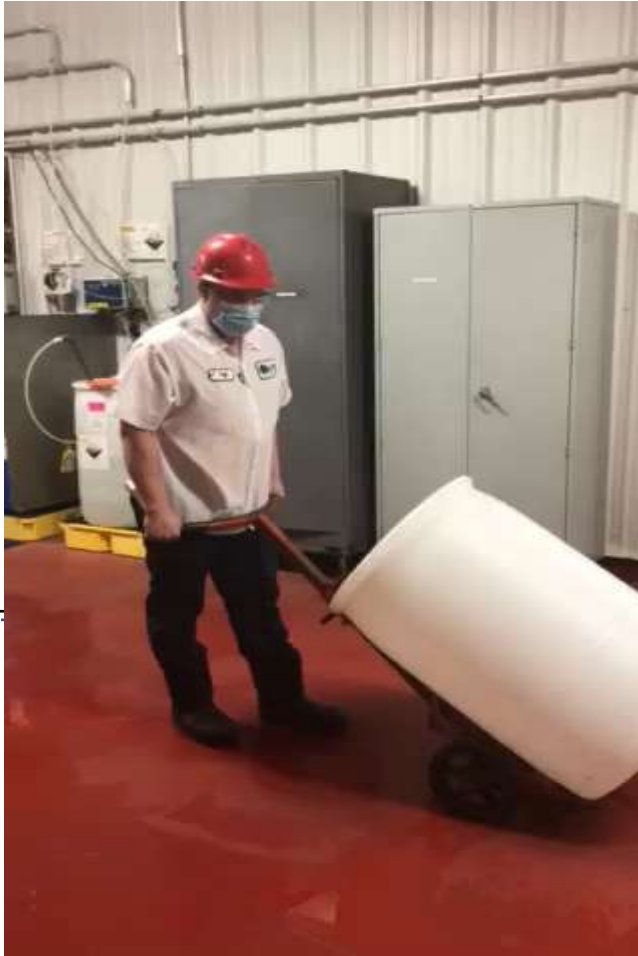
Before  
Video

Employees used a two-wheel cart to move drums. They had to push drum up ramp to containment stand

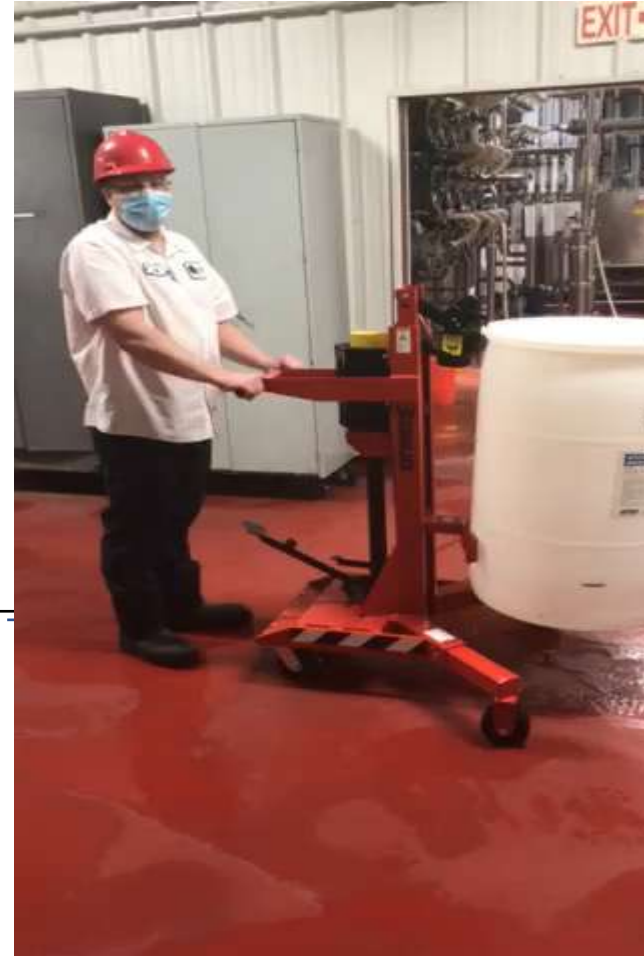
After  
Video

New cart purchased eliminating the need for a ramp

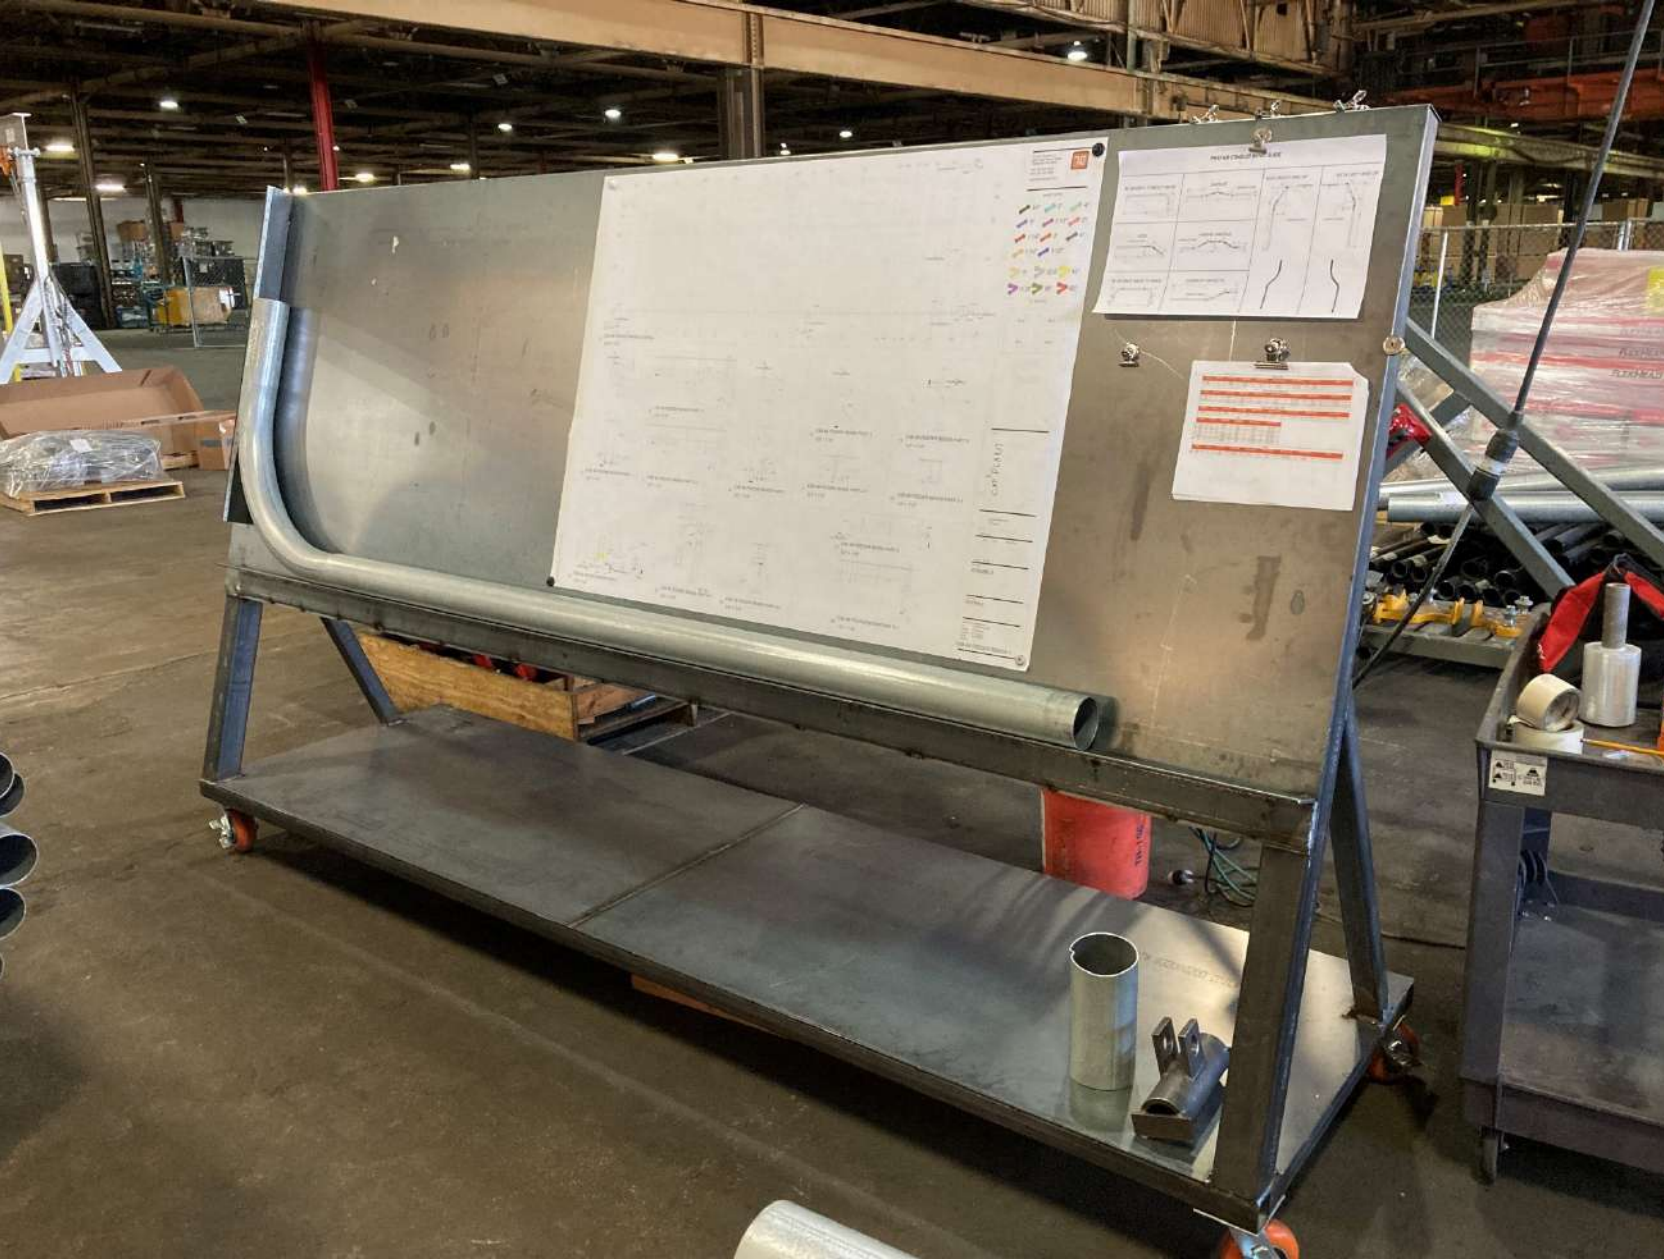
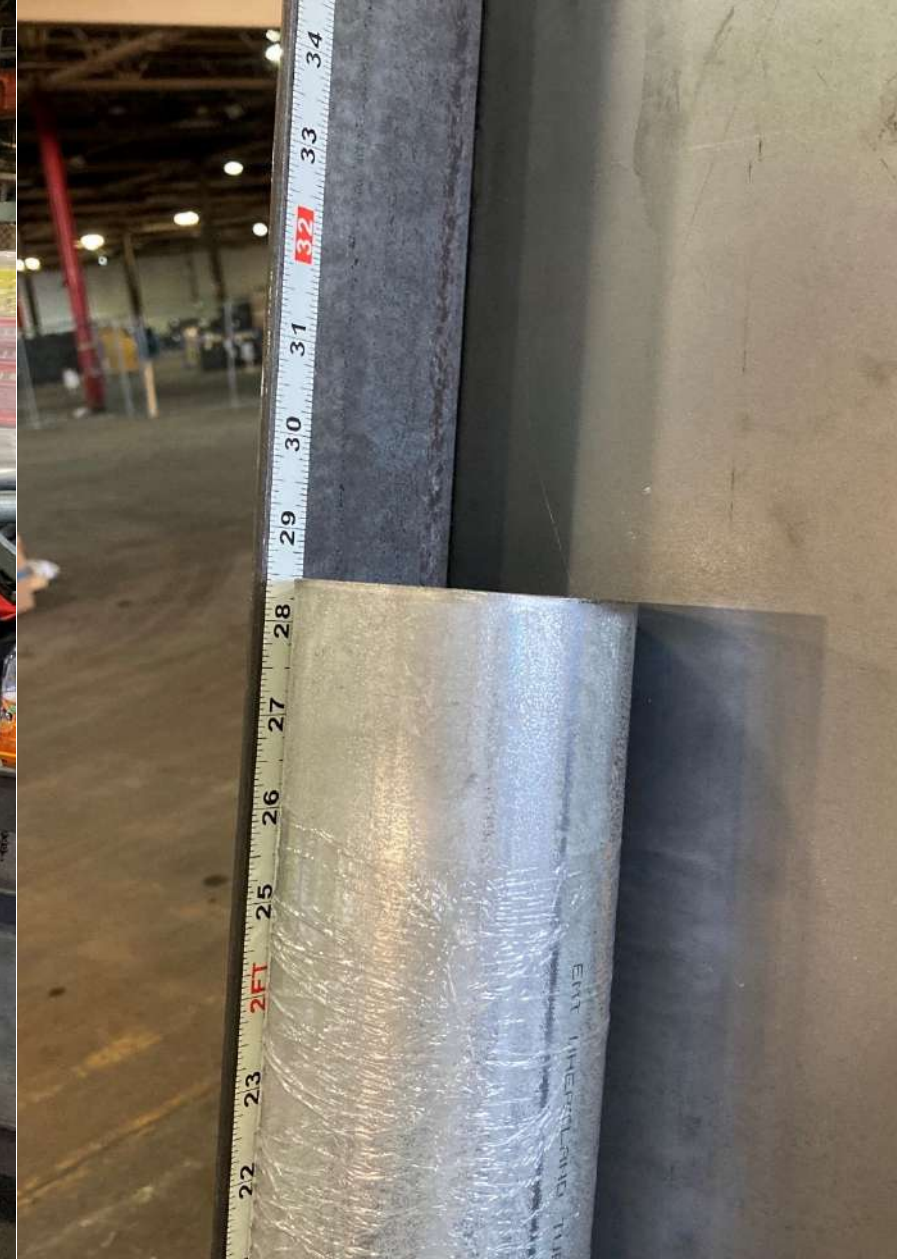
Before: Rigid conduit and EMT is cut to length and bent using a bender tool to 90 degrees. Once the conduit is bent, it must be measured to verify the 90 degree bend is accurate with respect to specified lengths of each end. When removed from the bender, the conduit was placed on the ground where levels and tape measures were utilized to verify. This process required the conduit to be lowered to the floor and then lifted back up when finished, which can be heavy and awkward at times to maneuver.

After: A custom bending table was designed and fabricated for this process. The conduit is transferred straight over from the bender to the table. From there it is transferred to a cart after verification. This reduces much of the material handling and eliminates the bending and lifting/lowering to the floor.

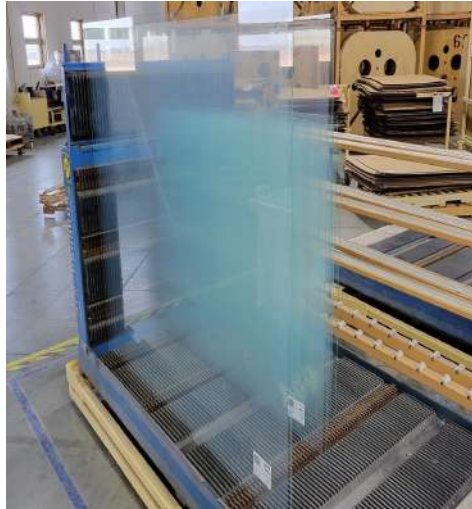
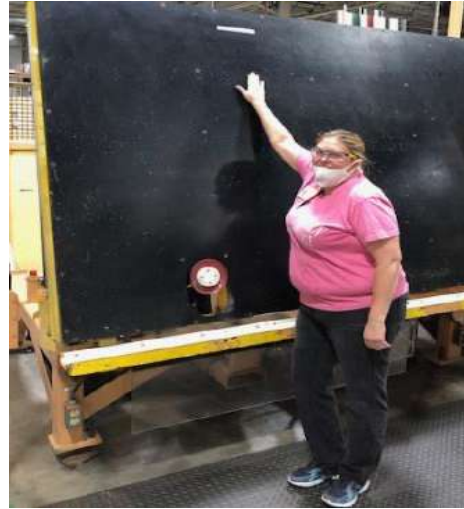
Before Photo

The large sheet of glass up to 55"x68" needed to be moved to the tilt table by bending down to floor level to grab it and carry it to the tilt table. At the tilt table the Team Member reaches as high as the mark above to install the stiles and rails onto the glass.

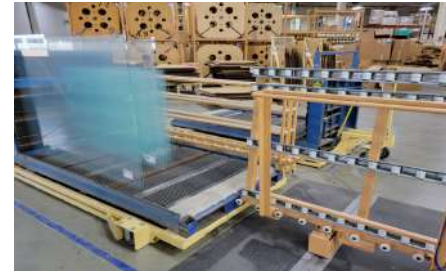
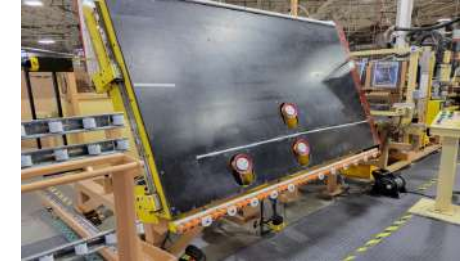
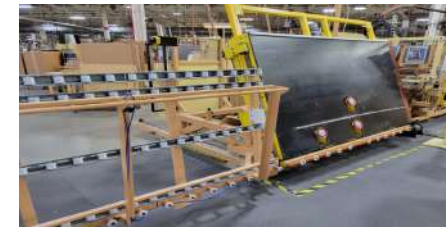
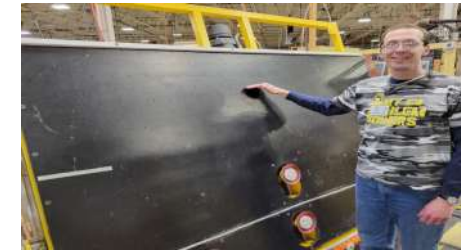
After Photo

A roller system was installed that allows the glass to be rolled directly off the squeezer rack without bending down to grab it. The tilt table was modified to raise and lower to accept the glass directly from the roller system. Also, by lowering the table it allows the Team Members to keep the unit in process in a better ergonomic position while installing the stiles and rails.

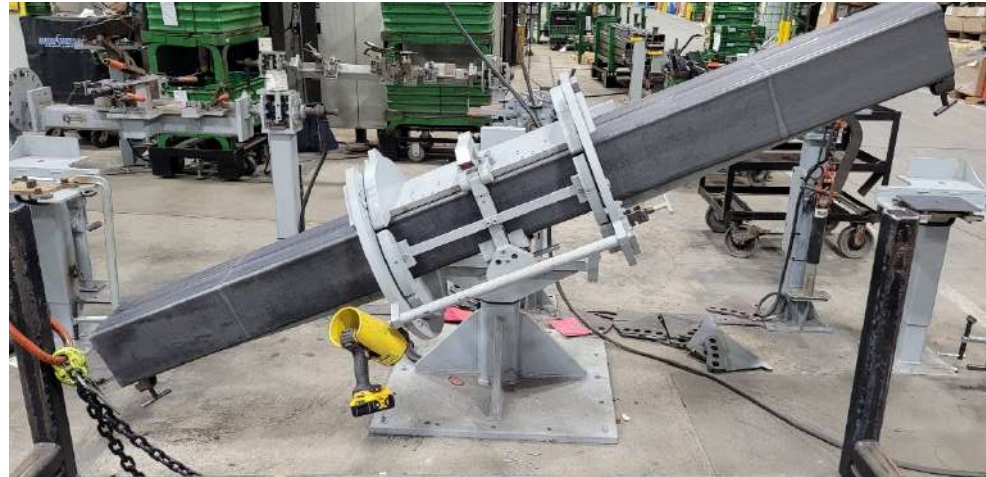
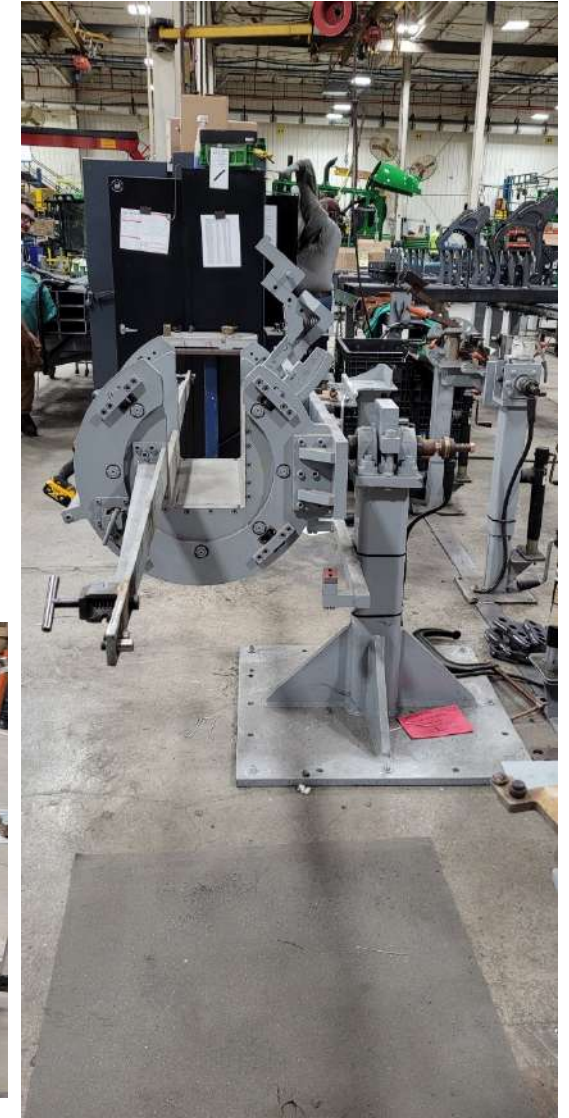
Employee no longer needs to manually roll the tube over the table to complete all welds on outside and inside tube. The Pac Man fixture allows the square tube to be spun inside the fixture, which eliminates safety concerns with smashing fingers, strained muscles and ergonomic positions when welding gusset inside the channel.

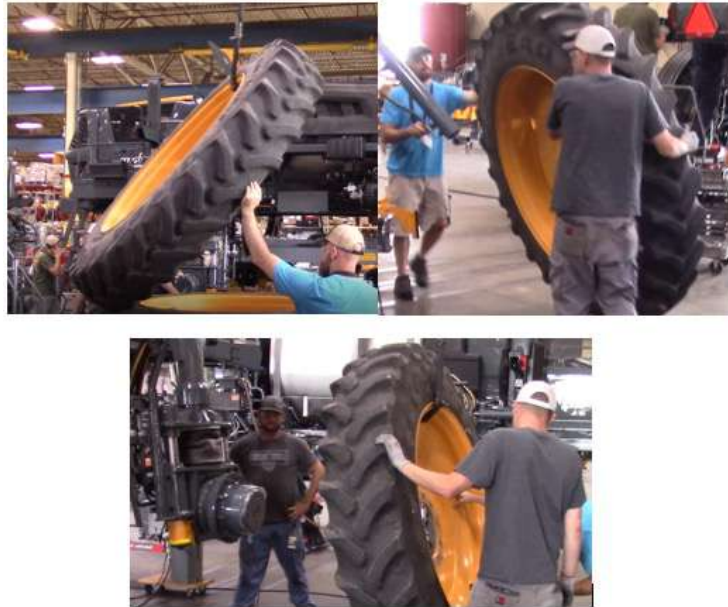
Before Photo

Operators would mount sprayer tires onto machine with overhead hoist, walk tire to hub, handle tire to orient and push onto hub, winch wheels together for alignment and tighten lug nuts. Hazards: Pinch/crush points. Upper body Ergo concerns. Strain on body.

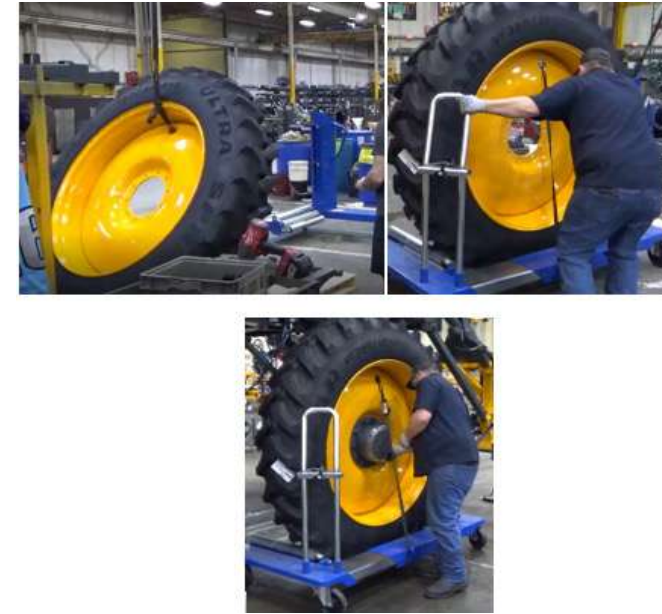
After Photo

Operators use hoist to place tire onto tire cart. Secure tire, pushcart with tire over to hub. Tire stays on cart until tire is secure on machine. This process eliminates an unstable load, strain of pushing wheel onto hub and reduces pinch and crush points. Less physical handling of tire.

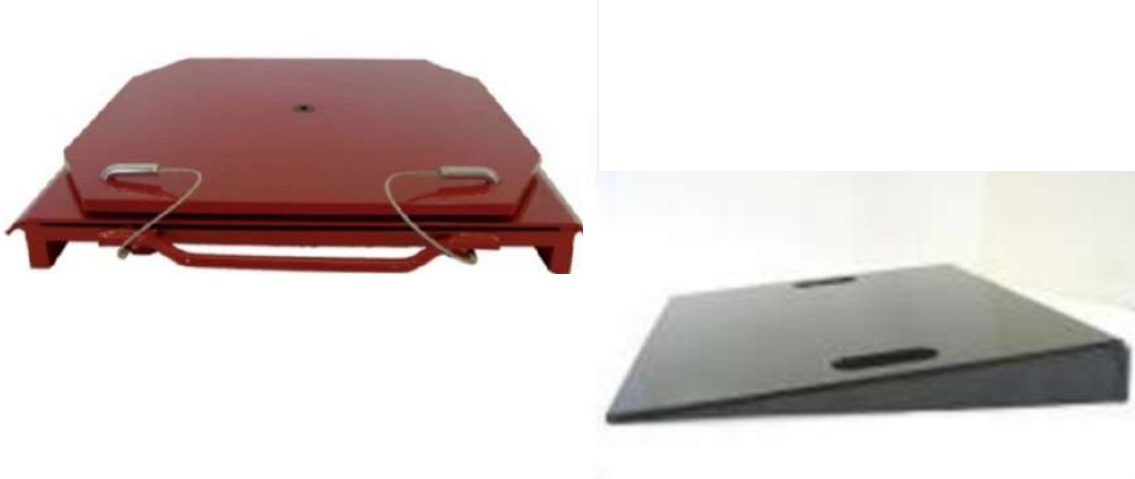
Before Photo

Operators had to carry turn plates, over 100#, for every machine to adjust toe-in on the front suspension along with ramp. Either had to be a two person lift or time-consuming use of cart.

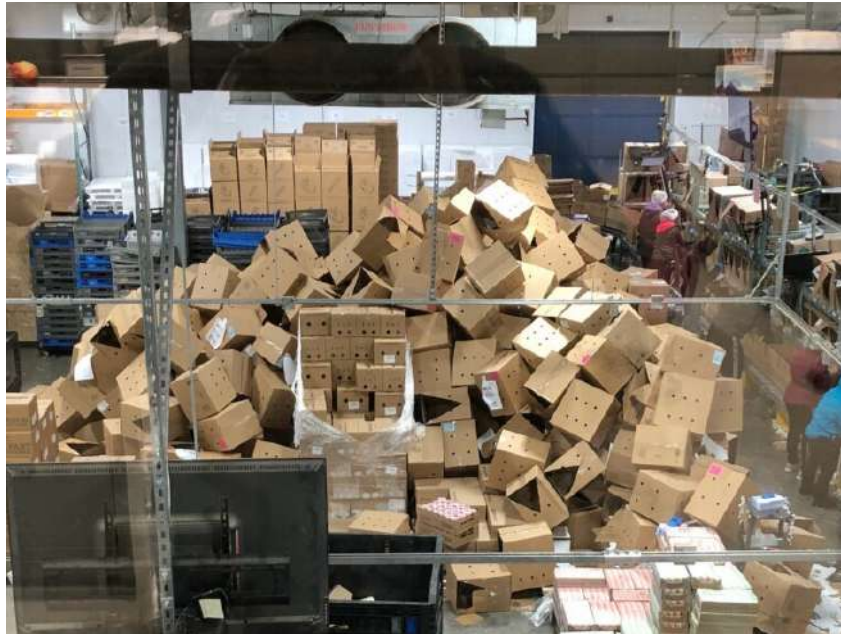
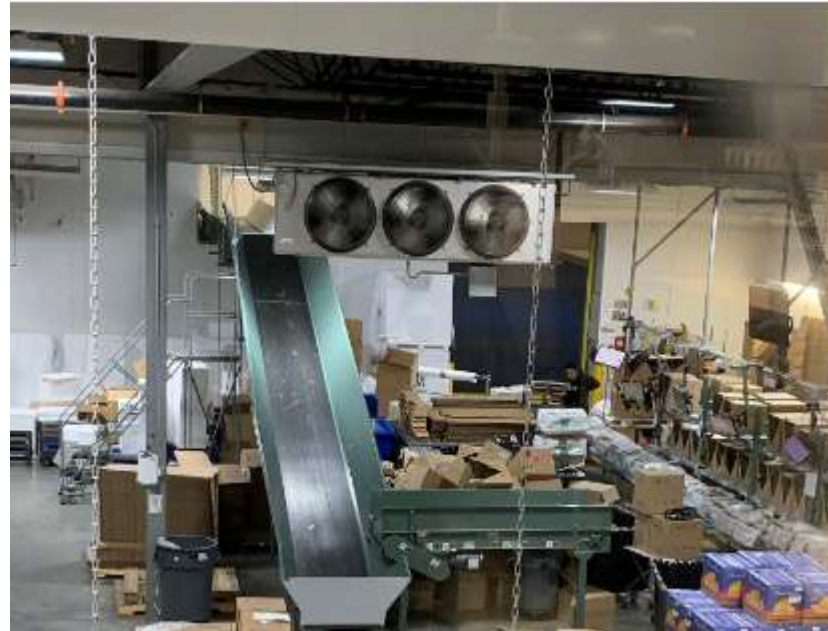
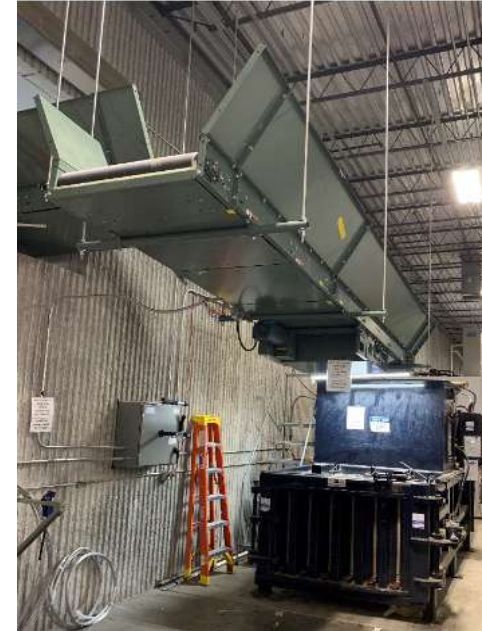
Engineering Control– The team designed and installed a way to move empty cardboard from production to a cardboard baler.

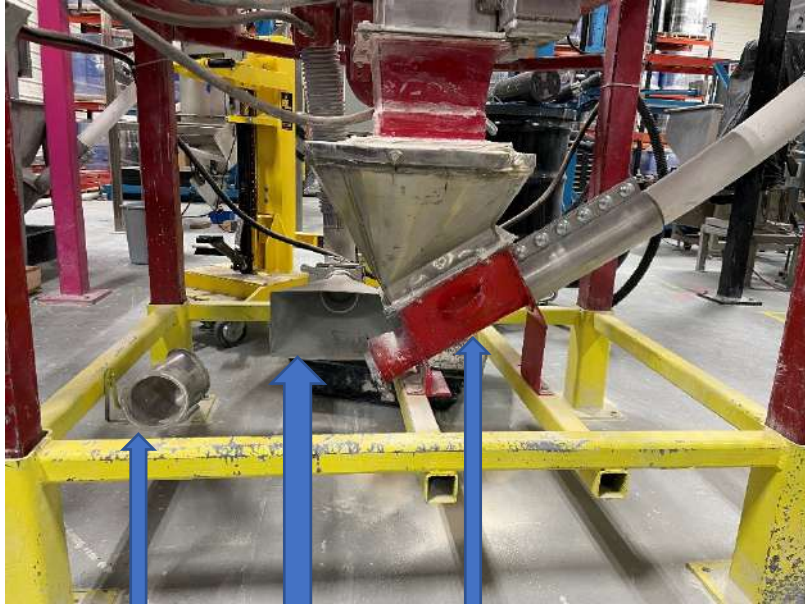
New elbow adaptor that helps retain auger during cleanout process and direct powder down to catch pan

Auger housing where residual powder needs to be cleaned from

Local ventilation hood to capture fugitive dust during auger cleanout

The BASF Ames manufacturing facility uses a dry powder auger system for a process at the site. This process required operators to cleanout residual powder between batches to avoid cross contamination of raw material lots. Site quality required employees to disassemble the auger housing and run auger in reverse to remove residual raw material before beginning next run. There were safety incidents associated with the task where the auger would come out of the housing causing hazards to employees. During normal cleanout, the process would generate fugitive dusts and the residual material was hard to capture. The employees responsible for this area worked with quality and maintenance to improve the process. The first improvement was to conduct a risk assessment of the cross-contamination concern between raw material lots. Working with quality, it was determined to be an acceptable risk to eliminate the between batch auger cleanout requirement. The auger still needed to be cleaned out at the end of each production week. Working with maintenance, the employees requested that a local ventilation hood be installed to capture fugitive dusts. Lastly, the maintenance team provided an elbow adaptor for the team to use to direct the flow of residual powder during clean out to a catch pan on floor. This elbow also eliminated the potential for the auger to reverse out of its housing during cleanout.

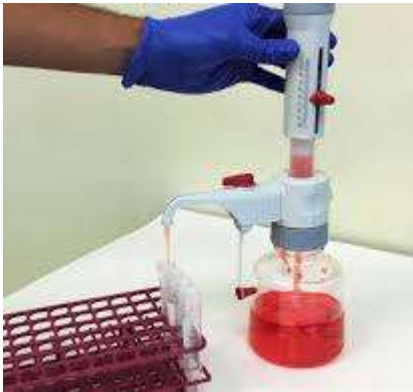
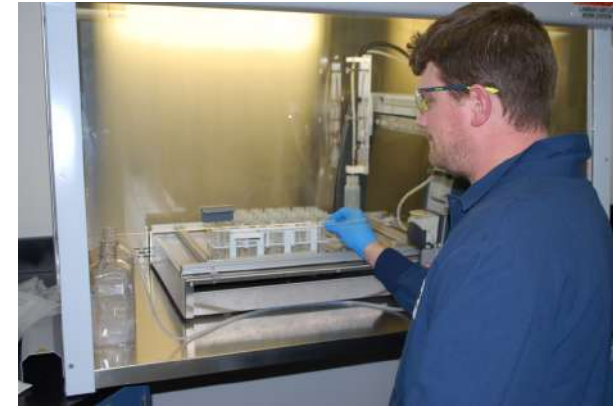
The BASF Ames manufacturing facility identified an ergonomic risk present in their quality assurance laboratory and in 2021 a team of lab employees sought out an automated tube filler and put together a proposal to management for purchasing the equipment. Prior to the new equipment employees would manually fill up to 500 individual 9 mL tubes in one day using a dispensette. This repetitive motion required hand operation of the tool and ergonomic risk was reduced by frequent breaks, stretching, and job rotation. The new tube filler is capable of filling up to 1,400 individual 9 mL tubes in a day. Employees setup the equipment and program how many tubes they need filled and to what volume and the equipment completes the filling task. The lab employees are proud of this hazard control project and reported positive impacts on efficiency and safety in the lab.

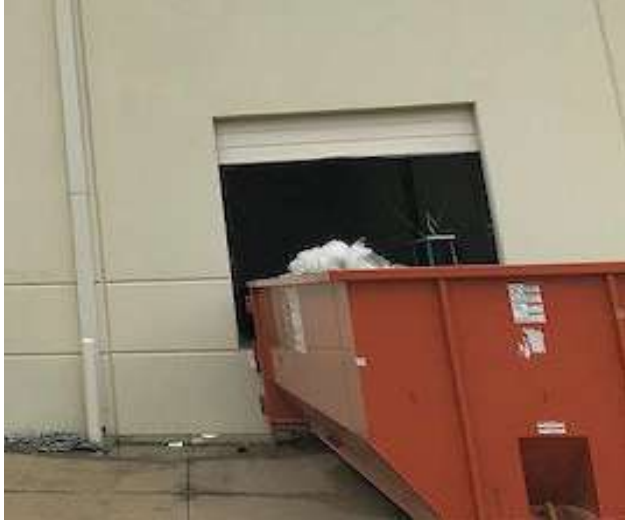
**Before Photo**

Above: A dumpster was placed outside of our loading dock, leading to several injuries from slip trip & falls and lifting above shoulder height injuries.

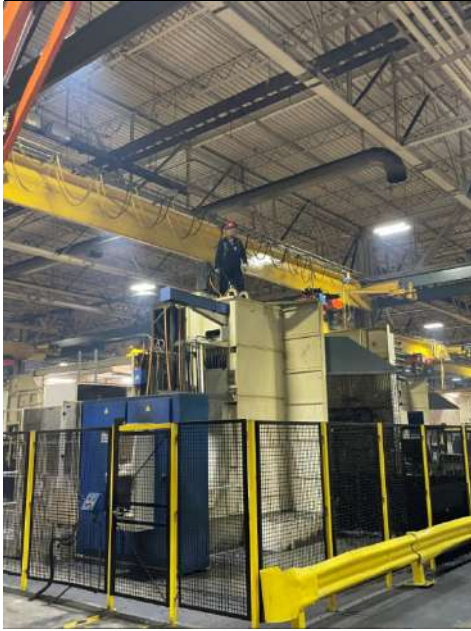
This project specifically targeted reducing fall hazard risk when working on top of our large component machining centers. We have ten of these machines across our operation and between the height of the machine above ground and the underground pit that surrounds this equipment, employees are working nearly 30 feet above ground and needed tie off points.

As a short-term process improvement, the maintenance team worked with our engineering team to develop fall restraint tie-off locations (left). To build on this success, the maintenance team contracted an engineering firm to accommodate the low overhead room available when using bridge cranes during normal operations. The solution provided was a custom telescoping fall arrest anchor point that built upon the original solution by raising the point of retention to improve employee safety and accommodate the working space available.

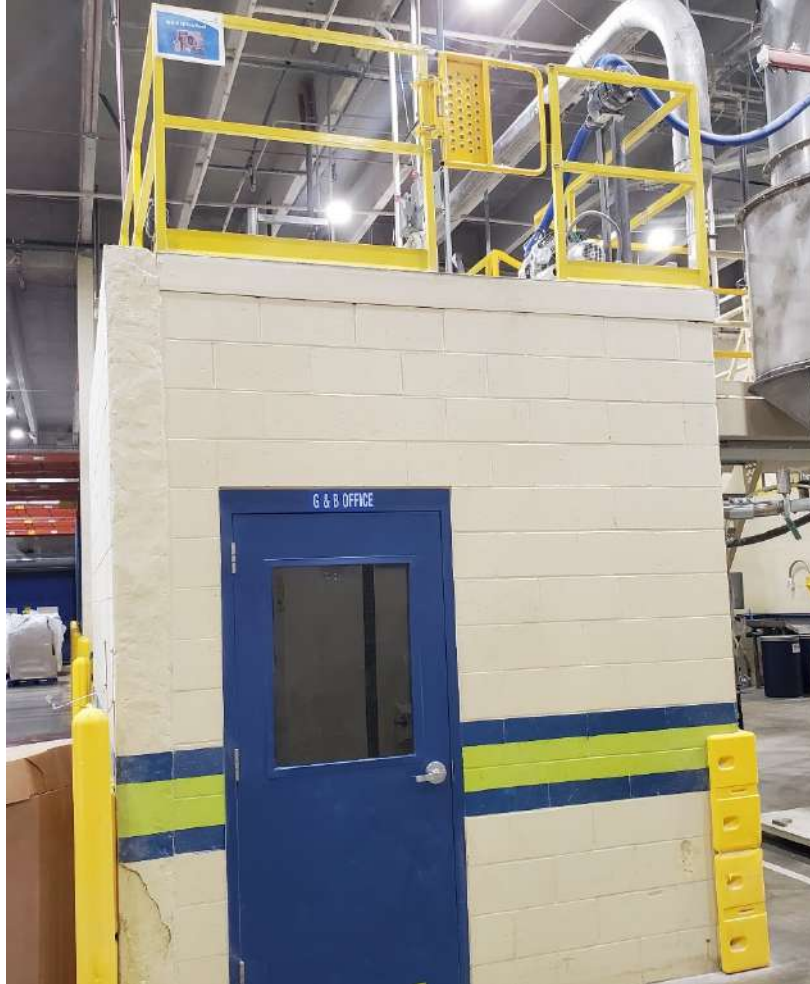
Before

Employees used to have to access the roof of the office to clean combustible dust on a regular basis with a scissor lift.

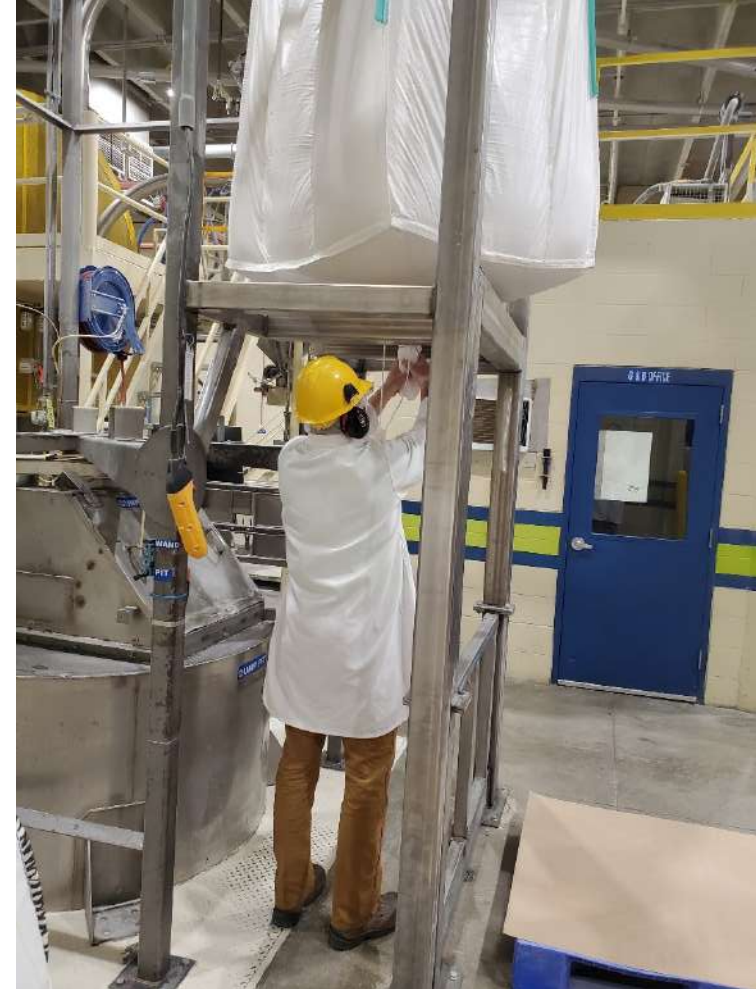
After

A safety structure was designed and installed to protect employees if they had to be under the load while opening the throat to drain the product.
